Model: Cor-C1.5	Date: 02-Dec-16	No.: RD2840013
-----------------	-----------------	----------------

Subject: Firmware Release Note: ProgramInfoService		Prepared by: R. Tsurumi	
From: 1st Tech Service Sect., MFP/Printer Tech Service Dept.			
Classification:	<input type="checkbox"/> Troubleshooting	<input type="checkbox"/> Part information	<input type="checkbox"/> Action required
	<input type="checkbox"/> Mechanical	<input type="checkbox"/> Electrical	<input type="checkbox"/> Service manual revision
	<input type="checkbox"/> Paper path	<input type="checkbox"/> Transmit/receive	<input type="checkbox"/> Retrofit information
	<input type="checkbox"/> Product Safety	<input checked="" type="checkbox"/> Other (Firmware)	<input checked="" type="checkbox"/> Tier 2

This RTB has been issued to announce the firmware release information for the **ProgramInfoService**.

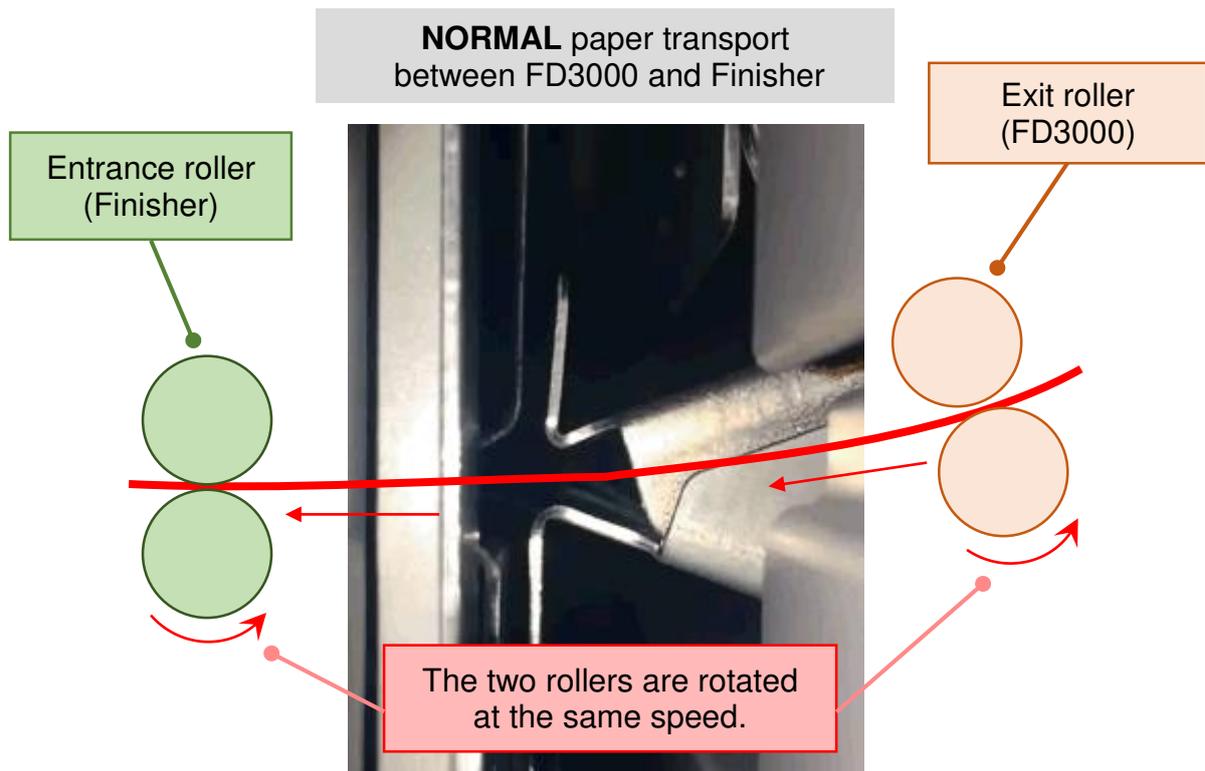
CAUSE

Firmware error (roller rotation speed control)

Due to the above error, the exit roller in the FD3000 is rotated at a higher speed than the entrance roller in the finisher (Normally, these speeds should be the same). This causes slack to develop in the paper, which then lifts up the upper metallic plate. As a result, the upper plate then drops onto the lower plate. Then a metallic “clinking” noise is produced.

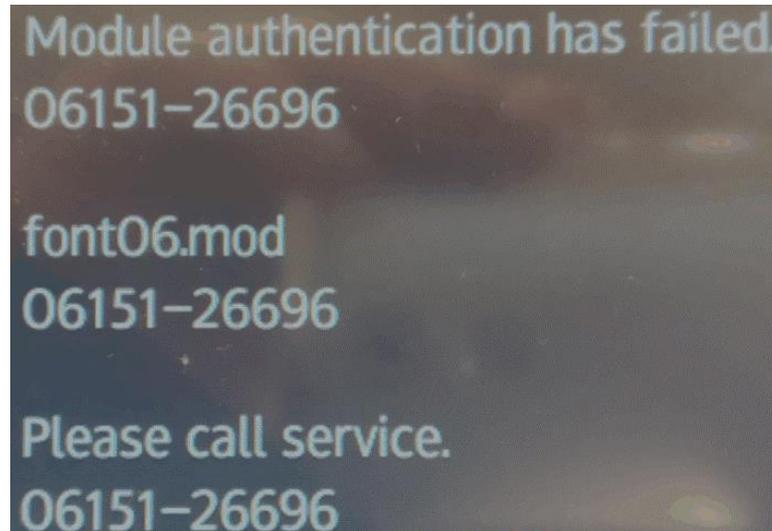
Important Notice about IRIPS Font Firmware

- **DO NOT update** the IRIPS Font firmware with **v1.03** (D2895596) in the field. This is the version that was pre-installed in the initial production lot.
- If you do, the following error message will appear and the main system will freeze. You will then have to replace the controller board.

- If you need to update the IRIPD Font firmware, use the **latest version** (Example: **v1.13**, which has already been released).
- Machines which still have the original v1.03 installed will work normally.

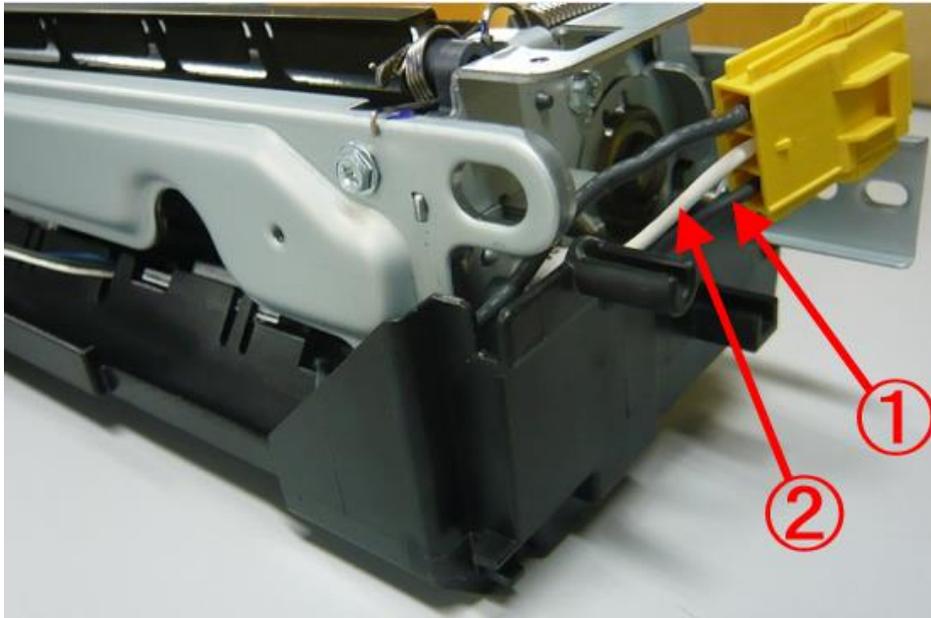
- ***How to distinguish between the four fusing units***

Step 1:***Remove the fusing upper cover.*****Step 2:*****Check the color of the two harnesses (#1 and #2).***

**Step 3:*****Identify the model from the table below.***

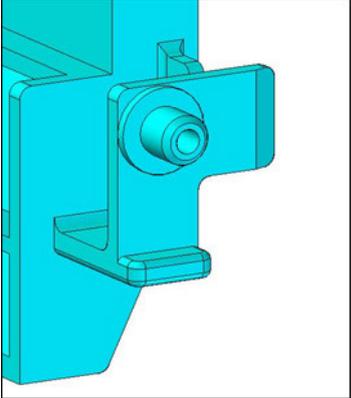
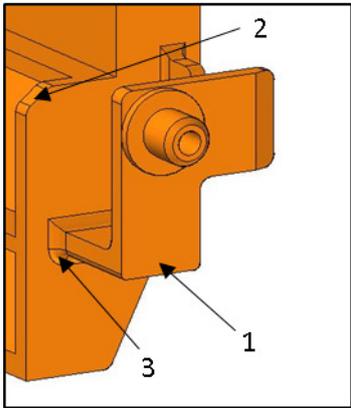
Old D1492721	New D6942721
Shape

Reason: To further strengthen and prevent breaking of the guide plate.

<ol style="list-style-type: none"> 1. Deleted stopper 2. Changed angle regulation 3. Strengthened part

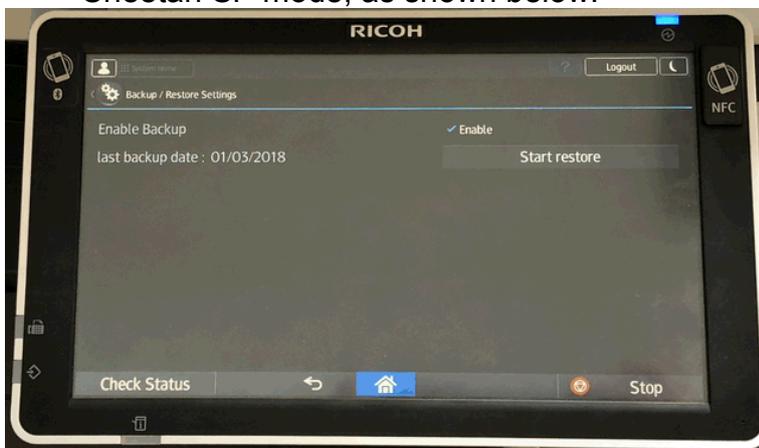
- This is because there is a bug with the operation panel backup feature. Specifically, the machine enters Energy Saver mode and freezes during the first backup performed (in early morning hours) after the feature is installed.
- To ensure this does not occur, **disable** the operation panel backup feature in the Cheetah SP mode, as shown below.

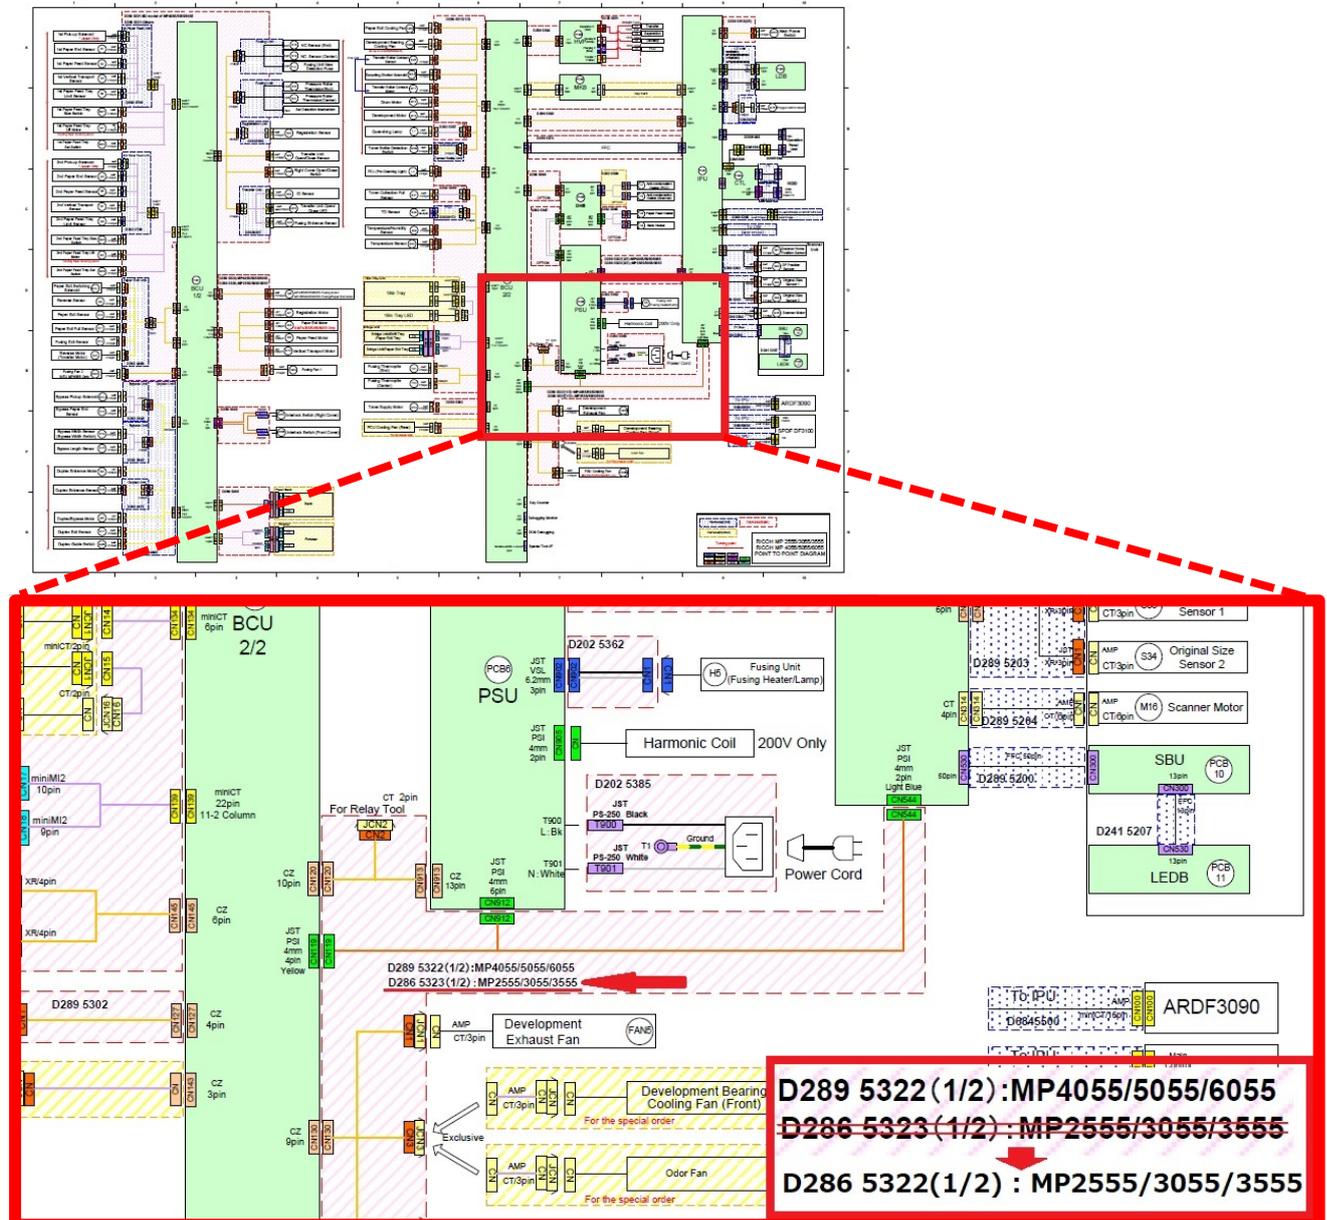
Point to Point Revision

The part number (D2865323) of the harness that runs from the PSU to the IPU and BCU is incorrect. The correct part number is D2865322. The incorrect part number in Point to Point is referred to in the figure below.

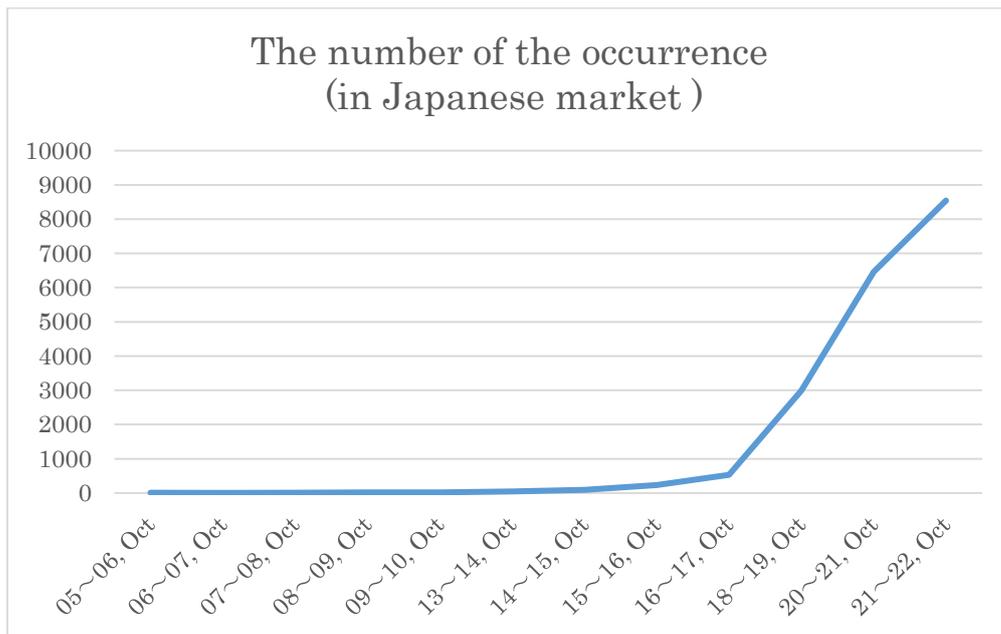
- **Occurrence number of SC899 occurrence (in Japanese domestic market)**

**IMPORTANT Notice about “System/Copy” Firmware
v1.28 (Met-C2), v1.14 (Met-C2.1),v1.16 (Cor-C1.5)**

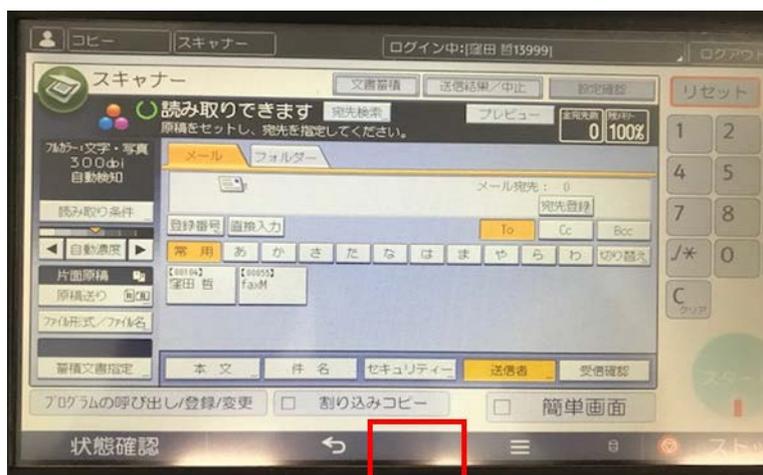
Specifically:

With firmware combination **#3** below, the Home button is not displayed, making it impossible to switch between applications.

Comb.	CheetahSystem	LegacyUI	Result
1	1.30 or older	1.22 or older	Good
2	1.31 or newer	1.22 or older	Good
3	1.30 or older	1.23 or newer	Problem occurs
4	1.31 or newer	1.23 or newer	Good
