Model: 1Bin Tray BN3110		Date: 4-Aug-15	No.: RD692001
Subject: JAM64		Prepared by: E.Hinata	
From: 1st Tech Service Sect., MFP/P Tech Service Dept.			
Classification:	<input checked="" type="checkbox"/> Troubleshooting	<input type="checkbox"/> Part information	<input type="checkbox"/> Action required
	<input type="checkbox"/> Mechanical	<input type="checkbox"/> Electrical	<input type="checkbox"/> Service manual revision
	<input type="checkbox"/> Paper path	<input type="checkbox"/> Transmit/receive	<input type="checkbox"/> Retrofit information
	<input type="checkbox"/> Product Safety	<input type="checkbox"/> Other ()	<input type="checkbox"/> Tier 2

Model: 1Bin Tray BN3110		Date: 25-Nov-15	No.: RD692002
Subject: Cannot remove jammed paper showing JAM code 64		Prepared by: T. Hirakawa	
From: 1st Field Quality Manement sect. FQM Dept.			
Classification:	<input checked="" type="checkbox"/> Troubleshooting <input type="checkbox"/> Mechanical <input type="checkbox"/> Paper path <input type="checkbox"/> Product Safety	<input type="checkbox"/> Part information <input type="checkbox"/> Electrical <input type="checkbox"/> Transmit/receive <input type="checkbox"/> Other ()	<input type="checkb

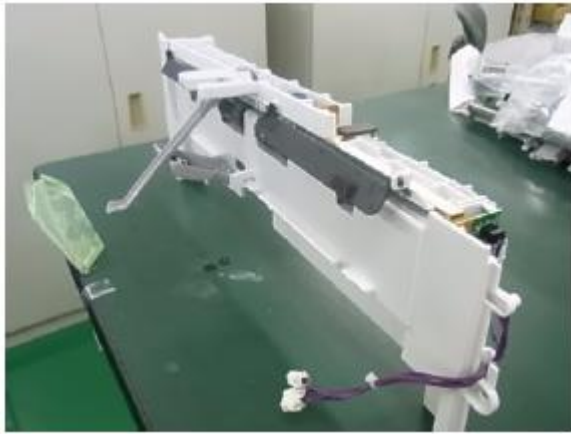
1. Remove the entire paper exit section of the 1-bin Tray from the machine.

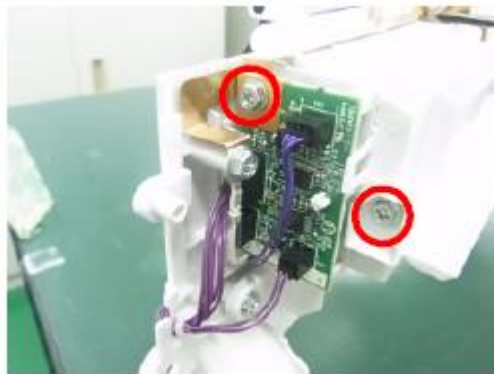
2. Remove the two screws.

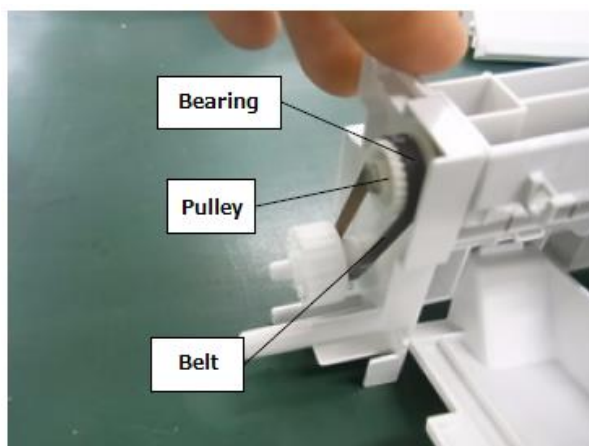
3. Remove the rear belt.

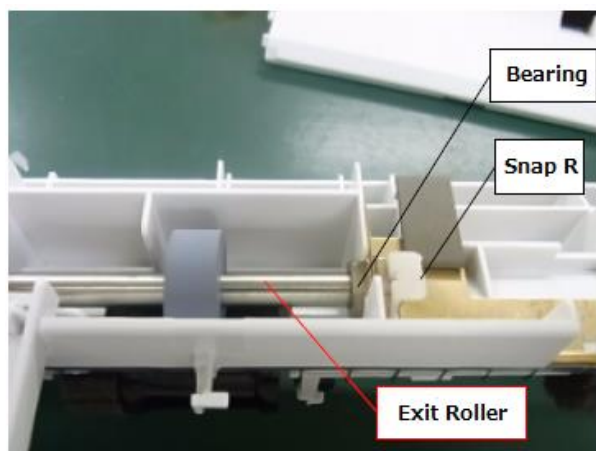
4. Remove the bearing and snap ring at the front (operator-side), and then remove the bearing pulley at the rear (non-operator side).

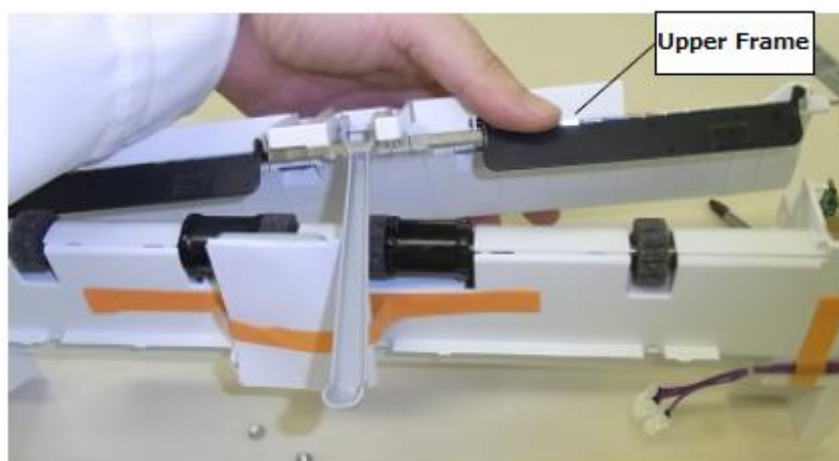
5. Remove the roller, and then remove the upper frame.

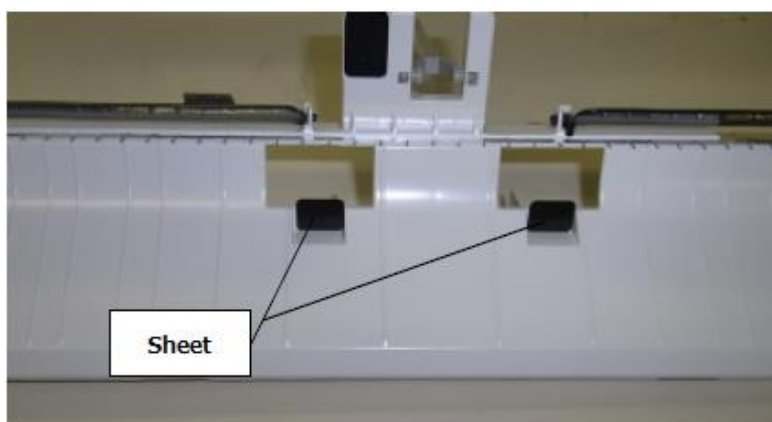
The leading edge of damp and curled paper tends to contact the guide Mylar that was added in front of the exit roller. The paper jams and becomes folded up (an accordion jam). As a result, the operator cannot see the jammed paper and initiates a service call.

6. Remove the two sheets from the upper frame.

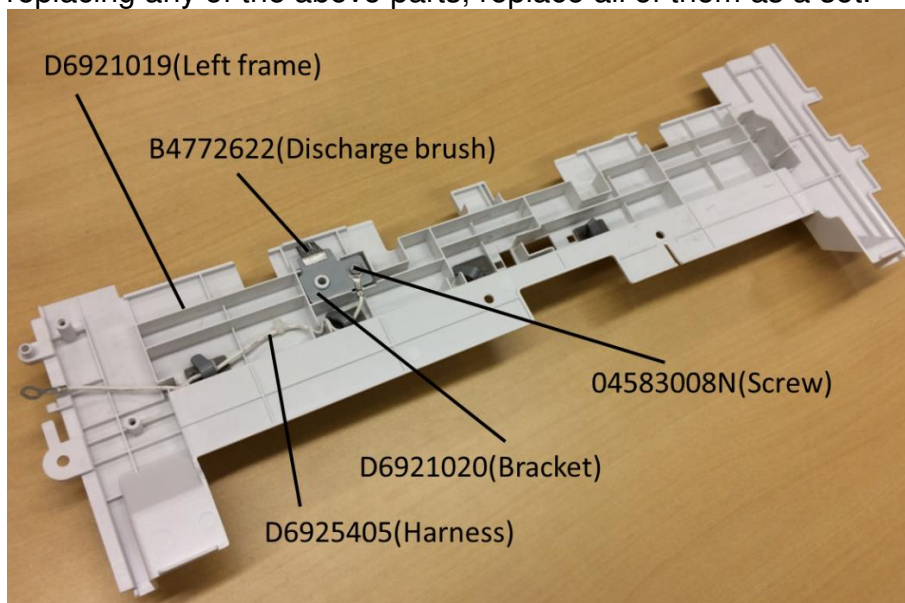
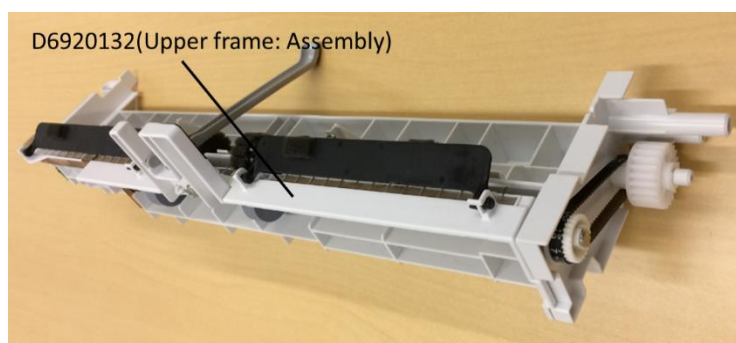
To lower the level of static noise generated.

NOTE: When replacing any of the above parts, replace all of them as a set.
