Model: ARDF DF3090		Date: 30-Oct-14	No.: RD779002
Subject: Parts Catalog Correction		Prepared by: Y.Kuwabara	
From: Improvement for reverse feeding in ARDF			
Classification:	<input type="checkbox"/> Troubleshooting <input type="checkbox"/> Mechanical <input type="checkbox"/> Paper path <input type="checkbox"/> Product Safety	<input checked="" type="checkbox"/> Part information <input type="checkbox"/> Electrical <input type="checkbox"/> Transmit/receive <input type="checkbox"/> Other (     )	<input type="checkbox"/> Action required <input type="checkbox"/> Service manual revision <input type="checkbox"/> Retrofit information <input type="checkbox"/> Tier 2

Model: ARDF DF3090		Date: 16-Jan-15	No.: RD779003
Subject: Poor stacking on ARDF DF3090 original exit tray		Prepared by: E.Hinata	
From: 1st Tech Service Sect., MFP/P Tech Service Dept.			
Classification:	<input checked="" type="checkbox"/> Troubleshooting <input type="checkbox"/> Mechanical <input type="checkbox"/> Paper path <input type="checkbox"/> Product Safety	<input type="checkbox"/> Part information <input type="checkbox"/> Electrical <input type="checkbox"/> Transmit/receive <input type="checkbox"/> Other (     )	<inpu

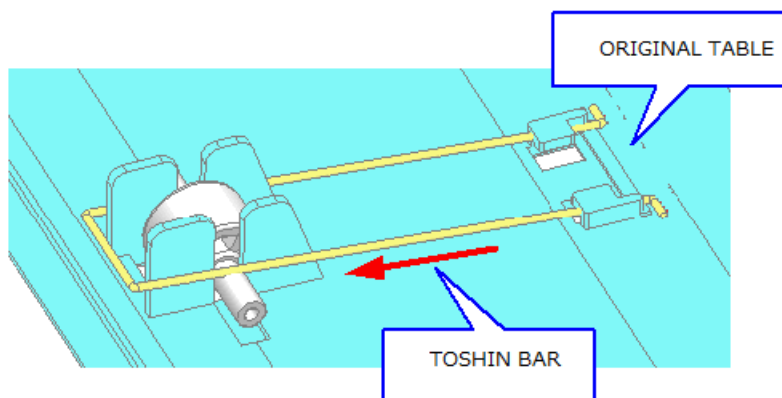
- 1) Added a fixed-position rib to the original table.
- 2) Lengthened the TOSHIN BAR.

**Reason:** To further improve ARDF reverse feed performance.

1. Attach the TOSHIN BAR and pull in the direction of the red arrow.
2. Attach the rib to the original table.

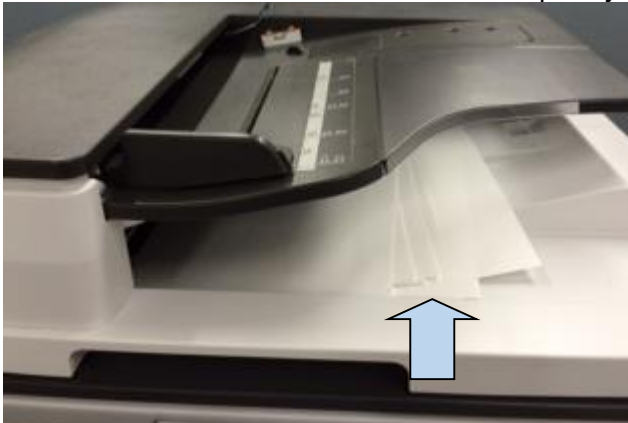
Originals fed from ARDF DF3090 are stacked poorly on the original exit tray.

- Originals are designed to exit slightly faster as soon as scanning completes.
- The original exit tray is not level between the operator and non-operator sides.

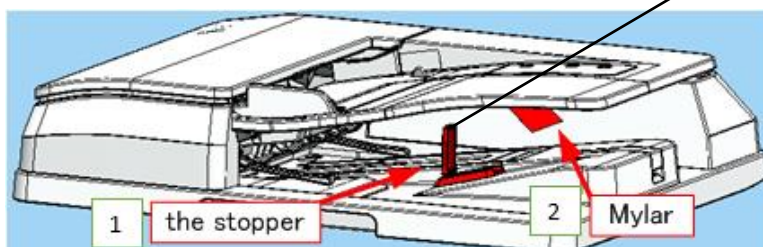
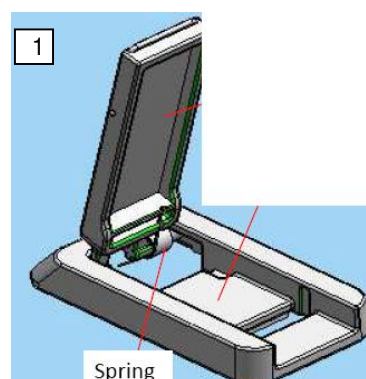
If poor stacking still occurs with A4/LT LEF, attach the following parts.

Attach stopper [1] and Mylar [2] (See **Procedure** below).

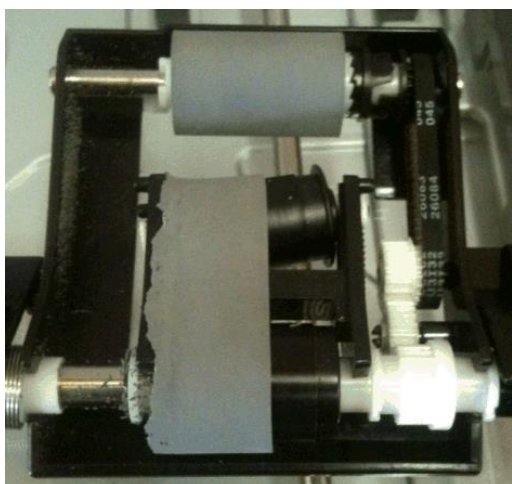
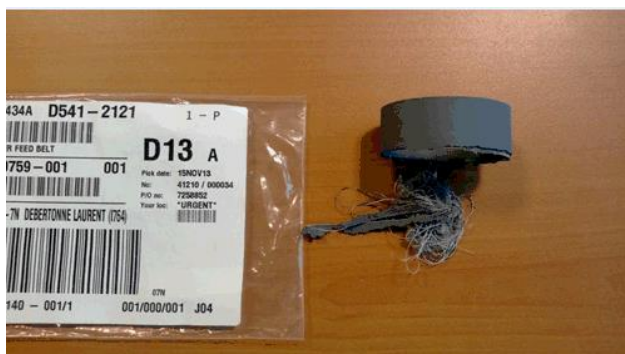
The thread in the feed belt comes apart. Eventually, the belt is torn.

When a user pulls jammed paper forcibly toward the front or rear side of machine, the belt shifts to one side and goes over the flange of the roller.

Replace the feed belt (D5412121) with the modified part (D6842171).

With this part change, the material has been changed so as not to shift to one side easily.

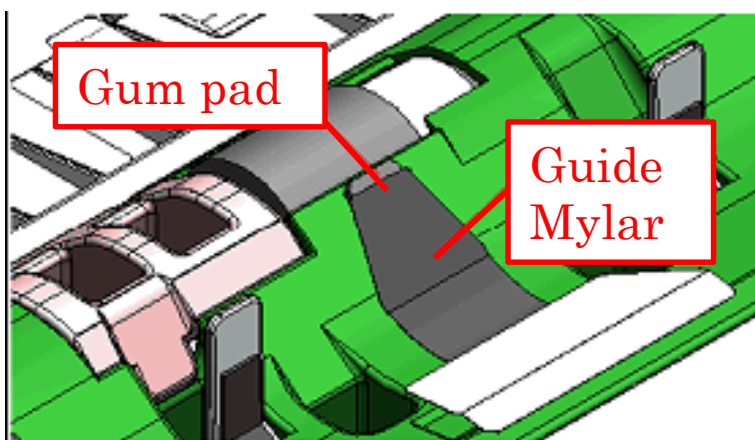
Multi-feeds may occur when feeding originals with the DF3030.

The friction between originals is too high for the friction pad to separate the sheets.

A rubber pad and guide Mylar were added.
