Model: Paper Feed Unit PB3210/PB3220	Date: 04-Dec-13	No.: RD787001c
--------------------------------------	-----------------	----------------

Subject: Firmware Release Note: Paper Feed Unit PB3210/PB3220		Prepared by: E. Hinata	
From: 1st Tech Service Sect., MFP/Printer Tech Service Dept.			
Classification:	<input type="checkbox"/> Troubleshooting	<input type="checkbox"/> Part information	<input type="checkbox"/> Action required
	<input type="checkbox"/> Mechanical	<input type="checkbox"/> Electrical	<input type="checkbox"/> Service manual revision
	<input type="checkbox"/> Paper path	<input type="checkbox"/> Transmit/receive	<input type="checkbox"/> Retrofit information
	<input type="checkbox"/> Product Safety	<input checked="" type="checkbox"/> Other (Firmware)	<input checked="" type="checkbox"/> Tier 2

Model: Paper Feed Unit PB3210		Date: 23-Jan-15	No.: RD787002
Subject: The paper tray is displayed as being empty, even while there is still paper in the tray.		Prepared by: E.Hinata	
From: 1st Tech Service Sect., MFP/P Tech Service Dept.			
Classification:	<input checked="" type="checkbox"/> Troubleshooting	<input type="checkbox"/> Part information	<input type="checkbox"/> Actio

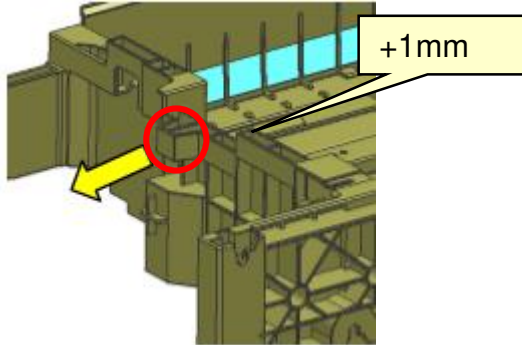
Paper tray rear side:

Heat or cold during machine transportation deforms the paper trays, causing the tray not to contact the push switch on the mainframe.

The part of the paper tray that contacts the push switch was increased in size by 1mm. See the diagram below.

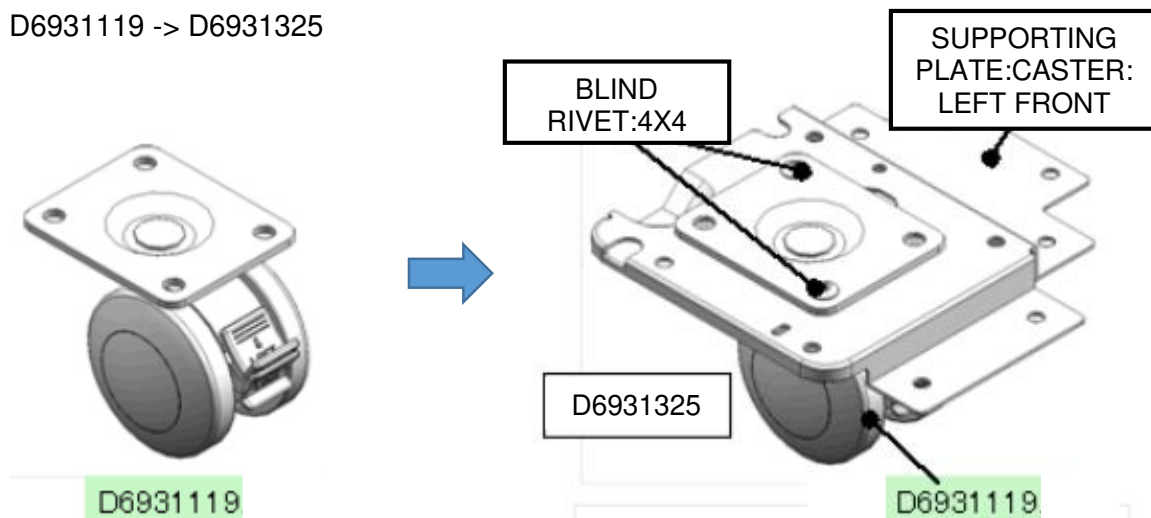
D6931119 -> D6931325

1. To improve the part's strength against shock vibration.
2. To make the part easier to replace in the field.

1. The caster and plate were registered together as an assembly.
2. The shape of the arm cover was changed.
