Model: Finisher SR3230, SR3240		Date: 26-May-16	No.: RD3BA002
Subject: Accessory trays of other models		Prepared by: Y.Ino	
From: 1st Tech Service Sect., MFP/P Tech Service Dept.			
Classification:	<input type="checkbox"/> Troubleshooting <input type="checkbox"/> Mechanical <input type="checkbox"/> Paper path <input type="checkbox"/> Product Safety	<input type="checkbox"/> Part information <input type="checkbox"/> Electrical <input type="checkbox"/> Transmit/receive <input checked="" type="checkbox"/> Other (Information)	<input type="checkbox"/> Action required <input checked="" type="checkbox"/> Service manual revision <input type="checkbox"/> Retrofit information <input type="checkbox"/> Tier 2

Subject: Poor stacking of stapled job		Prepared by: Y.Taniguchi	
From: 1st Tech Service Sect., MFP/P Tech Service Dept.			
Classification:	<input checked="" type="checkbox"/> Troubleshooting	<input type="checkbox"/> Part information	<input type="checkbox"/> Action required
	<input type="checkbox"/> Mechanical	<input type="checkbox"/> Electrical	<input type="checkbox"/> Service manual revision
	<input type="checkbox"/> Paper path	<input type="checkbox"/> Transmit/receive	<input type="check

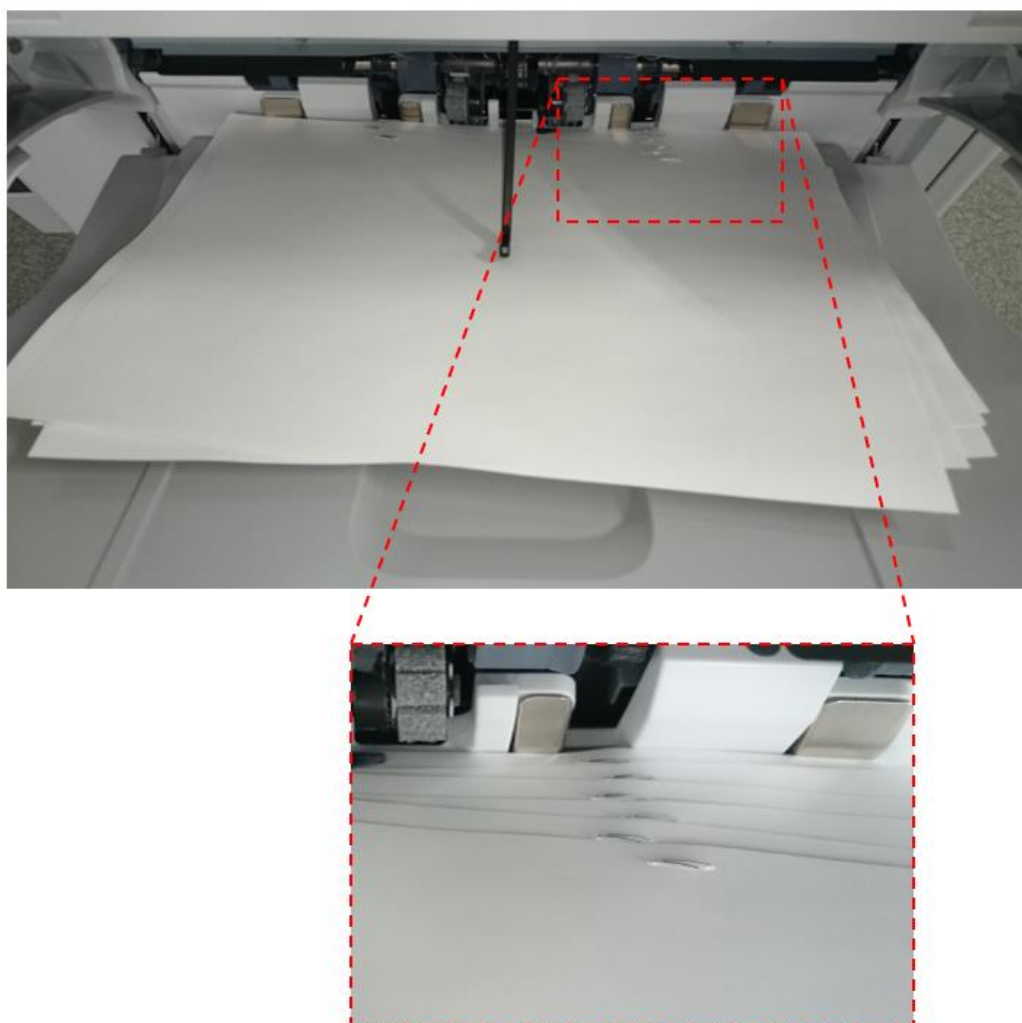
A4 booklets (2 sheets x 50), fed LEF, stapled at corner

Stapled booklets are misaligned in the exit tray as shown below.

Stapled jobs are not fed out at the correct speed. Specifically, they are fed out faster than on predecessor finishers (SR3160/SR3170).

As a result, booklets tend to be pushed farther out when fed out. When each booklet then slides back down to settle into the stack, its trailing edge catches on the staple of the booklet already stacked underneath it. This happens with several booklets many times in a row, producing the type of staggered alignment shown in the photo above.

The Finisher firmware was modified so as to optimize the speed at which the booklets are fed out (Applied from: May 2016).

Update the Finisher firmware to **ver.1.050.07** or newer.

Note: *This firmware prevents the misalignment from continually occurring, i.e. on several booklets many times in a row. The booklets may still catch on the staple intermittently a few times.*

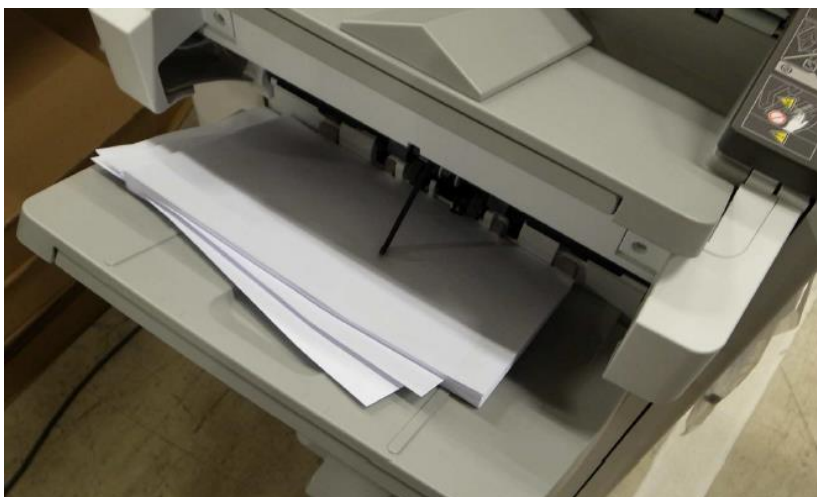
Example: Two sheets protruding from a stack of 50.

One or more sheets (A4/LT or smaller) protrude from the stack when the sheet(s) are fed out to the tray late.

The edge of the guide Mylar protrudes over the paper exit roller.

When the affected sheet(s) are fed out to the tray late, the paper rides up on the guide Mylar. As a result, the sheet(s) are then pushed by those behind them.

Re-attach the guide Mylar (see **PROCEDURE** below).

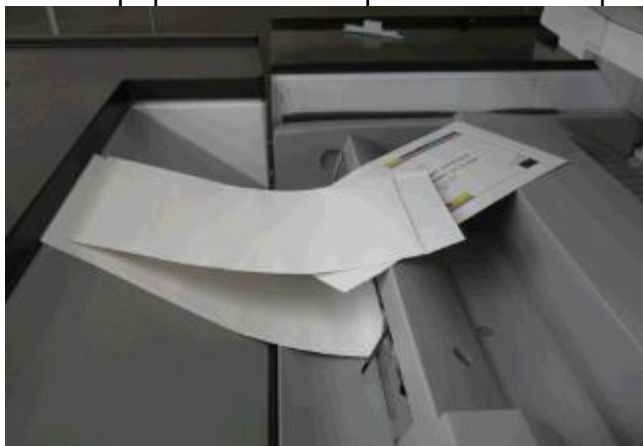
Banner paper and envelopes are stacked poorly.

Procure and attach the following mylar, which was designed specifically for this purpose.

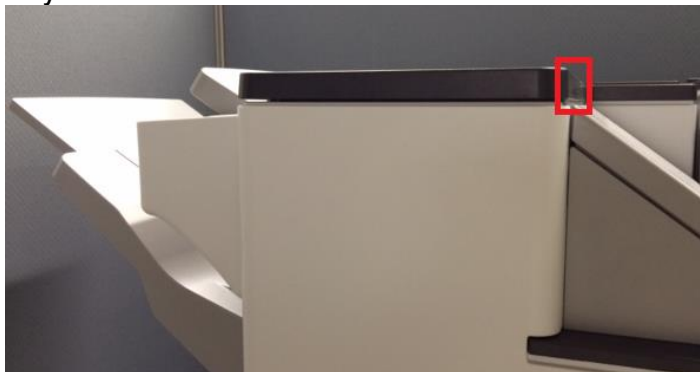
The sheets hit the top cover at the location in the red square below when fed out to the tray.
