Model: Hadar-PJ1XGA		Date: 30-Oct-15	No.: RY088001
Subject: I/O shift issue		Prepared by: T. Takahashi	
From: 1st Tech Service Sect., MFP/P Tech Service Dept.			
Classification:	<input checked="" type="checkbox"/> Troubleshooting <input type="checkbox"/> Mechanical <input type="checkbox"/> Paper path <input type="checkbox"/> Product Safety	<input type="checkbox"/> Part information <input type="checkbox"/> Electrical <input type="checkbox"/> Transmit/receive <input type="checkbox"/> Other ()	<input type="checkbox"/> Action required <input type="checkbox"/> Service manual revision <input type="checkbox"/> Retrofit information <input type="checkbox"/> Tier 2

Affected models: Hadar-PJ1XGA (Y088)

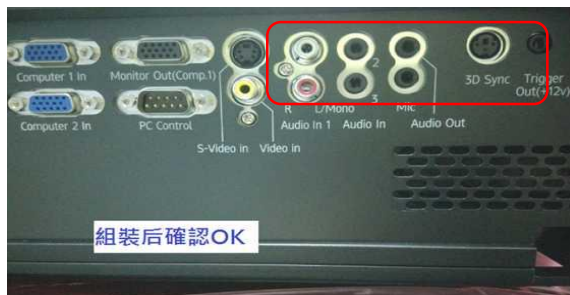
Normal:

The I/O port on the MB Module cannot be accessed (connector cannot be connected).

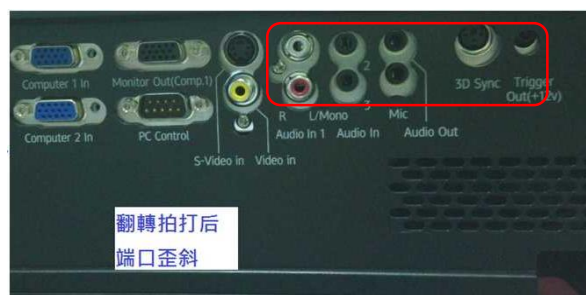
Abnormal:

The screws on the right side of the MB bottom shielding come loose. As a result, the MB module is raised with respect to the outer cover.
