## Technical Bulletin

Reissued: 23-Jun-04 Model: Neptune-C1

Subject: BICU & SCU Firmware Modification History			Prepared by: F.Noguchi		
From: 2nd Tech. Support Sec. Service Support Dept.					
Classification:	<ul> <li>Troubleshooting</li> <li>Mechanical</li> <li>Paper path</li> <li>Other ()</li> </ul>	Part informat     Electrical     Transmit/rec	ion eive	<ul> <li>Action required</li> <li>Service manual revision</li> <li>Retrofit information</li> </ul>

Model: Neptune-C1			Dat	e: 23-Jun-04	No.: RB125002	
Subject: Black Spots				Prepared by: F.Noguchi		
From: 2nd Tech Support Sec. Service Support Dept.						
Classification:	Troubleshooting	Part info	ormat	tion 🗌 Ac	tion required	
	Mechanical	Electric	al	🗌 Se	ervice manual revision	
	Paper path Transmit/re		it/rec	eive 🗌 Re	etrofit information	
	Other ()

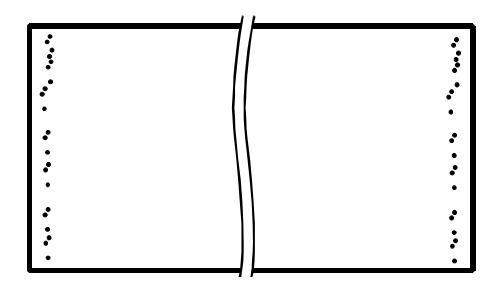
Black spots appear on the right and/or left edges of printouts that are 841mm or greater in width.

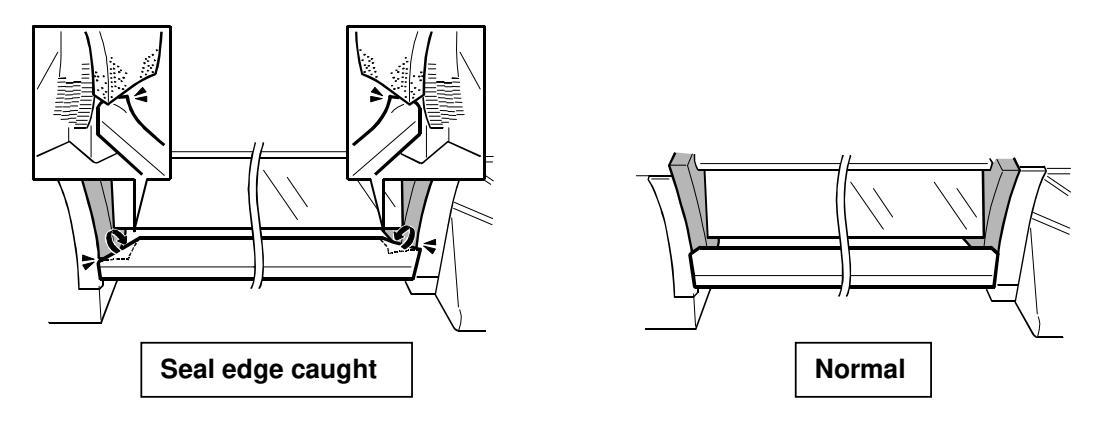
The edge of the cleaning unit entrance seal is caught under the side seal(s), allowing toner to drop down from the cleaning unit.

- Check if the edge of the entrance seal is out of position, and reposition the seal if necessary.
- Clean the transfer & separation corona unit, because toner can sometimes accumulate on this surface.

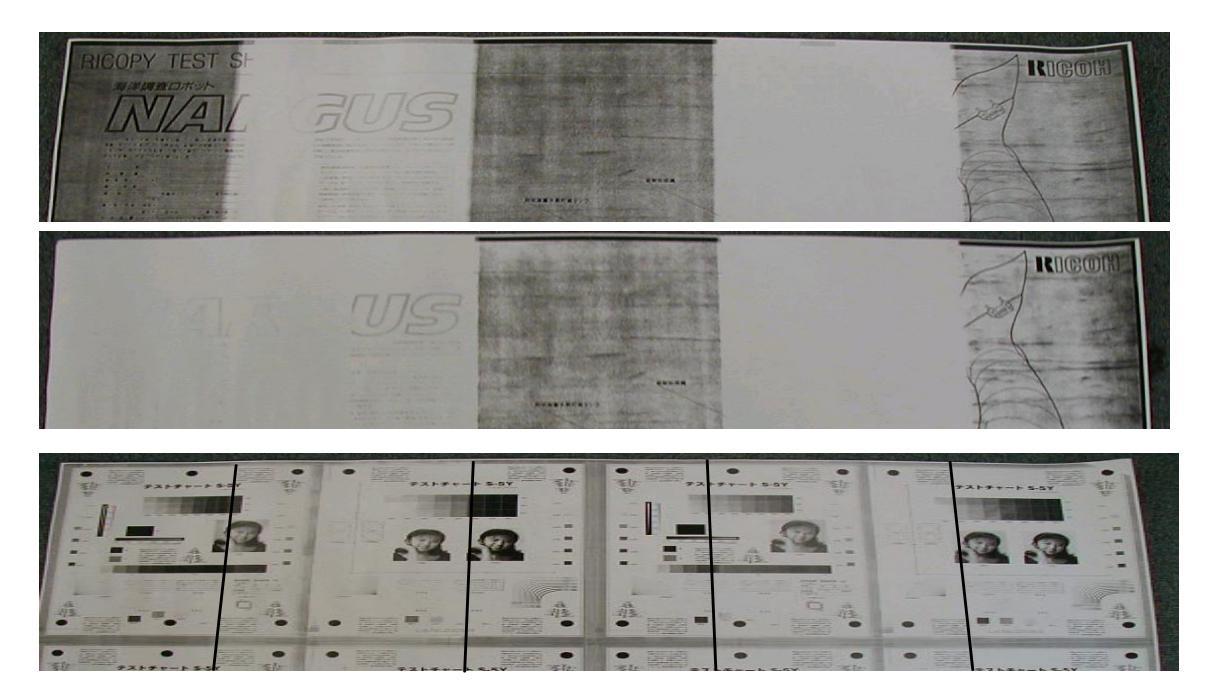
Case 1: The image density is low at CIS #2 and CIS #4.

CIS #5	CIS #4	CIS #3	CIS #2	CIS #1
	Low Image Density		Low Image Density

- **Case 1:** The machine is installed near a window, and direct sunlight gets into the CIS areas (inside the Scanner section).
- Case 2: The white plate is not flat against the original.

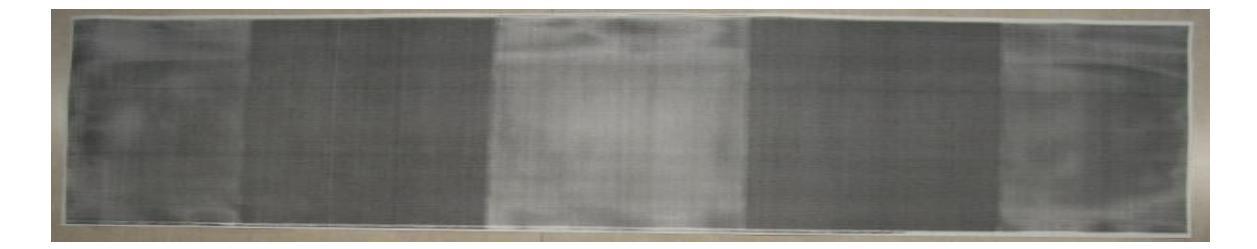
**Case 2**: The image density is low at CIS #1, CIS #3 and CIS #5.

CIS #5	CIS #4	CIS #3	CIS #2	CIS #1
Light image		Light image		Light image
density (lighter		density (lighter		density (lighter
than normal)		than normal)		than normal)

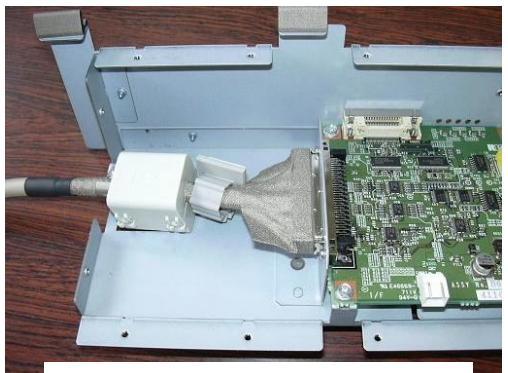
1. During transport, the shipping clamp for the ferrite core harness disconnects from the I/F unit frame. As a result, the ferrite core vibrates and the PCB connector comes loose.

Clamp disconnects completely

- 1. When you install the I/F unit, open the I/F unit cover and make sure that the connectors are connected correctly. If they are not, reconnect them.
- 2. Replace the gold harness clamp with the new N4 clamp and tapping screw (M3x8).

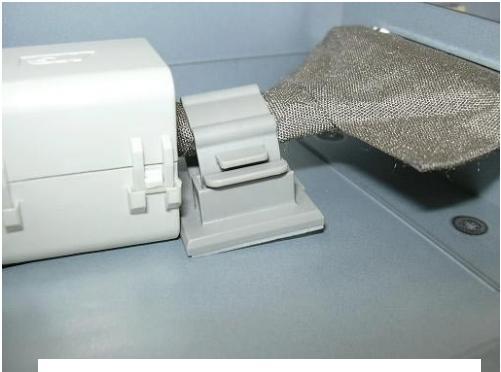
Clamp disconnects partially

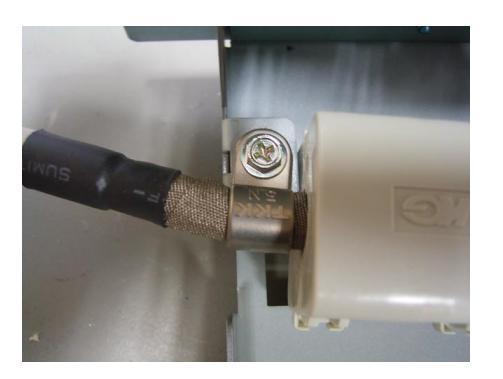
2. At I/F unit installation, the ferrite core harness is pulled strongly and the gold harness clamp comes loose. As a result, the PCB connector comes loose.
