## Technical Bulletin

Model: SP5			Date	e: 15-Oct-98	No: 1	
Subject: DIP SW of I/O Board				Prepared by: M.Tsuyuki		
From: GTS and S Field Infomation Dept						
Classification:	Troubleshooting	Part informat		tion Actio	n required	
	Mechanical	Electrical		🖂 Serv	ice manual revision	
	Paper path	Transmit/rec		eive 🗌 Retro	ofit information	
	Other ()

Model: SP5 Da			Dat	e: 31-Oct-	No.: 4	
Subject: Development Entrance Seal Replacement				Prepared by: A. Sasaki		
From: GTS and S Field Information Dept.						
Classification:	<ul> <li>Troubleshooting</li> <li>Mechanical</li> <li>Paper path</li> <li>Other ()</li> </ul>	Part info Electric Transm	ormat al it/rec	ion [ [ eive [	Actior	n required be manual revision fit information

Model: SP5				e: 30-Nov	/-98	No.: 5
Subject: Black Spots on First Copy after Warming up				Prepared by: A. Sasaki		
From: GTS and S Field Information Dept.						
Classification:	Troubleshooting	Part info	ormat	tion	Action	n required
	Mechanical		al	al 🗌 Se		ce manual revision
	Paper path	Transmit/re		eive	Retro	fit information
	Other ()

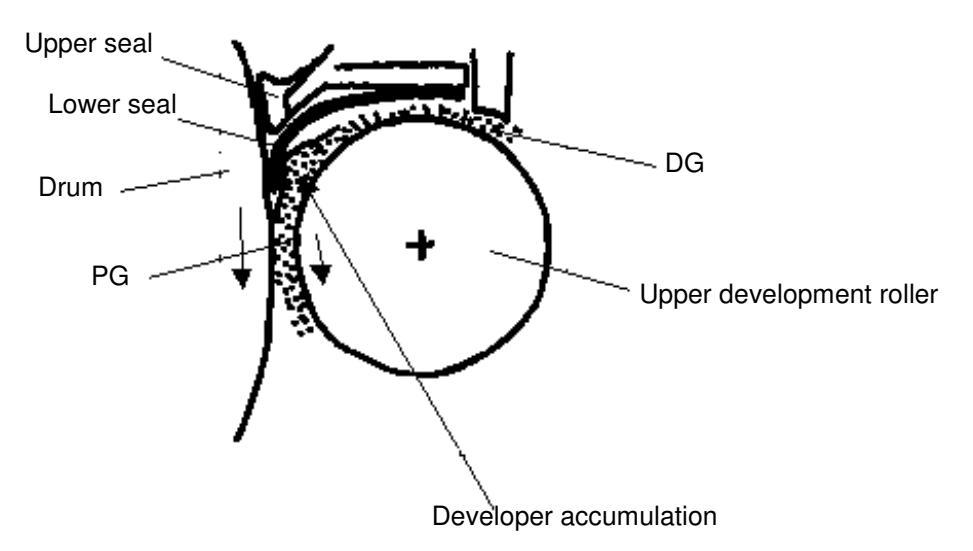
The lower seal (straight; the upper seal is a loop) of the development unit entrance seal ass'y (P/N A2293092) may get pinched between the developer and the drum if a large amount of developer accumulates near the photoconductor gap (PG). The seal may be pulled out of position by the friction caused by the rotation of the drum. In the worst case, the seal would peel off.

The width of the lower seal is 18 mm, which may be too much. This problem does not occur with the previous entrance seal ass'y (P/N A0963103) that has a width of 17mm.

The width of the lower seal will be returned to the original 17 mm from 18 mm. Though the 17 mm lower seal may wrap up, the function of this part is not adversely affected. The part number of the new development unit entrance seal ass'y will be A2293091.

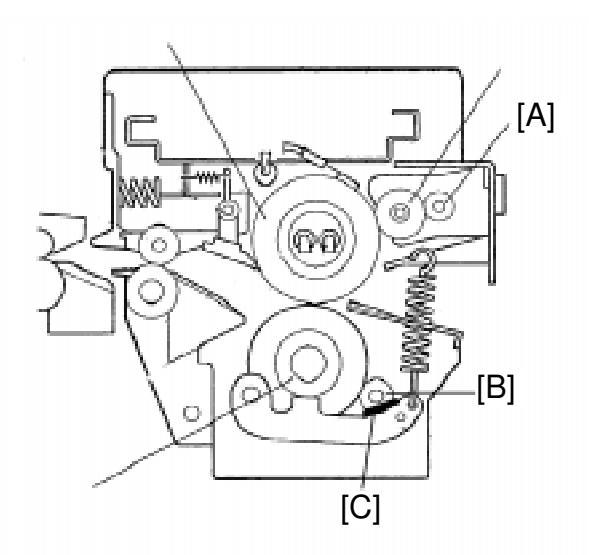
When the machine turns off and the temperature of the fusing unit becomes low, toner adheres less strongly to the hot roller cleaning roller [A] and pressure roller cleaning roller [B]. In this condition, the toner on the hot roller cleaning roller [A], pressure roller cleaning roller [B] or pressure roller cleaning brush [C] may be transferred back to the hot roller or pressure roller and may finally adhere to the first copy after warming up.

This problem depends on how much calcium carbonate comes out from the copy paper and mixes with toner. When more calcium carbonate is mixed with toner, the problem becomes worse if the brush [C] is not installed.

That is why the pressure roller cleaning brush [C] is installed only in the European and Asian/Oceanian models to remove toner from the pressure roller cleaning roller [B]. (The brush is not installed in the American model.)

- Please change the setting of SP1-103 from 0 (5.5 min) to 2 (15 min). A longer fusing idling time can help to make the temperature of the pressure roller just after warming up higher.
- 2. Please judge the necessity of the pressure roller cleaning brush by looking how the mixture of toner and calcium carbonate adheres to the cleaning roller surface.

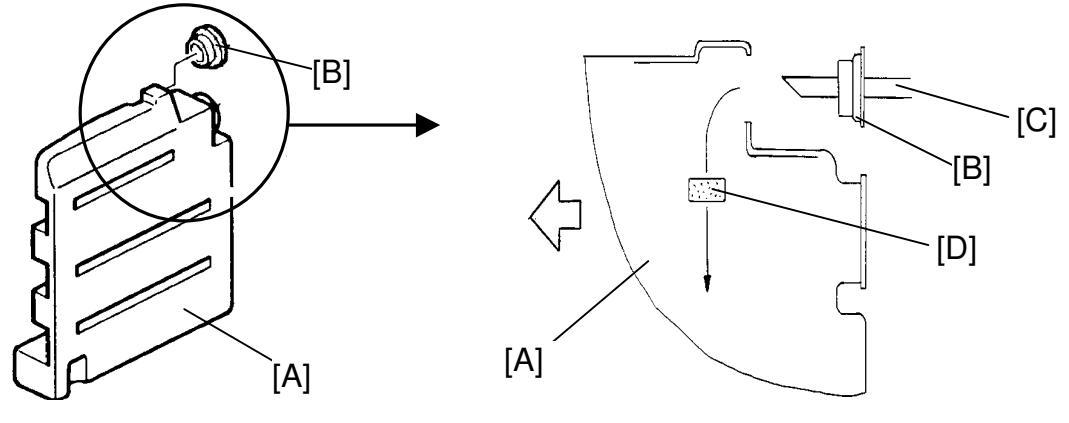
When the toner collection bottle is installed, it might not be inserted all the way.

Please note that when removing the bottle [A], the cap [B] of the bottle hole might remain on the nozzle [C] and the sponge seal [D] inside the cap may drop into the bottle.

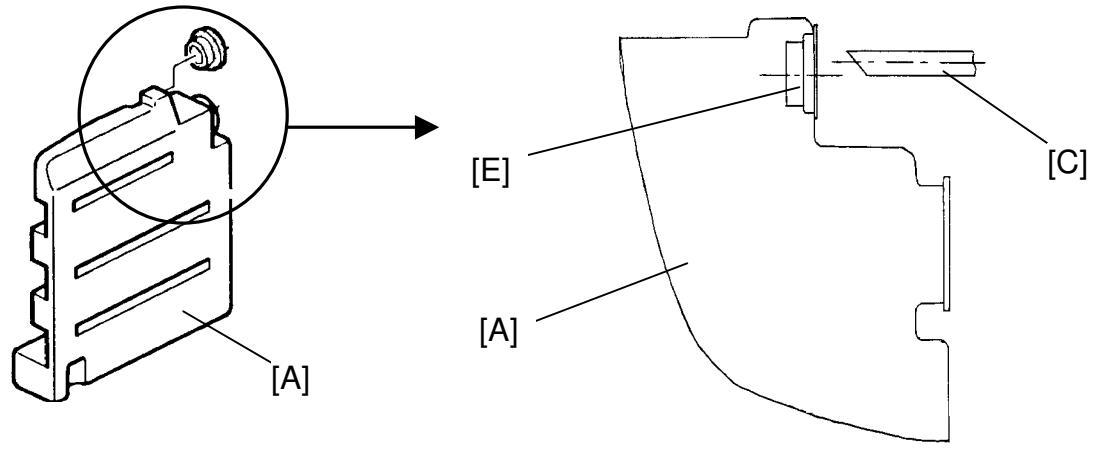
The positions of the opening [E] in the bottle and the toner collection nozzle [C] are mismatched by a few millimeters due to a production error on the bottle.

The production process of the bottle has been reviewed and corrected.

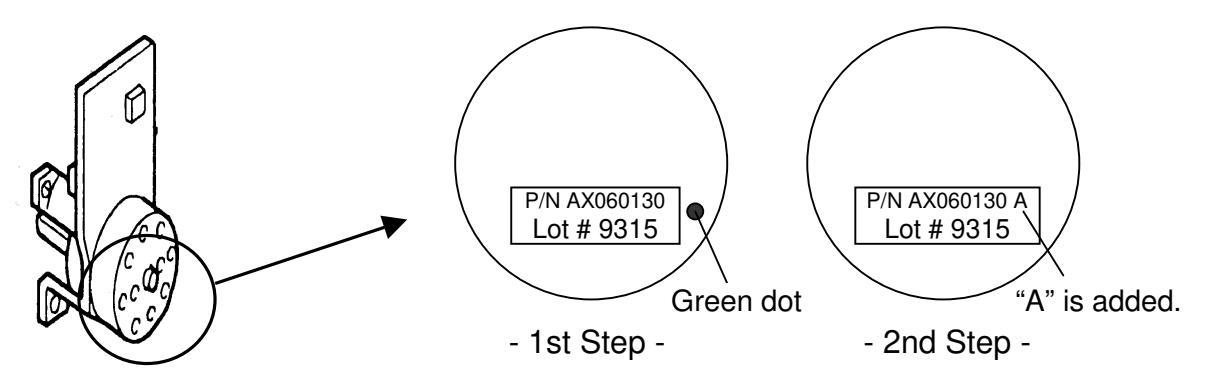
An IC on the motor control board attached to the lift motor is damaged and the lift motor cannot be controlled.

Static electricity is a possible cause.

To prevent the IC from being damaged, a resistor has been added to the motor control board.

- 1st Step: A green dot has been added to the right side of the lot number label as shown.
- 2nd Step: The suffix of the part number has been changed from no suffix (AX060130) to "A" (AX060130 A) on the lot number label as shown.

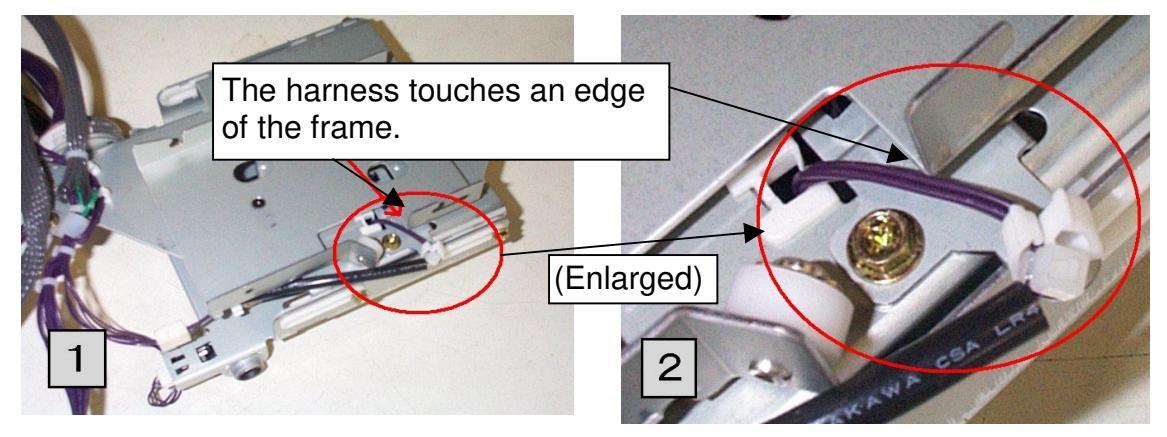
The stapler rotation HP sensor harness shorts to the frame
