| Model: Bellini | | | Dat | e: 15-Dec-99 | No.: RA294001 |
| Subject: Toner Hopper Gear Replcement at Installation | | | Prepared by: H.K. | | |
| From: Technical Services Dept., GTS Division | | | | | |

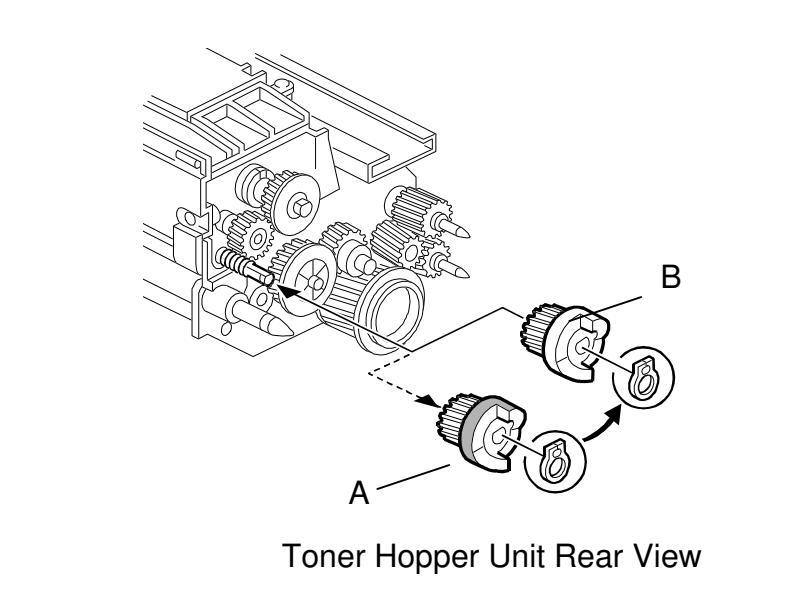
While SP2-207-2 (Toner Bank Toner Supply) is performed at installation, the rotation of the toner hopper gear (AB013748: Joint Gear -15Z) may cause an oversupply of toner from the hopper to the development unit. This in turn causes relatively high image density in copies/printouts made just following installation. To correct this, machines in mass-production have been modified as follows:

*Remove the Joint Gear 15Z that has been marked red [A]. Replace it with the white gear [B] and a spare C-ring packed in the accessory plastic bag.

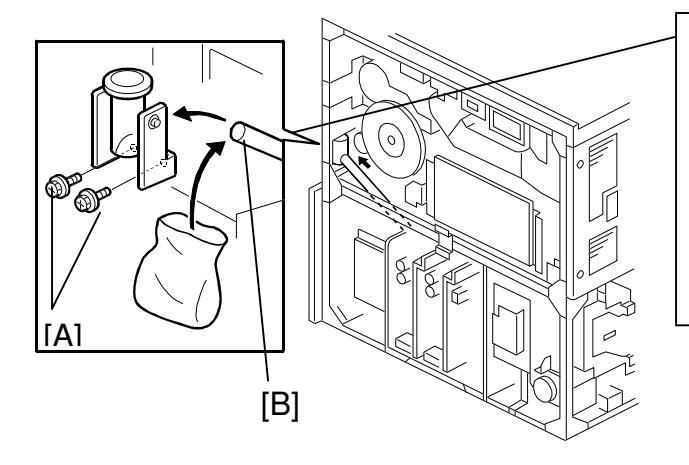
We have found that toner in the toner transport tube may be blocked due to vibrations during machine transportation. Please note the following remarks and do the procedure when the machine is transported.

- 1) When transporting the machine, do the following operations. Otherwise, the toner system may be blocked.
- 2) Be careful not to drop the toner.
- 3) If this procedure is not carried out, SC592 (Toner Bank Motor Error) or SC495 (Toner Bottle Unit Error) could be displayed and the toner transport tube and screw should be replaced.

- 6. Energize the toner bank motor and toner supply coil clutch for 2 minutes using SP5-804-61 and -64 to remove all of the toner in the supply tube.
- 7. Re-install all removed parts except for the toner bottles.

Take extra caution not to bend the toner transport coil tube [B]. If it is bent, this can cause the coil (screw) inside to be overloaded, locked, or damaged. SC592 will be displayed, and the coil (screw) inside should be replaced.

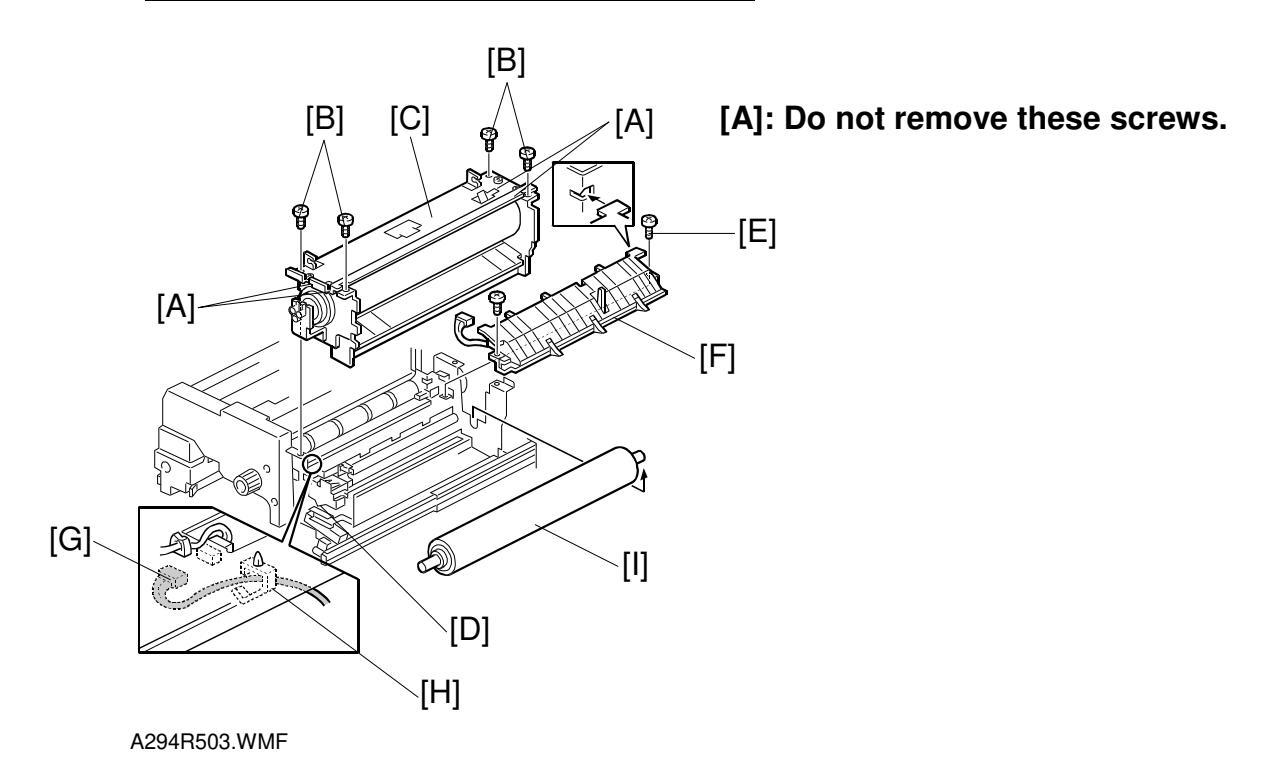
We have found that an audible resonance may occur inside the fusing unit while making copies. To correct this, the method for reinstalling the hot roller unit has been changed. Please correct the note on page 6-85 in the service manual as follows:

- 5. Remove the four **M5 pan head screws** [B] and remove the hot roller unit [C].
 - NOTE: 1) When re-installing the hot roller unit, make sure that the flanges of the ball bearings in the hot roller unit are set inside the fusing exit side plate [D] and the gear in the hot roller unit is installed on the rear side.
 2) Secure the M5 pan head screws in the following order: left-rear, right-front, right-rear, left-front.

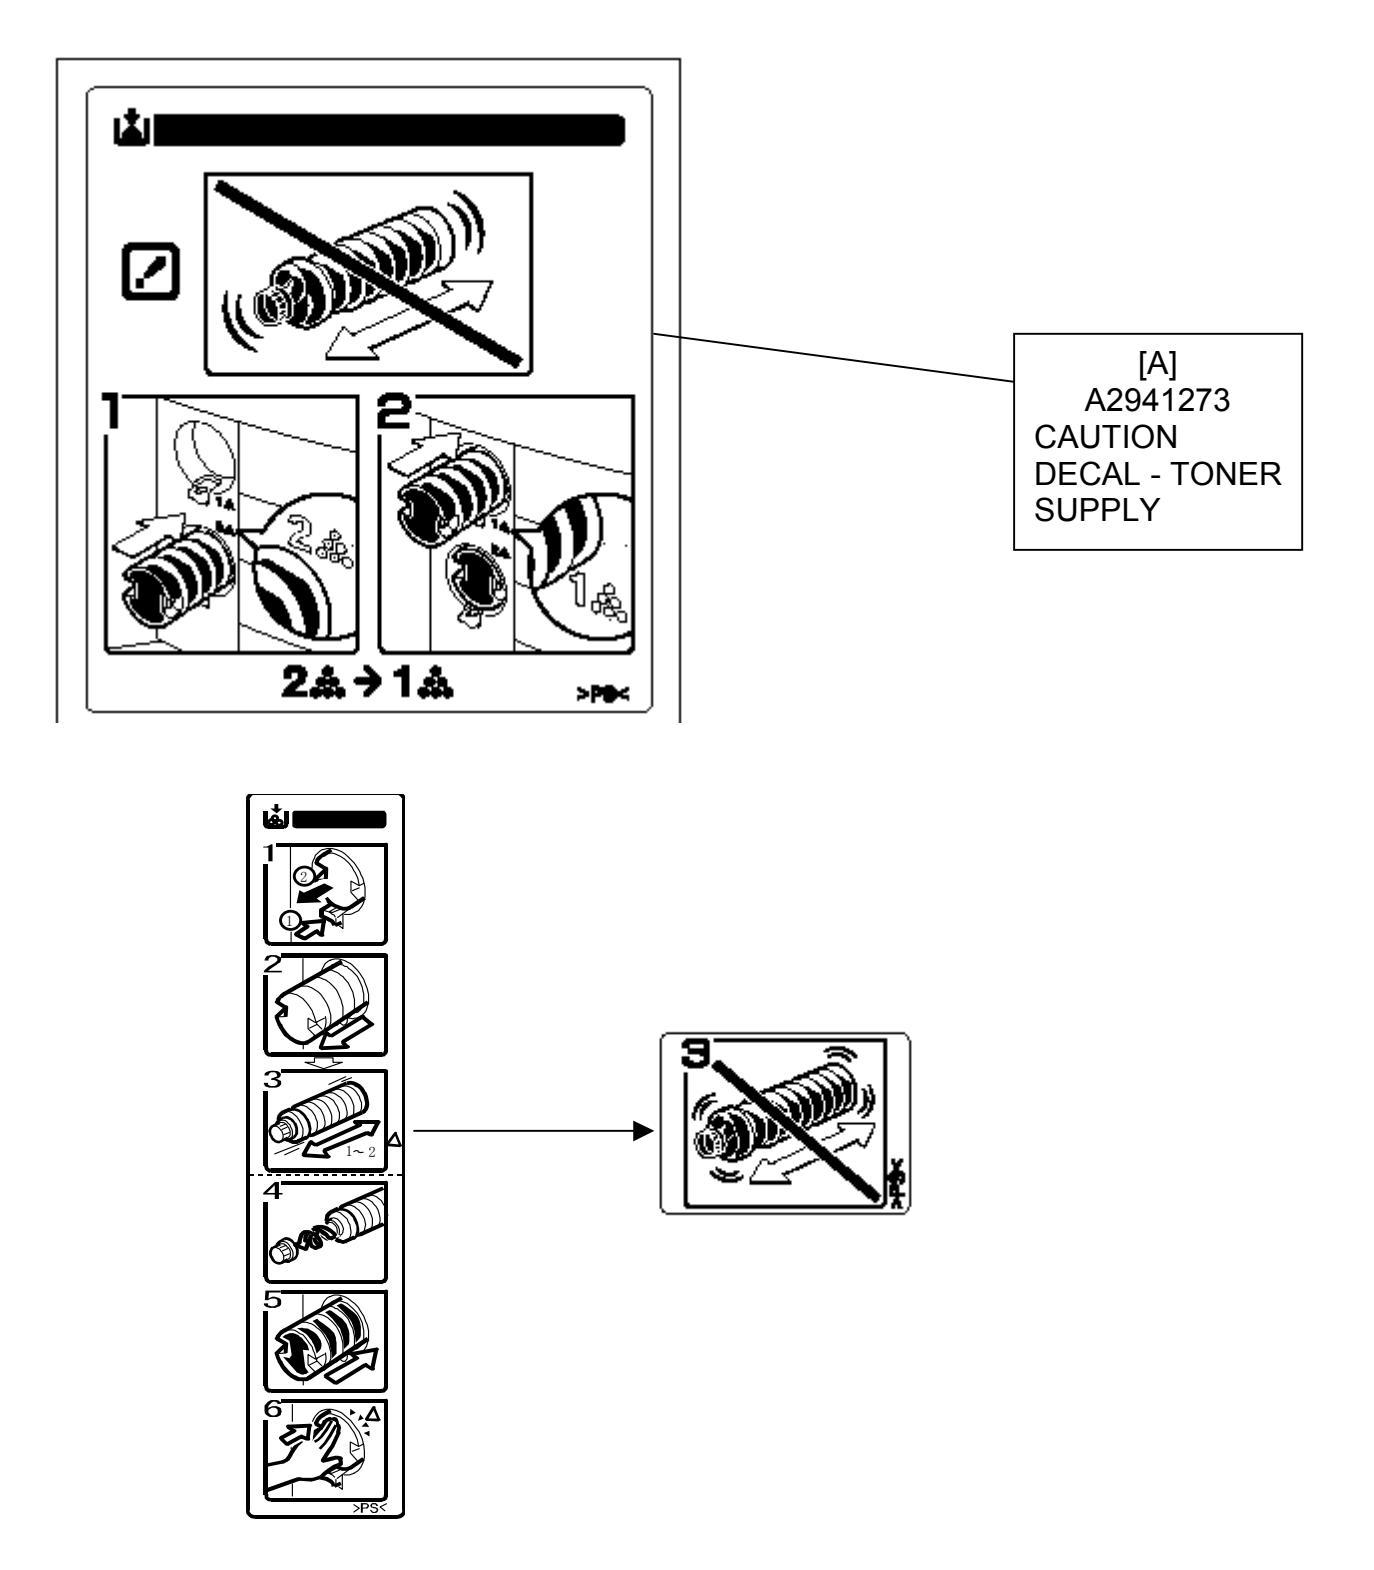
Toner Bank Decal [B] (A2941272)

The open/close mechanism for the lower toner bottle cap does not work properly. In some cases, the mechanism does not return the cap to the bottle, which causes the toner to spill when the bottle is removed.

- 1. The lower toner bottle is not placed in the toner bank unit or the toner end condition is detected for the lower toner bottle *and*:
- 2. The upper toner bottle is shaken several times before it is set.

Update the SICU & BCU to V.7.31.3. Demonstrate to the customer the correct way to install the toner bottles (according to the decal illustrations).

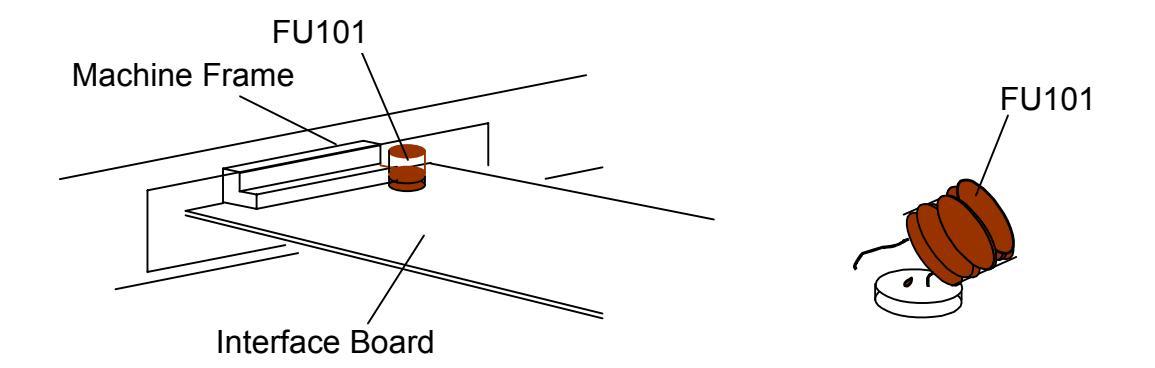
When the interface board is inserted, the top part of the fuse brushes against the machine frame and a leg of the fuse comes loose.

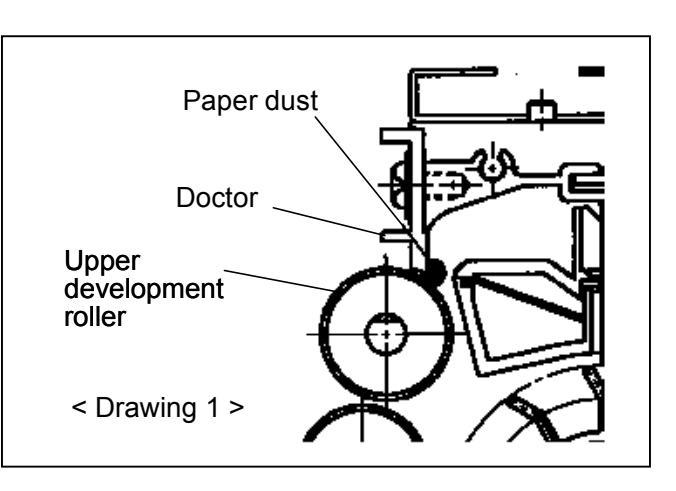
Paper dust is gathered at the front and rear sides of the doctor gap in the development unit. This gap becomes narrower, causing a drop in the airflow from the development lower casing. This can cause toner dusting from both edges of the development unit.

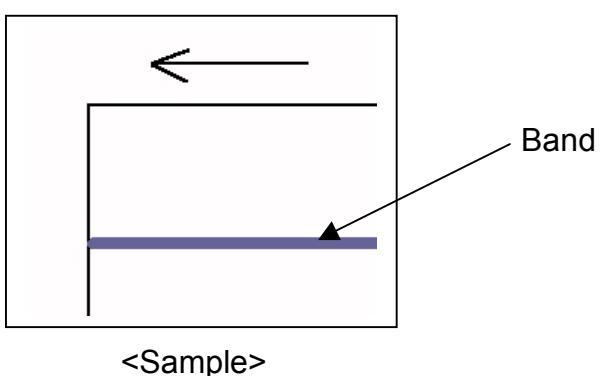
3. Dirty Background with Bands

The most likely cause is that the development roller surface has become dirty with toner. Clean the surface by following the steps below.

- 1) Remove the development unit
- 2) Tilt the unit 60° to the right so that the development roller surfaces face up. Note: Be careful not to tilt the unit to horizontal (90°).

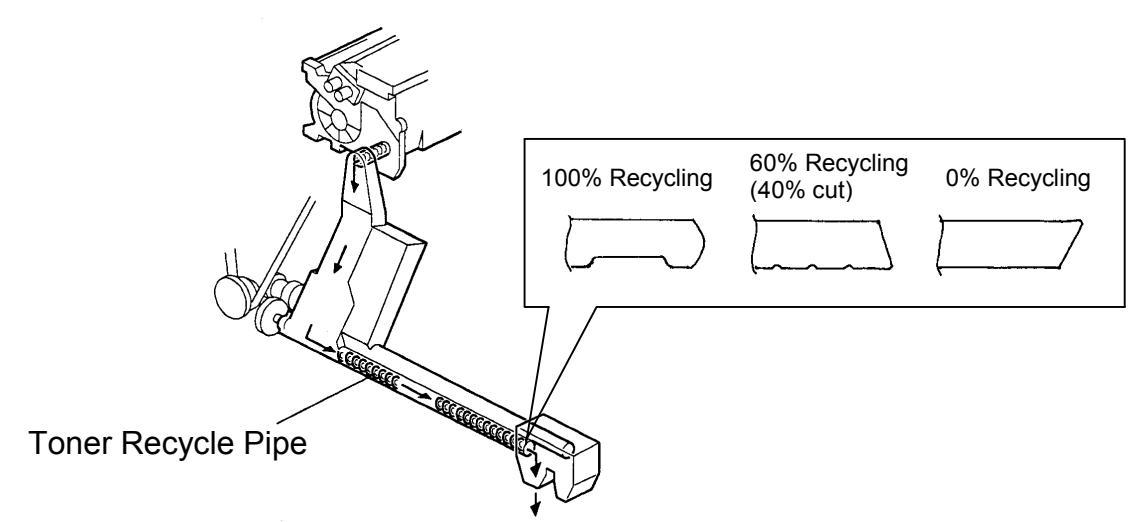
Paper fibers became mixed in with the recycled toner in the development unit.

- A combination of the following will minimize the appearance of the fiber spots:
- 1. Dispose of the developer in the development unit and clean the unit.
- 2. Decrease the percent of toner being recycled by changing the angle of the toner recycle pipe (see the illustration below). If the pipe is on 100% recycling, we recommend changing over to 60% recycling at first.
