Model: Azalea	Date: 28	-Feb-97	No: 002	1/5		
Subject: ROM Modification for Scanner / Printer Function			Prepared by: N. Kaiya			
From: QAC 1st Field Information Dept.			Checke	d by: T. Inoue	nove	
Classification:	 □ Troubleshooting □ Mechanical □ Paper path □ Other () 	 Part information Electrical Transmit/re 	ation ceive	 Action required Service manual revi Retrofit information 	sion

Model: Azalea			Dat	e: 15-Mar-97	No: 3
Subject: Paper Creasing in Duplex Mode				Prepared by: N. Kaiya	
From: QAC 1st Field Information Dept.				Checked by: T. Inoue	
Classification:	☑ Troubleshooting	Part information Action required		n required	
	🗌 Mechanical	Electrical		🛛 Servi	ce manual revision
	Paper path	Transmit/receive		ceive 🗌 Retro	fit information
	☐ Other())

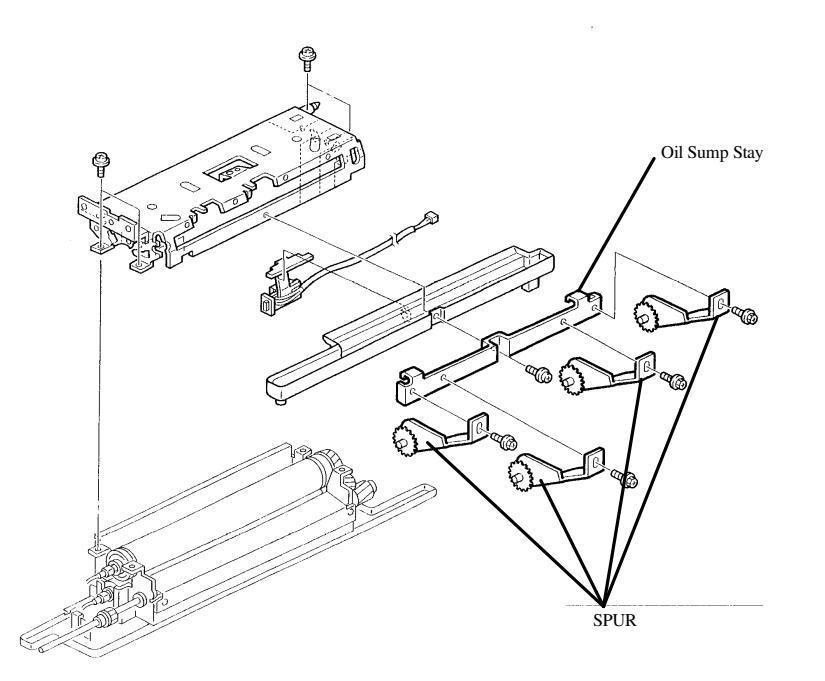
Scratched Image

If the paper becomes too slack before entering the fusing unit, the paper will come into contact with the upper fusing entrance guide, causing a scratched image. Four spurs are added on the oil sump to prevent the paper from touching the upper fusing entrance guide.

The paper entrance guide has been modified to lower the paper path, preventing the paper from touching the hot roller surface before entering the nip band.

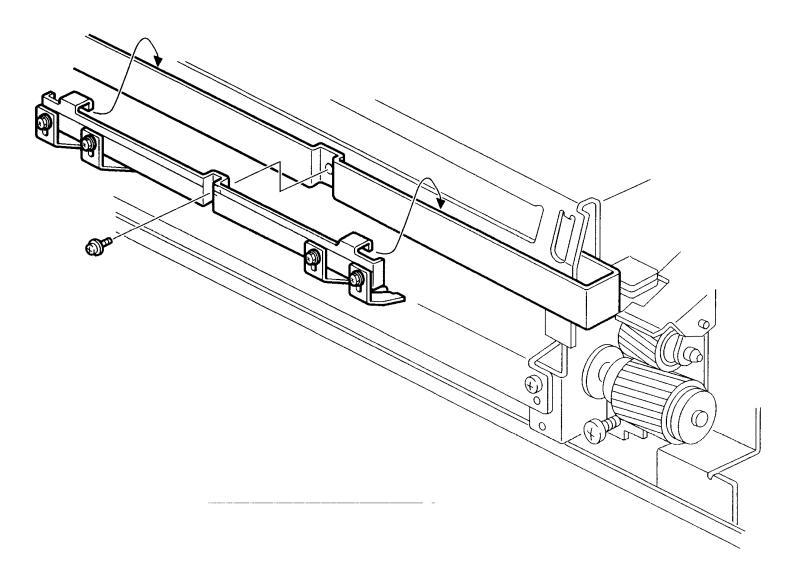
1. To do the fusing unit maintenance, the spurs need to be removed in many cases. The spurs can be removed as an assembly by one screw at the center and two hooks on the sides. Be careful not to damage the tips of the spurs.

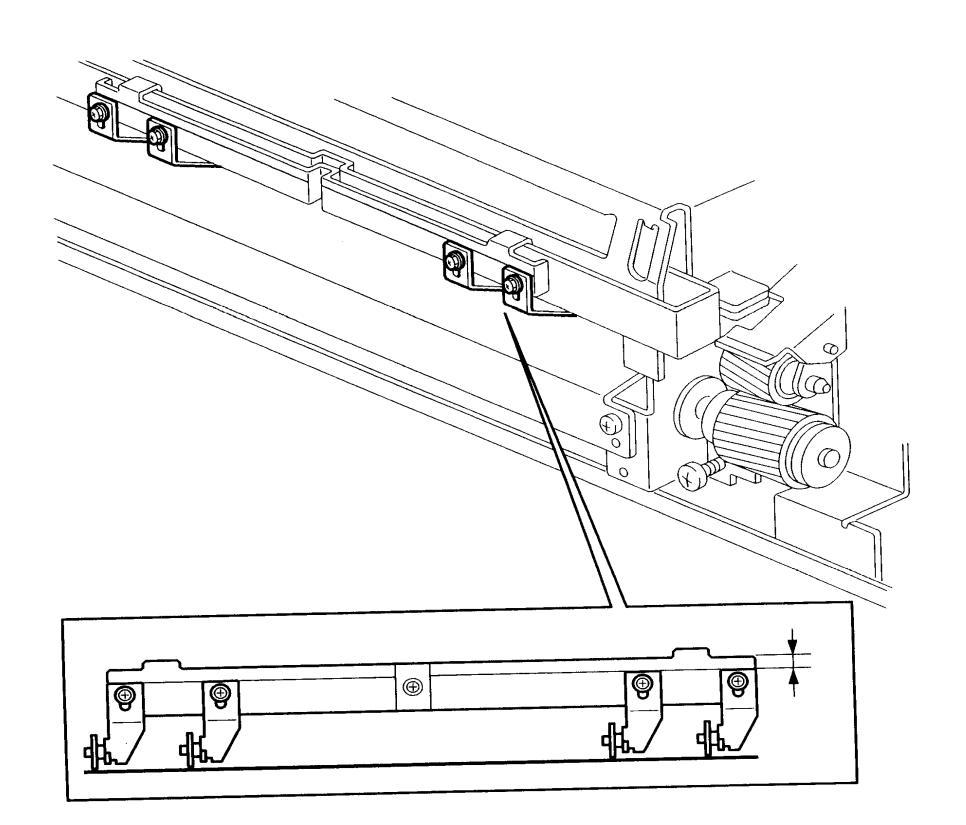
2. If the spurs are removed from the oil sump stay, it is necessary to align the edge of the spur bracket with the line on the oil sump stay when reinstalling them.

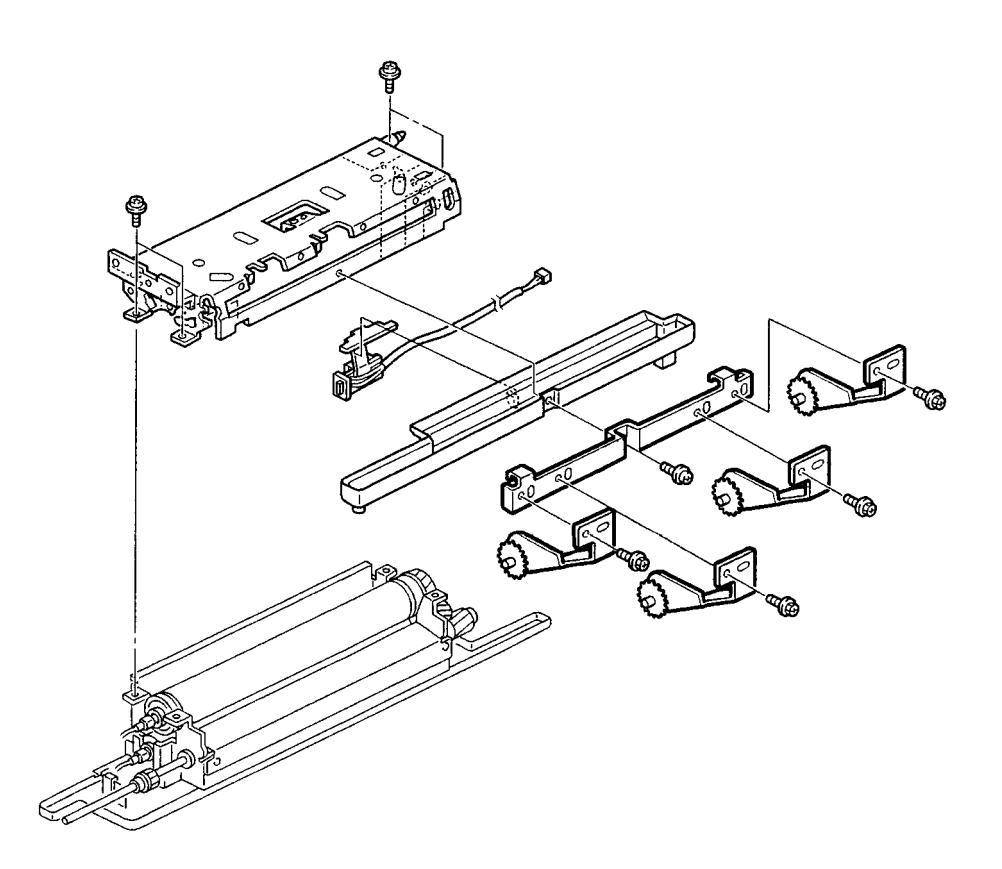
3. The spurs and oil sump stay have been improved so that the position of the spur bracket on the oil sump stay is fixed by a boss on the oil sump stay and a hole in the spur bracket. This modification has been made from the December '96 production for the basic model (A166) and the January '97 production for the auto duplex (A187) and the edit (A189) models. The part numbers of the spur and oil sump stay are not changed since old parts are not shipped as service parts.

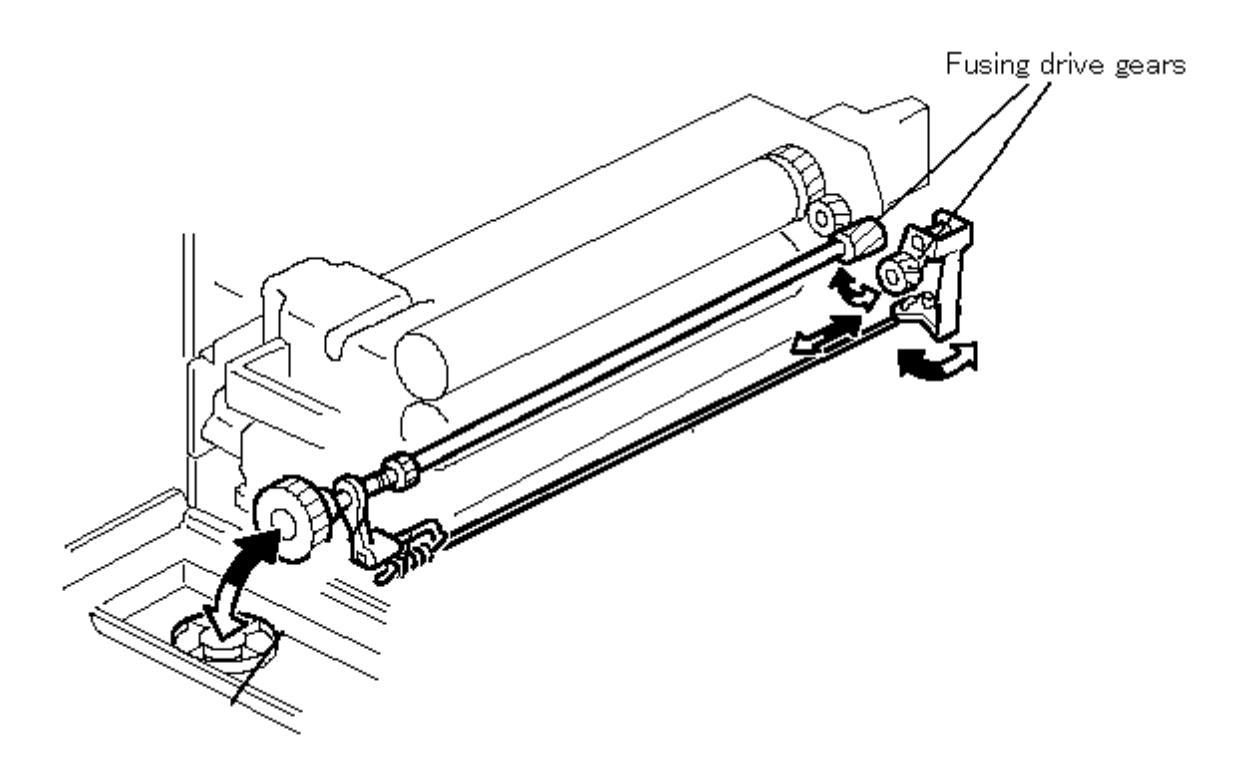
The problem may happen when the following conditions are met.

- 1. The fusing drive gears are out of grease.
- 2. The fusing drive gears are not properly engaged after they are released by opening the front cover.

- 1. Apply some grease (Mobil Temp 78) to the fusing drive gears. Make sure that all of the gear teeth are covered with grease.
- 2. Add a spacer (AA132097) between the fusing knob and the fusing release slider. The spacer will ensure proper meshing of the drive gears when the front cover is closed.
