Technical Bulletin

Model: Iris/Lilac Da			Dat	e: 30-Apr-99	No.: RA258001	
Subject: Color Controller Installation Procedure				Prepared by: Y. Sasaki		
From: Technical service Dept., GTS Division						
Classification:	Troubleshooting	Part info	ormat	tion 🗌 Action	n required	
	Mechanical Electrical		rical 🛛 🖾 Servi		ce manual revision	
Paper path Transmit		it/rec	eive 🗌 Retro	fit information		
	Other ()

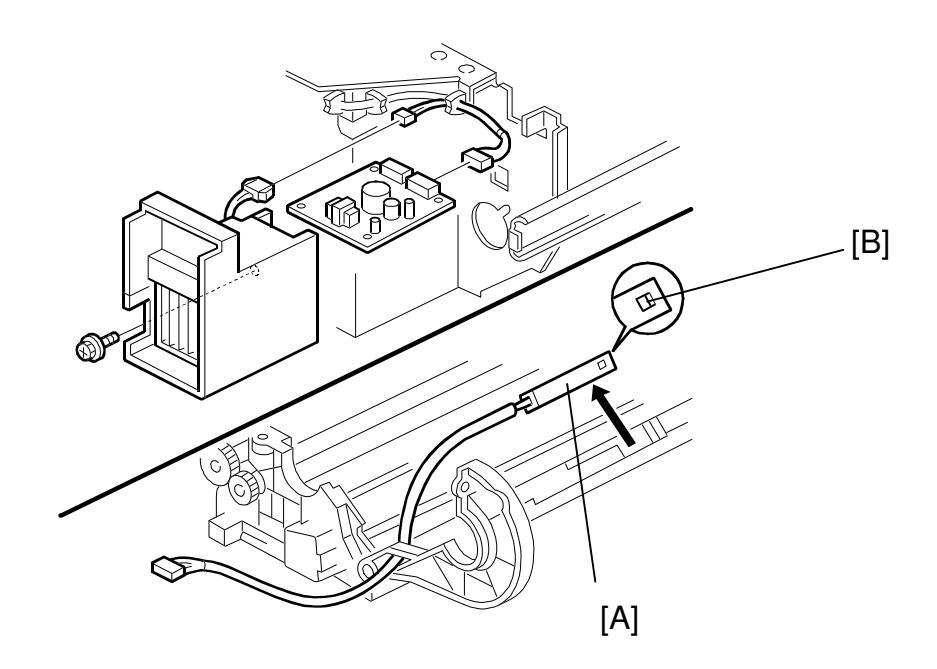
Please make note of the following remarks in order to prevent damage to the drum potential sensor and/or detection errors.

- The sensor is very sensitive. Do not drop the sensor or subject the probe [A] to shock in any way. Please handle it carefully.
- The service manual shows that the setting powder is applied to the drum in the drum unit. If the powder goes into the sensor through the window [B] or accumulates around the window, it may cause the sensor to detect the potential incorrectly. Therefore, please apply the setting powder to the drum before the drum is placed in the drum unit.
- If the potential sensor is not installed correctly in the drum unit, an error such as **20***, 41* or SC387 will result during the process control self-check.

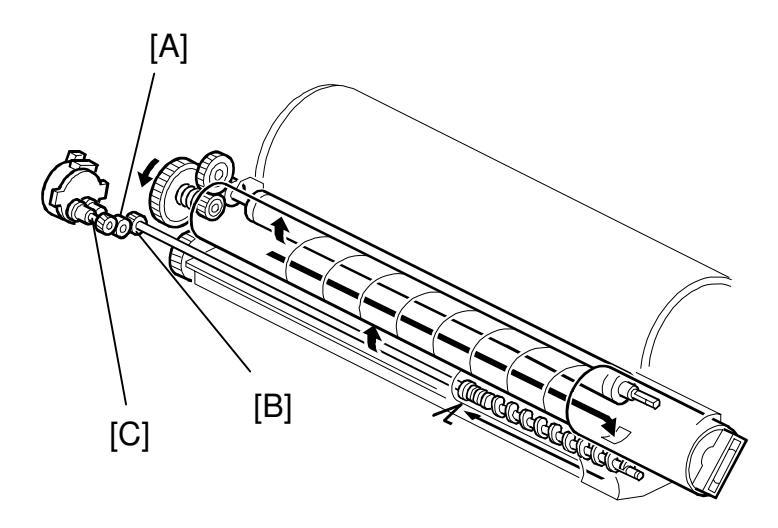
- The toner supply motor gear [A] and toner supply gear [B] were not properly engaged. This caused the toner to be not supplied. The toner supply motor may have been incorrectly positioned and then secured in this position during the production stage. In such a case, either the motor gear [A] did not touch the toner supply gear [B] and/or the gears were engaged too tightly, causing the gear shafts [C] to bend.
- 2. The toner supply gear [B] was broken. When the drawer unit is inserted in the machine with the development unit located at the development position, the toner supply gear [B] contacts the motor gear [A]. This may cause the gear [B] to be broken.

• If the gears on the motor shaft are properly engaged, reposition the motor in the cutout properly.		
		 If the gears on the motor shaft are not properly engaged or the shafts have already been bent, replace the motor. 		
2	When inserting the drawe position so that there is su the drum. Insert the drawe	r unit into the machine, place the development unit in a ufficient distance between the development sleeve and er unit.		
	Rotate the revolver counterclockwise so that the actuator [B] is positioned inside the dotted lines as shown in the illustration.

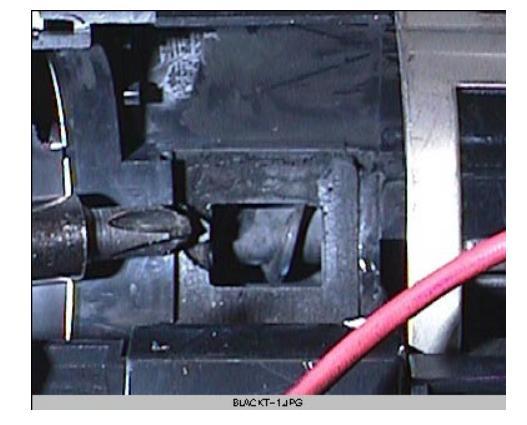
The toner hopper seal was damaged and peeled off as shown in the picture. This caused the fit of the toner bottle to become tight and/or the toner to leak and scatter.

The toner hopper seal was not firmly attached to the toner hopper. Therefore, when the toner bottle was installed, the seal became torn off.

- If this problem is found in the field, replace the seal by following the procedure described below.
- 1. Remove the toner bottle.
- 2. Pull out the drawer unit.
- 3. Remove the damaged seal and clean the surface of the toner hopper where the seal is attached using alcohol.
- **NOTE:** Make sure that no parts of the torn seal fall into the toner hopper. If this happens, white lines may result.
- 4. Attach the new seal. Make sure that it is properly fixed in place by pressing firmly.

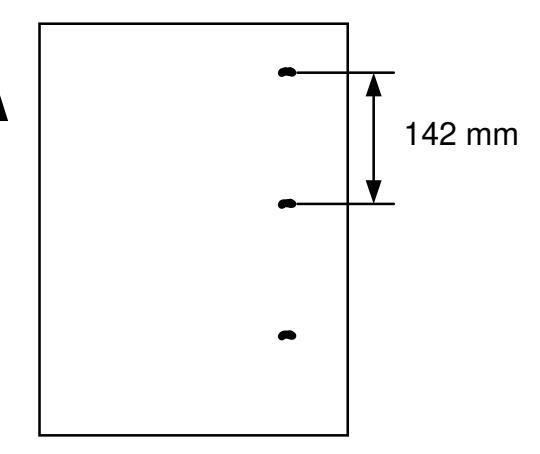
Dirty marks appear at 142 mm intervals on outputs.

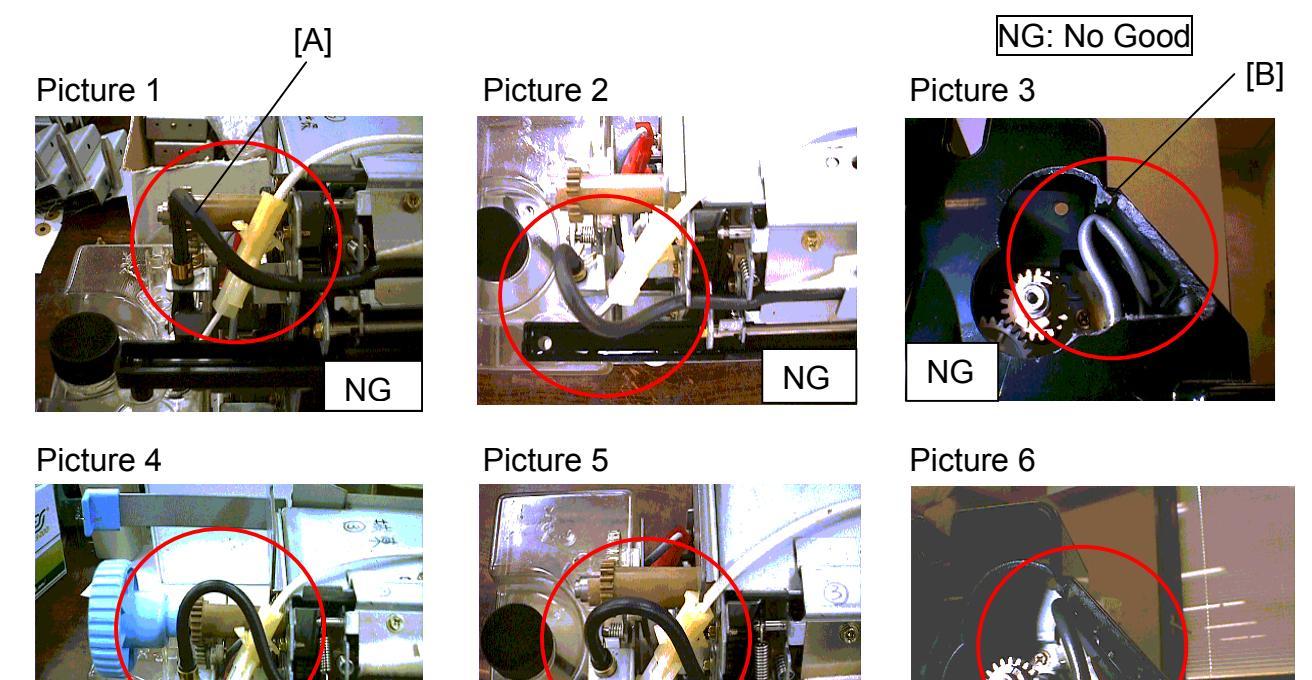
If the oil supply tube [A] is routed as shown in Pictures 1 & 2, the tube may bend when the upper cover [B] is installed as shown in Picture 3. To prevent this, the oil supply tube has to be routed as shown in Pictures 4 & 5.

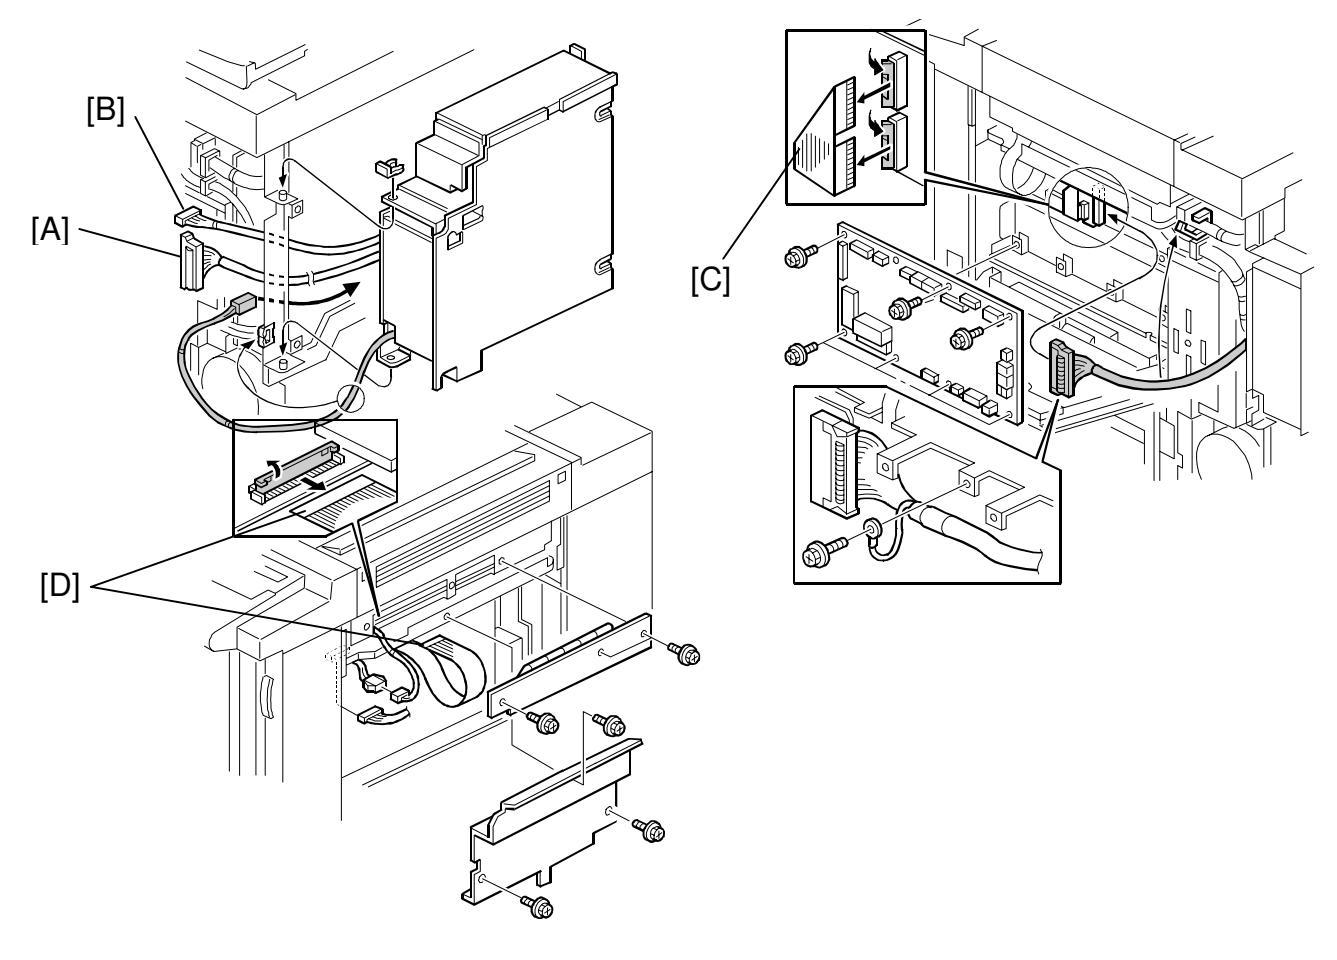
Some problems related to SC 326 or the ARDF were reported from the Japanese market. These problems were caused by mistakes during installation. Please note the remarks explained below and keep these items in mind when installing the I/F kit.

- 1. Please remember that if the connectors are not properly connected or the shorting cable is not removed, SC326 will occur. At each step of installation, make sure that:
- (1) The 100-pin shielded cable connector [A] is properly connected.
- (2) The I/F cable connector [B] is properly connected.
- (3) The shorting cable [C] is removed.
- (4) The LD flat cable [D] is properly connected.

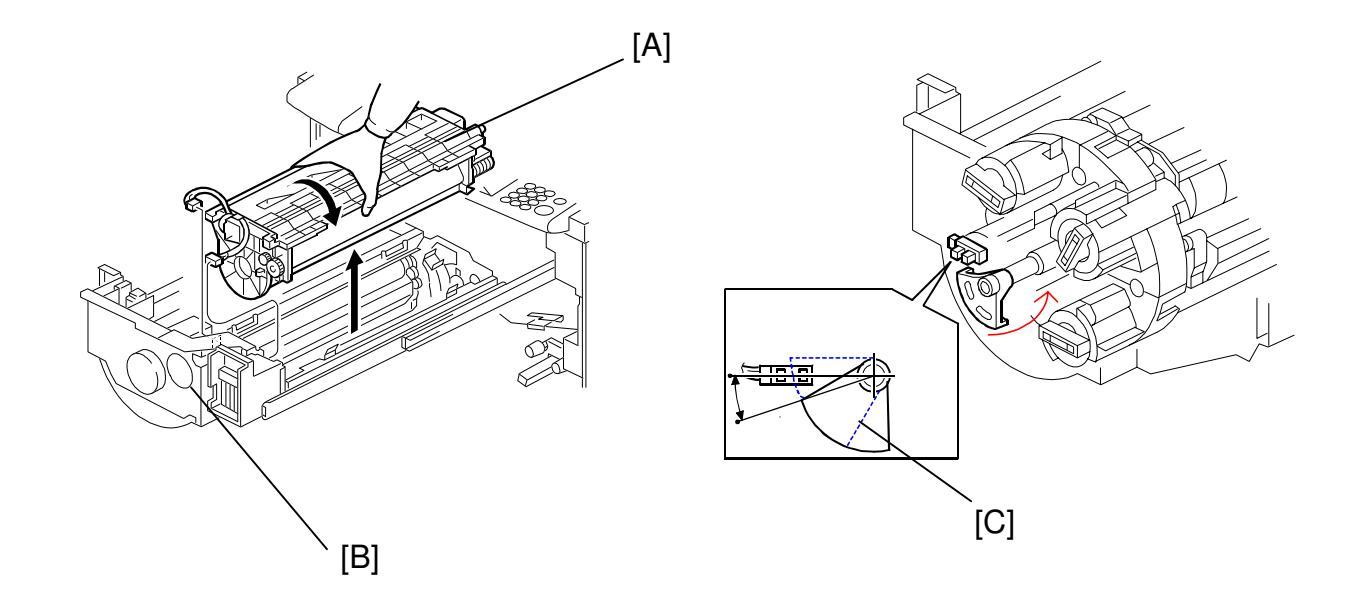
It is explained in the service manual that the drum unit [A] should be removed and covered with a black sheet of paper or 5 or more white sheets when the drawer unit [B] is pulled out. This will prevent light fatigue, which causes darker bands.

- **NOTE:** When the revolver unit is rotated without removing the drum unit, the development sleeve may come in contact with the drum surface. This may damage the drum and result in dots on the copies. This is due to the fact that normally, the PG (gap between the drum and sleeve) is properly maintained when the drawer unit is in the machine. Therefore, please make sure that the drum unit is removed whenever servicing the revolver section.
- **NOTE:** Before installing the drum unit in the drawer unit, the revolver unit should be rotated so that the actuator [C] is positioned in the sensor as explained in RTB 005.
- **NOTE:** Release the transfer belt pressure whenever pulling out the drawer unit from the machine. If pulling out the drawer unit without releasing the pressure, the drum and/or belt may be damaged.

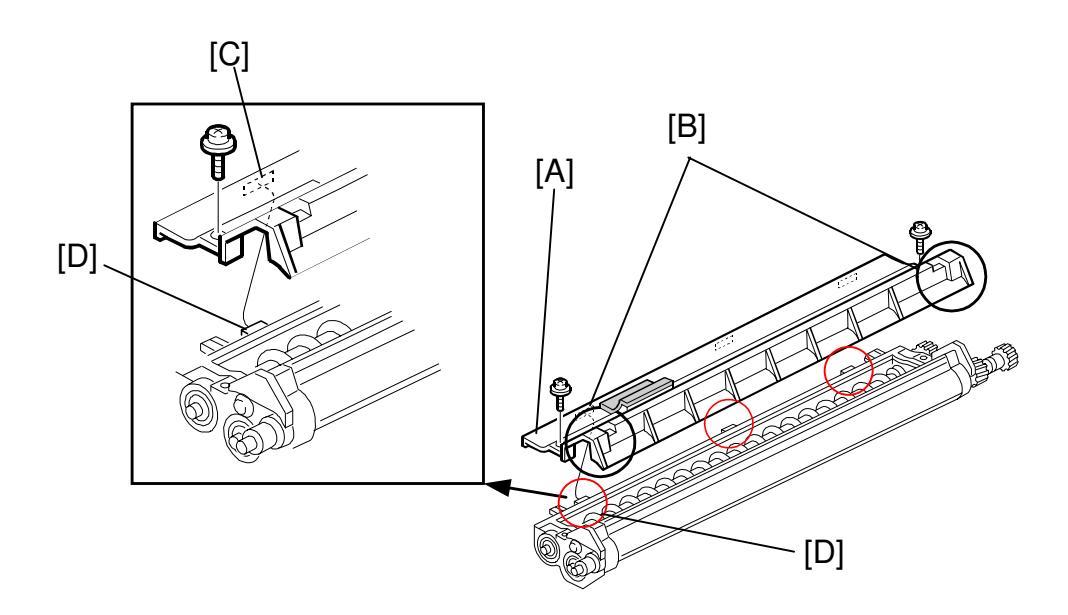
It was reported that developer spilled out from the development unit during developer initialization at the time of machine installation. To prevent any future occurrence, please make note of the following remarks regarding developer replacement and servicing of the development unit. (Some of these are explained in the service manual, page 3-15.)

There are 3 cutouts [C] in the developer cover. When positioning the cover on the development unit, each projection [D] on the development unit should be set into each cutout properly. If the developer cover is not properly set, developer may leak from the gap between cover and development unit.

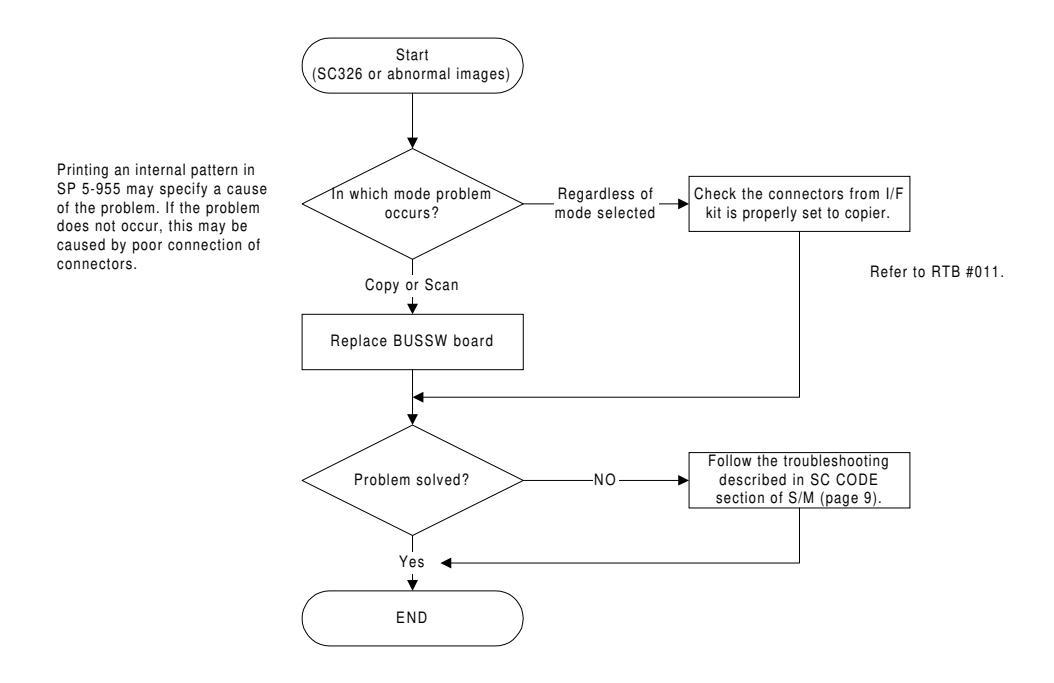
It was reported in the Japanese market that image quality problems or SC326 occur due to a defective BUSSW board in the Interface Kit. This RTB outlines the troubleshooting procedure.

Normally, the input pins (#12 to 17) of IC18 on the BUSSW board are not used for the function of the IC18. However, due to an error in the software programmed in IC18, these pins were allocated as output pins. The resulting increase in power consumption causes the IC to heat up and malfunction.

[1] Troubleshoot as shown below when the problem is reported.

- **NOTE:** If the problem is related to IC18, the replaced (old) PCB can be re-used after cutting pins #12 17. If occurrences still continue after cutting the pins, the problem is being caused by another PCB component.
- **NOTE:** If the BUSSW board (IC18) causes the problem and the part is not available, cutting the pins (#12 17) of IC18 as explained in section [2] on page 5 of this RTB solves the problem.

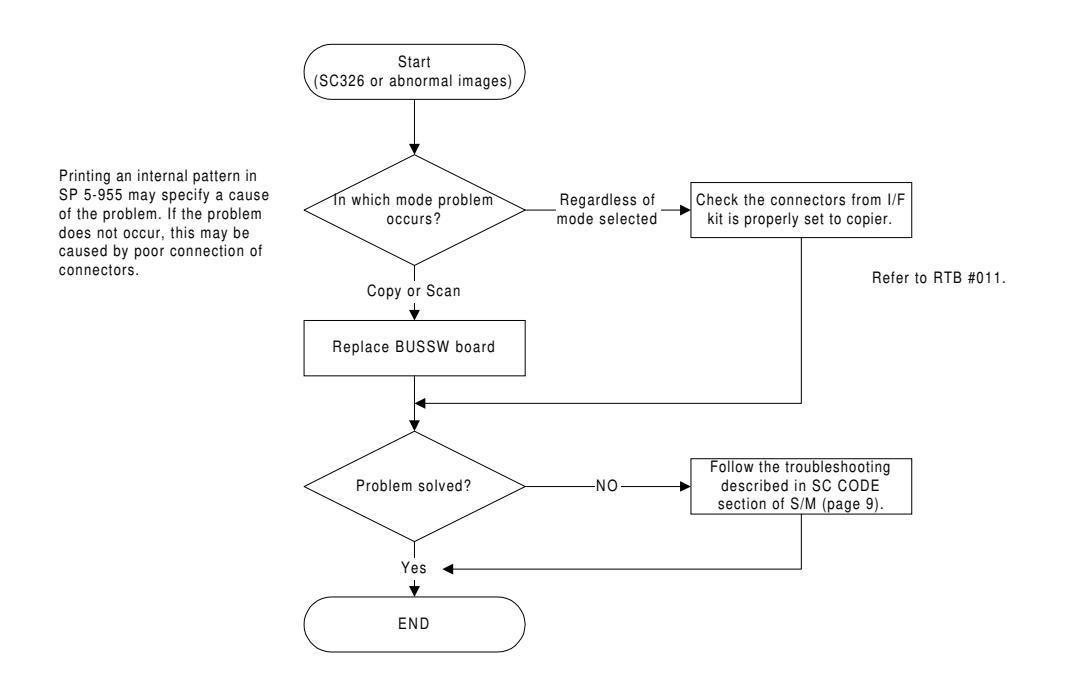
It was reported in the Japanese market that image quality problems or SC326 occur due to a defective BUSSW board in the Interface Kit. This RTB outlines the troubleshooting procedure.

Normally, the input pins (#12 to 17) of IC18 on the BUSSW board are not used for the function of the IC18. However, due to an error in the software programmed in IC18, these pins were allocated as output pins. The resulting increase in power consumption causes the IC to heat up and malfunction.

[1] Troubleshoot as shown below when the problem is reported.

- **NOTE:** If the problem is related to IC18, the replaced (old) PCB can be re-used after cutting pins #12 17. (If the PCB is Type 1, it is not repairable and therefore not re-usable.) If occurrences still continue after cutting the pins, the problem is being caused by another PCB component.
- **NOTE:** If the BUSSW board (IC18) causes the problem and the part is not available, cutting the pins (#12 17) of IC18 as explained section [2] on page <u>6</u> of this RTB solves the problem. (If the PCB is Type 1, the procedure on page 6 is not applicable.)

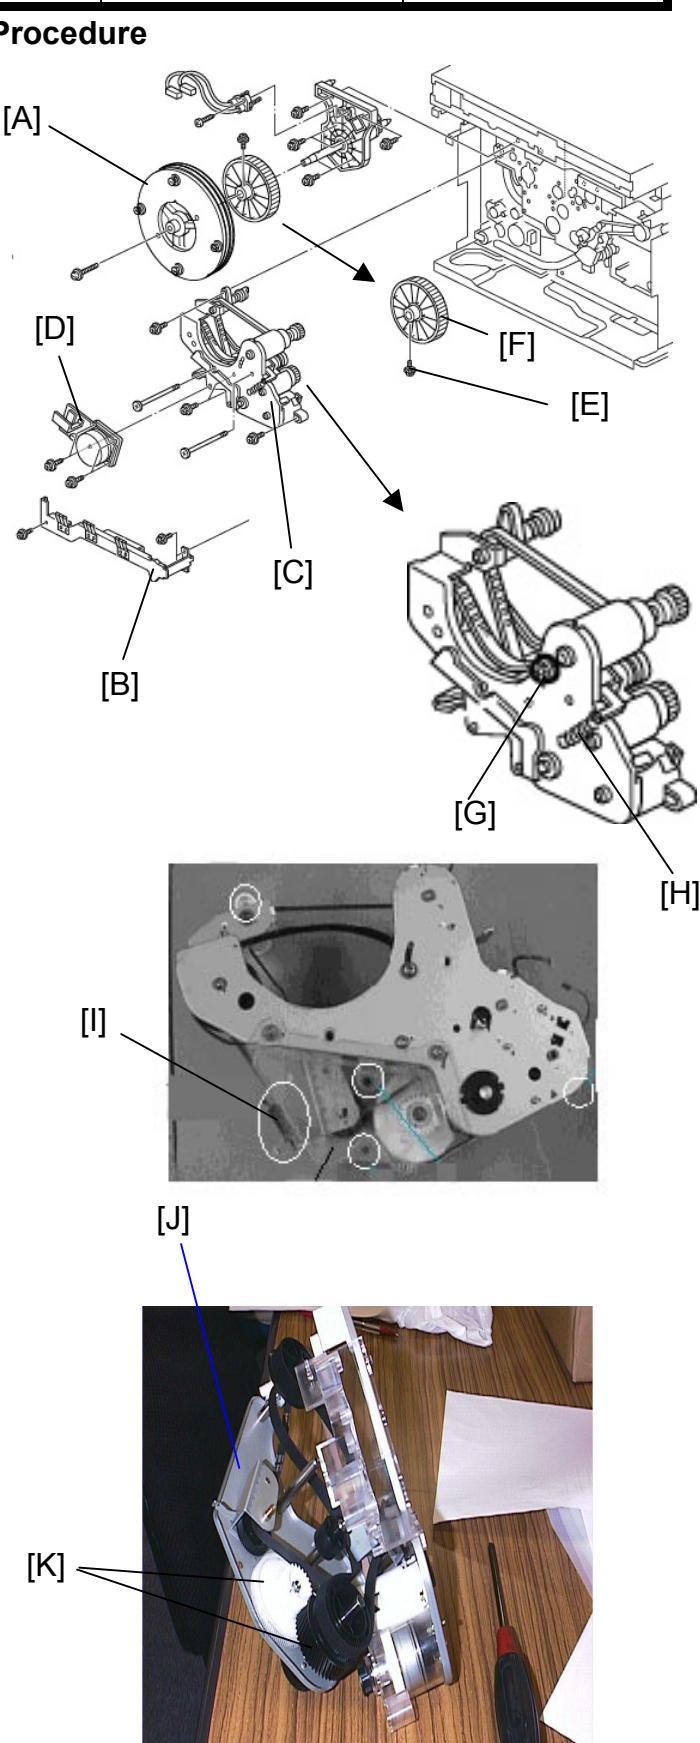
[5] 12-mm Banding : Gear Replacement Procedure

12-mm	Yes	No	The frequency generated by the gears in the drum drive unit causes 12-mm banding only in standard speed mode.	The gears have been modified to reduce the specific frequency generated when the gears rotate. P/N changed: #AB017512 -> #AB017521 #AB017477 -> #AB017520	 Replace the gears with modified ones. Refer to page 7/8 to 8/8.

- Remove the following parts: Rear covers / Fly-wheel [A] / Stay [B]
- 2. Remove the 3 screws securing the PSU and the 4 screws securing the I/O control board. Then, move these two parts aside to make space to remove the drum drive unit [C].
- **NOTE:** It is not necessary to remove the PSU and I/O board.
- 3. Disconnect the connector of the drum motor [D].
- Rotate the drum motor counterclockwise manually so that the screw [E] of the drum pulley [F] faces downward.
- 5. Loosen the screw [G] and remove the tension spring [H].
- 6. Remove the drum motor (4 screws) and drum pulley (1 screw)
- 7. Remove the 3 connectors from the drive unit and remove the unit (4 screws and 2 stud screws).
- 8. Remove the tension spring [I]. Then, remove the unit cover plate [J] (3 screws).

- (1) Before opening the drive unit, note the routing of the timing belts as well as the positioning of the pulleys. This will make it much easier to put the belts and pulleys back after the procedure.
- (2) Do not open the drive unit completely. If this is done, the timing belt and pulleys will come off the unit. Open the cover just enough for gear replacement (see the photo).
- Replace the white and black gears [K]. (The black gear is secured with 2 screws.)

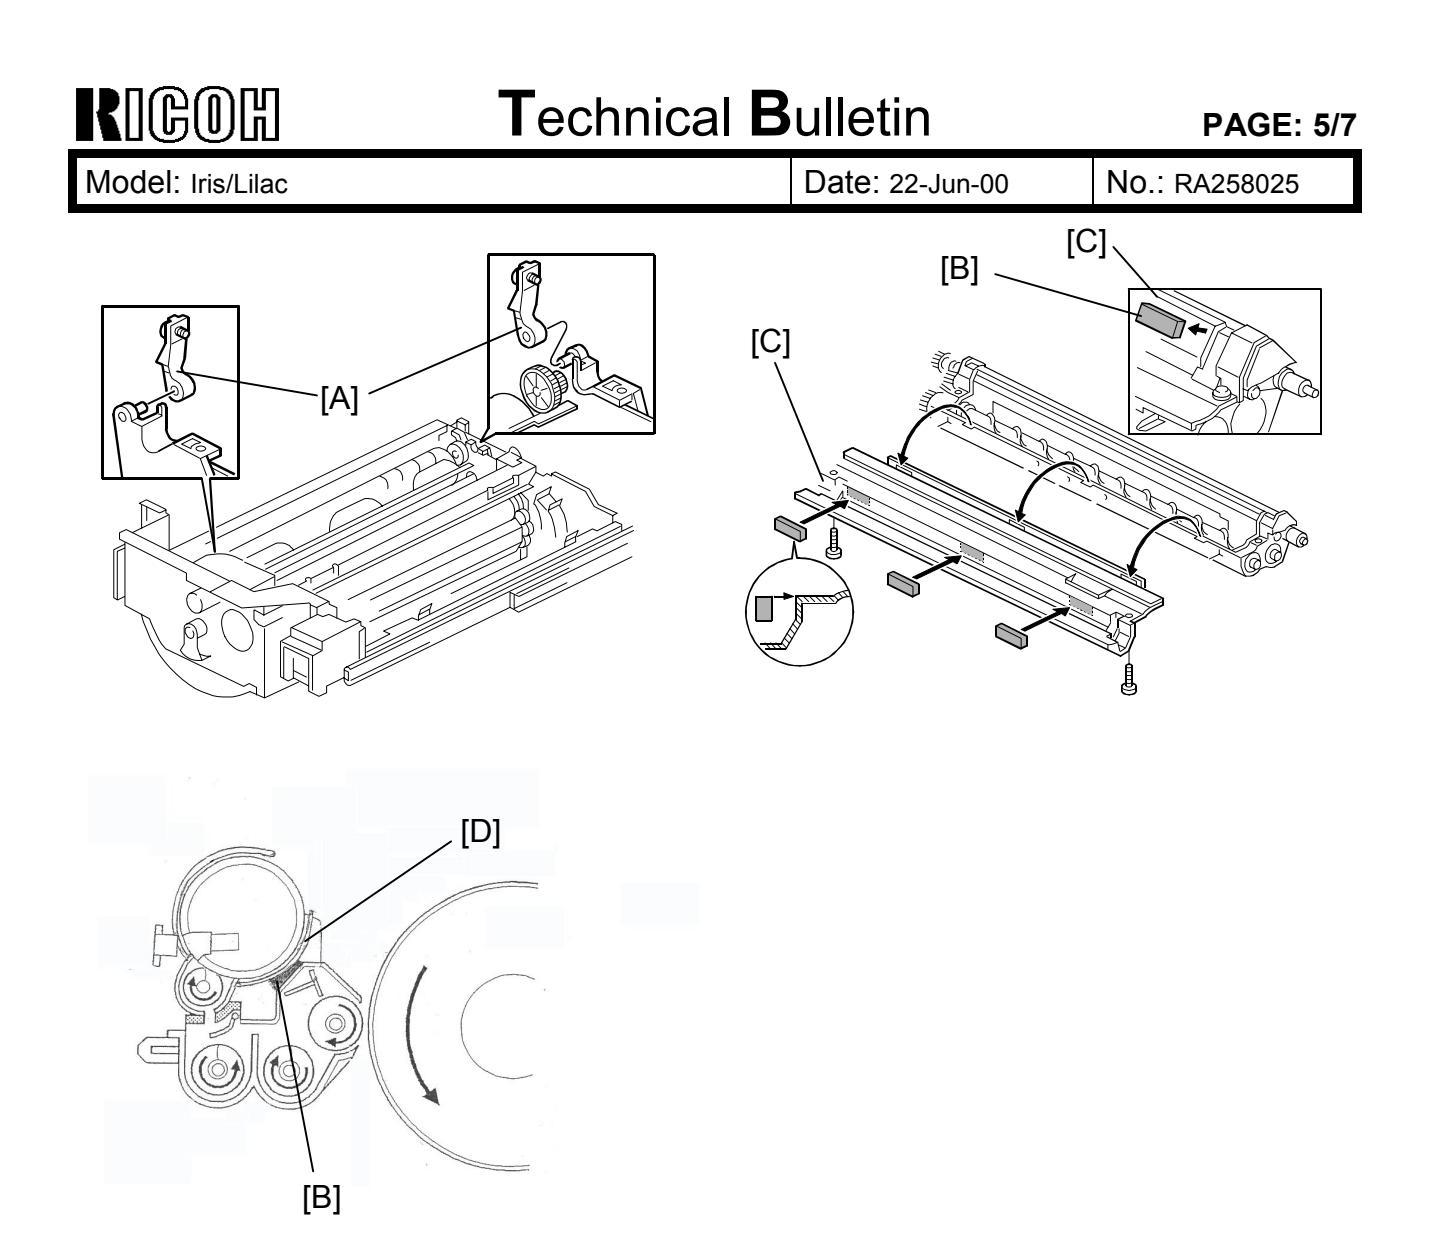
The PG seal should not be attached to the development holders for other colors. If this is done, the PG will become narrow and the developer brush may contact the drum while the revolver rotates. This causes a color band to appear on the outputs.

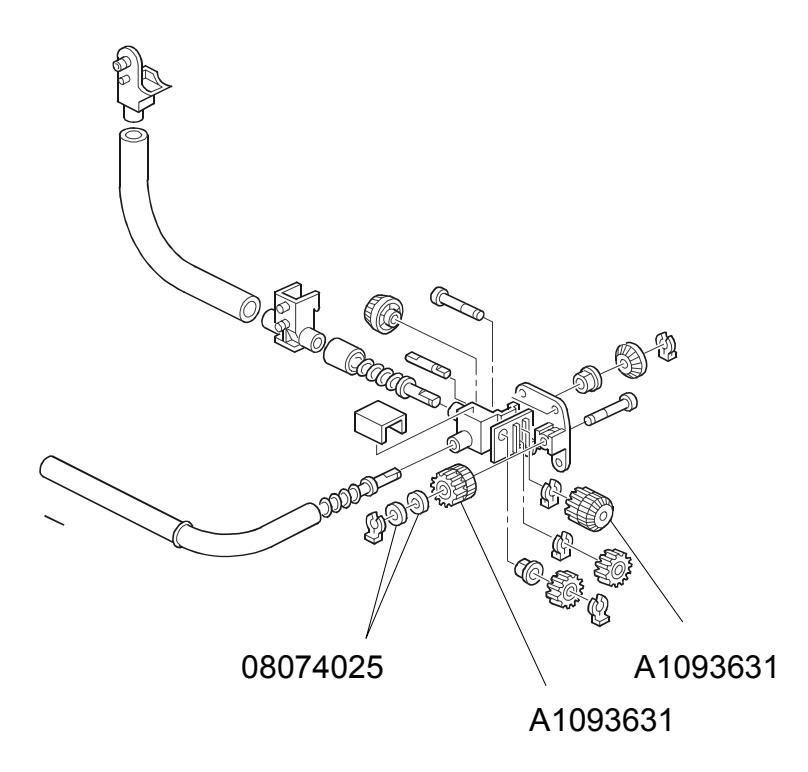
The surface of the drive shaft has been made smoother and grease has been applied to the drive shaft from August 2000 production.

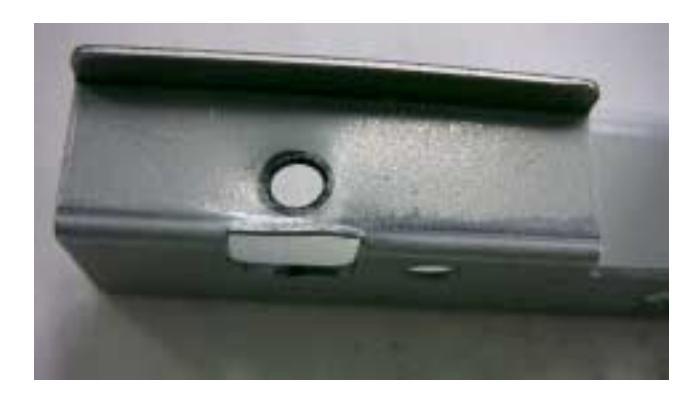
1. The Bias Roller is not set in the correct position, deforming the hole in the Pressure Release Lever (photo below). This can happen during servicing if the Pressure Release Lever is not set correctly when installing the Image Transfer Belt Unit.
