# Technical Bulletin

Model: Bc-C1		Date: 06-Jul-15		15	No.:RD245001	
Subject: Cleaning points for preventive maintenance				Prepared	d by: H.M	Iorishima
From: 2nd Tech Service Sect., MFP/P Tech Service Dept.						
Classification:	Troubleshooting	] Part info ] Electrica ] Transm ] Other (	ormat al it/rec	tion eive )	<ul> <li>Action</li> <li>Servio</li> <li>Retrol</li> <li>Tier 2</li> </ul>	n required ce manual revision fit information

Model: BC-C1			Date: 03-Dec-15			No.:RD245006
Subject: Modified polygon mirror housing to prevent blurred image and low image density					d by: A.Is	hida
From: 2nd Tech Service Sect., MFP/P Tech Service Dept.						
Classification:	Classification:       Image: Troubleshooting       Image: Part in the part in		ormat al it/rec	tion eive )	<ul> <li>Action</li> <li>Servic</li> <li>Retrof</li> <li>Tier 2</li> </ul>	n required ce manual revision fit information

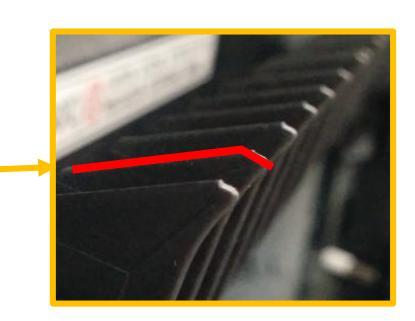
1. Reverse guide plate

Effective for: Streaks, Stains on paper edges

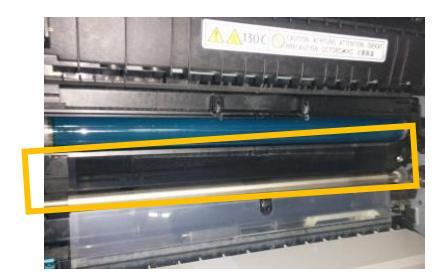
2. PCDU paper contact surface

<u>Effective for:</u> Stains on paper edges, Paper dust accumulation Work carefully to avoid damages to the drum.

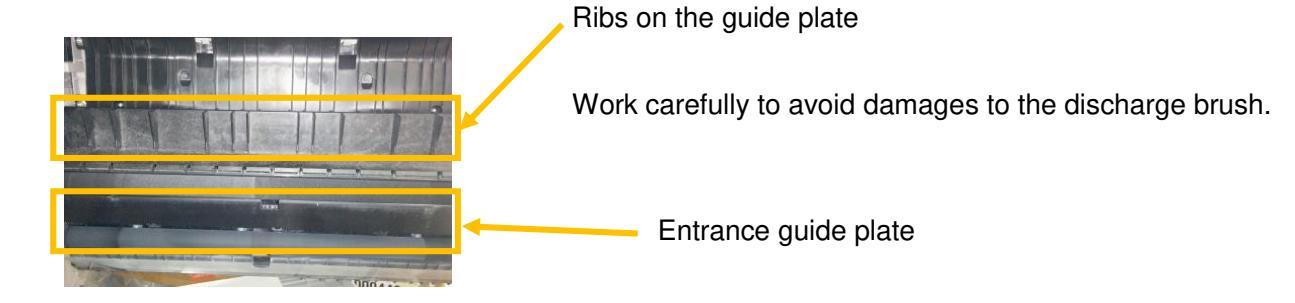
3. Transfer guide plate (transfer roller side)

Effective for: Stains on paper edges, Streaks

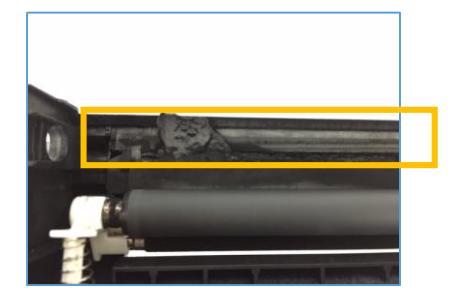
5. Around the PCU

Effective for: Stains on paper edges, Streaks

Remove the drum to clean around the PCU.

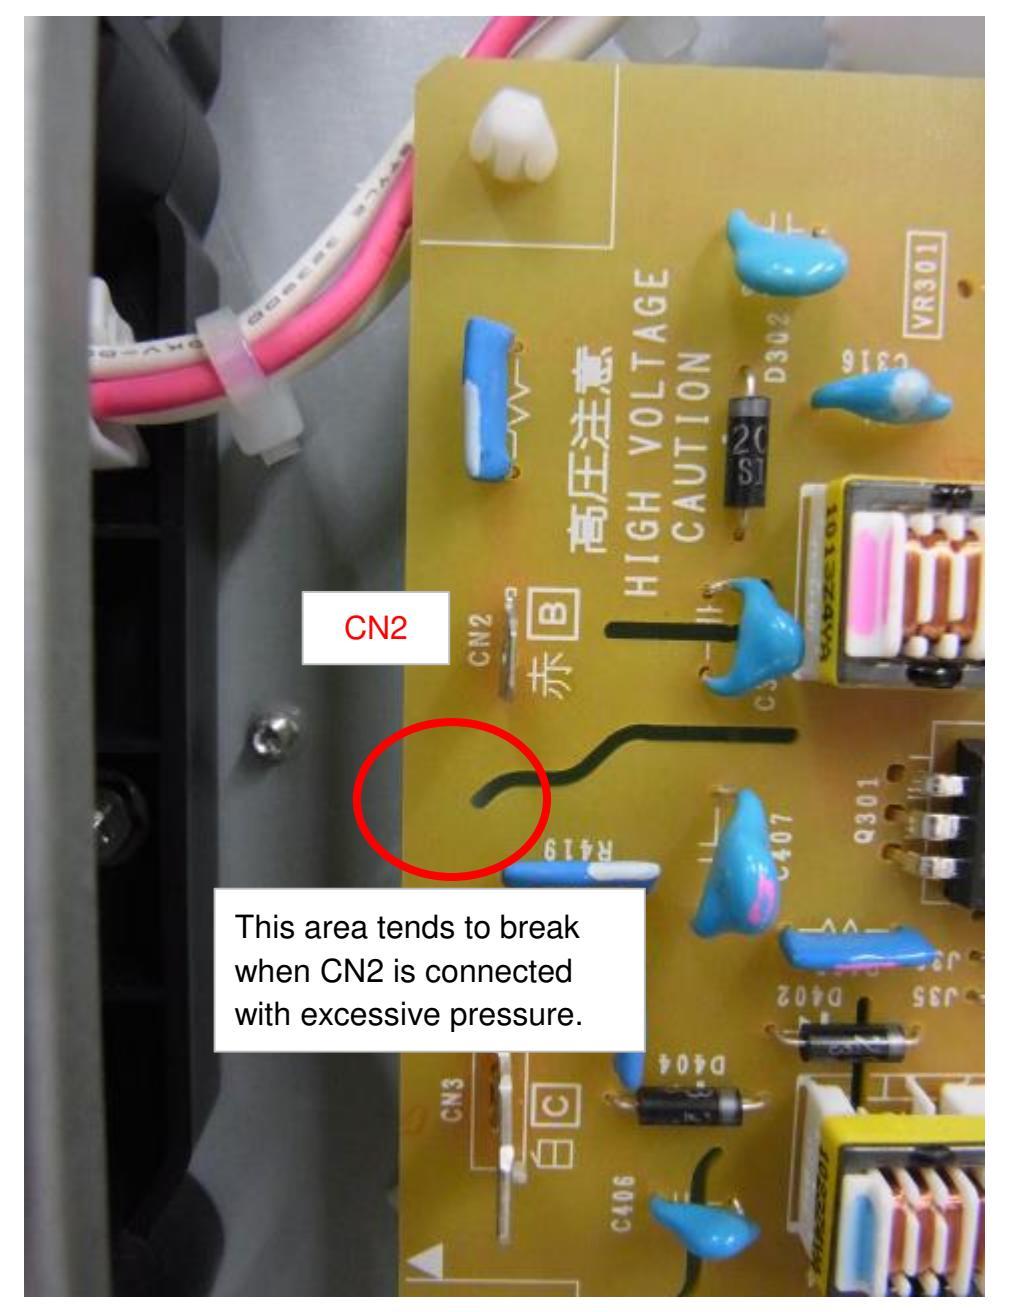
## HVP circuit board

The HVP circuit board physically breaks when connecting CN2.

The connector is connected with excessive pressure.

Slowly and gently connect the connector and release the pressure when the click sound is heard. Even if the click sound is not heard, DO NOT push in the connector any further.

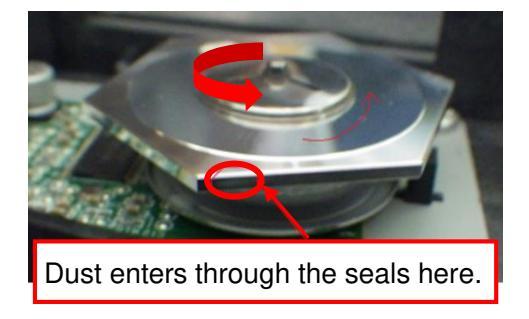
Blurred image, low image density

Dust enters the laser unit and adheres to the polygon mirror.

The height of the seals covering the polygon mirrors was increased (from 3mm to 6mm) to prevent dust from the entering the housing.

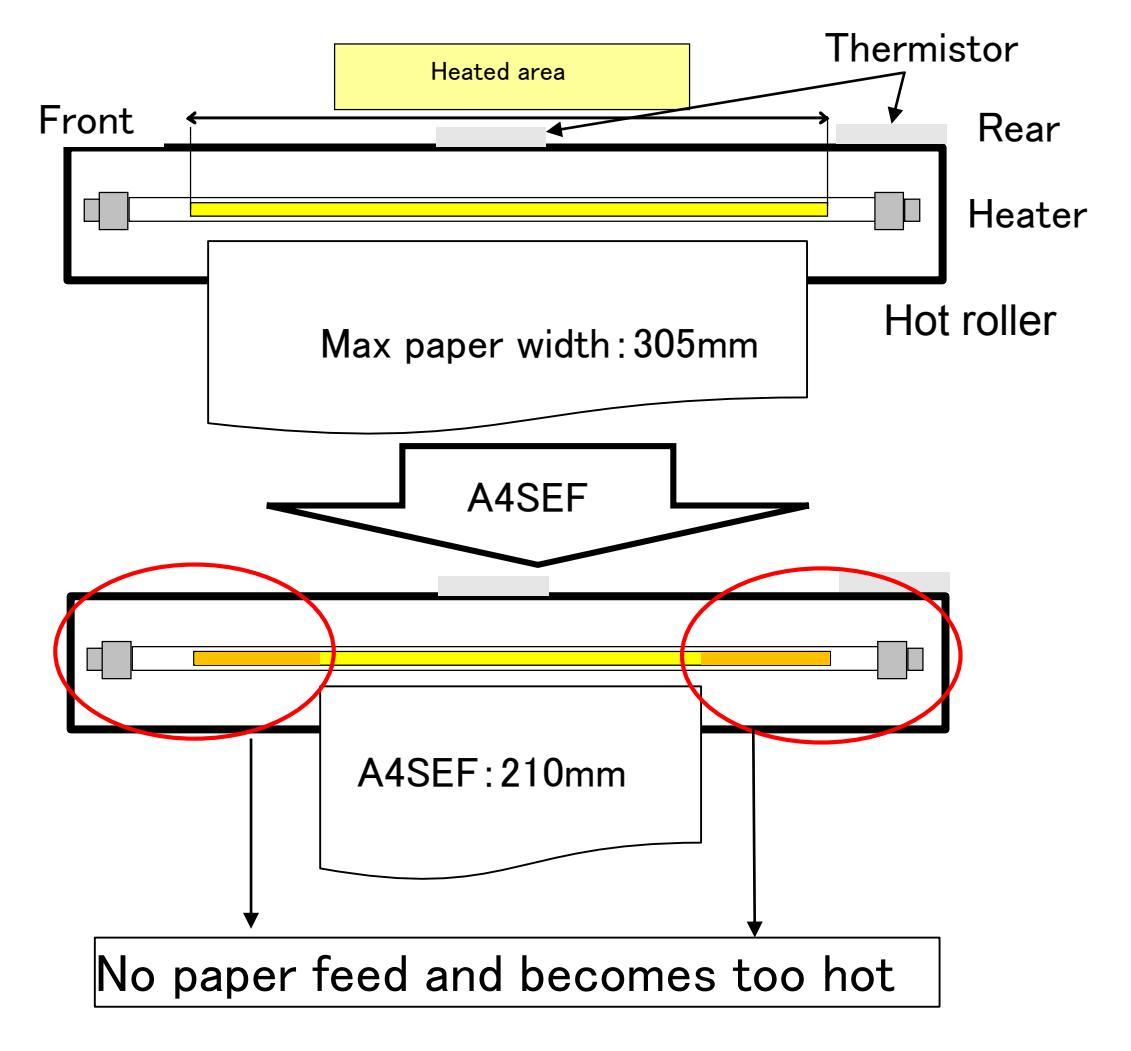
Copying stops for a short while when printing onto A4SEF and legal sized paper, so that the hot roller does not become too hot. The edges of the hot roller become very hot, as A4 SEF sheets do not contact these areas during fusing.

Change the paper feed direction to LEF. This will cause the paper to contact the entire roller surface and prevent overheating of the edges.

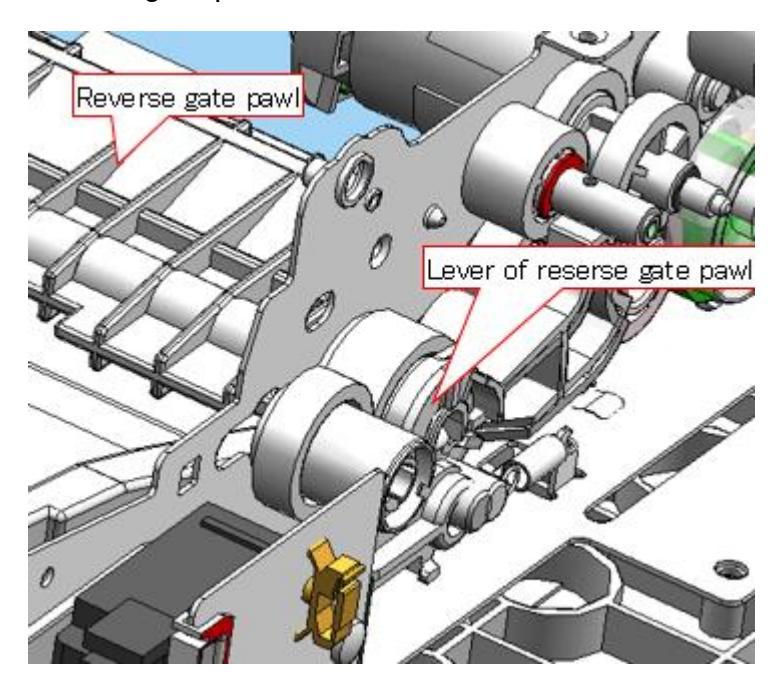
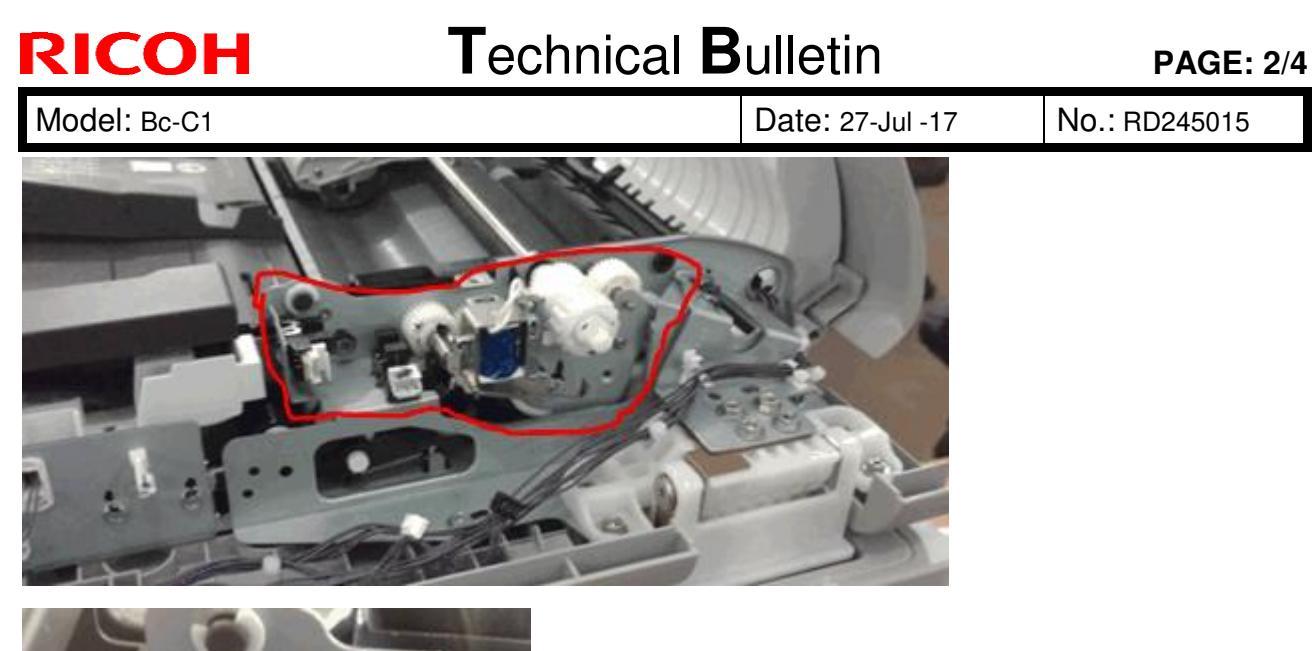
When the machine receives impacts on the box during transportation, the lever of the reverse gate pawl comes off.

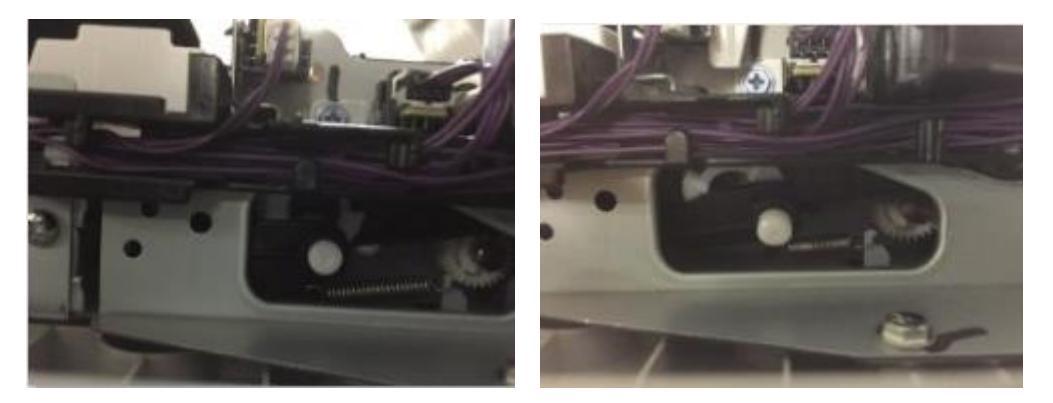
2. Check the lever of the reverse gate pawl to see if it comes off or not.
