Technical Bulletin

Model: Diana-C1	L		Dat	e: 27-Nov-	-08	No.: RD037001
Subject: PictBridge option (Camera Direct Print Card Type E)				Prepared	d by: к. м	Noriizumi
From: 1st Tech. S	Support Sec. Service Support D)ept.				
Classification:	☑ Troubleshooting	Part info	ormat	tion	Action	n required
	Mechanical	Electric	al		Servic	e manual revision
	Paper path	Transm	it/rec	eive	Retrof	fit information
	Product Safety	Other ()	🛛 Tier 2

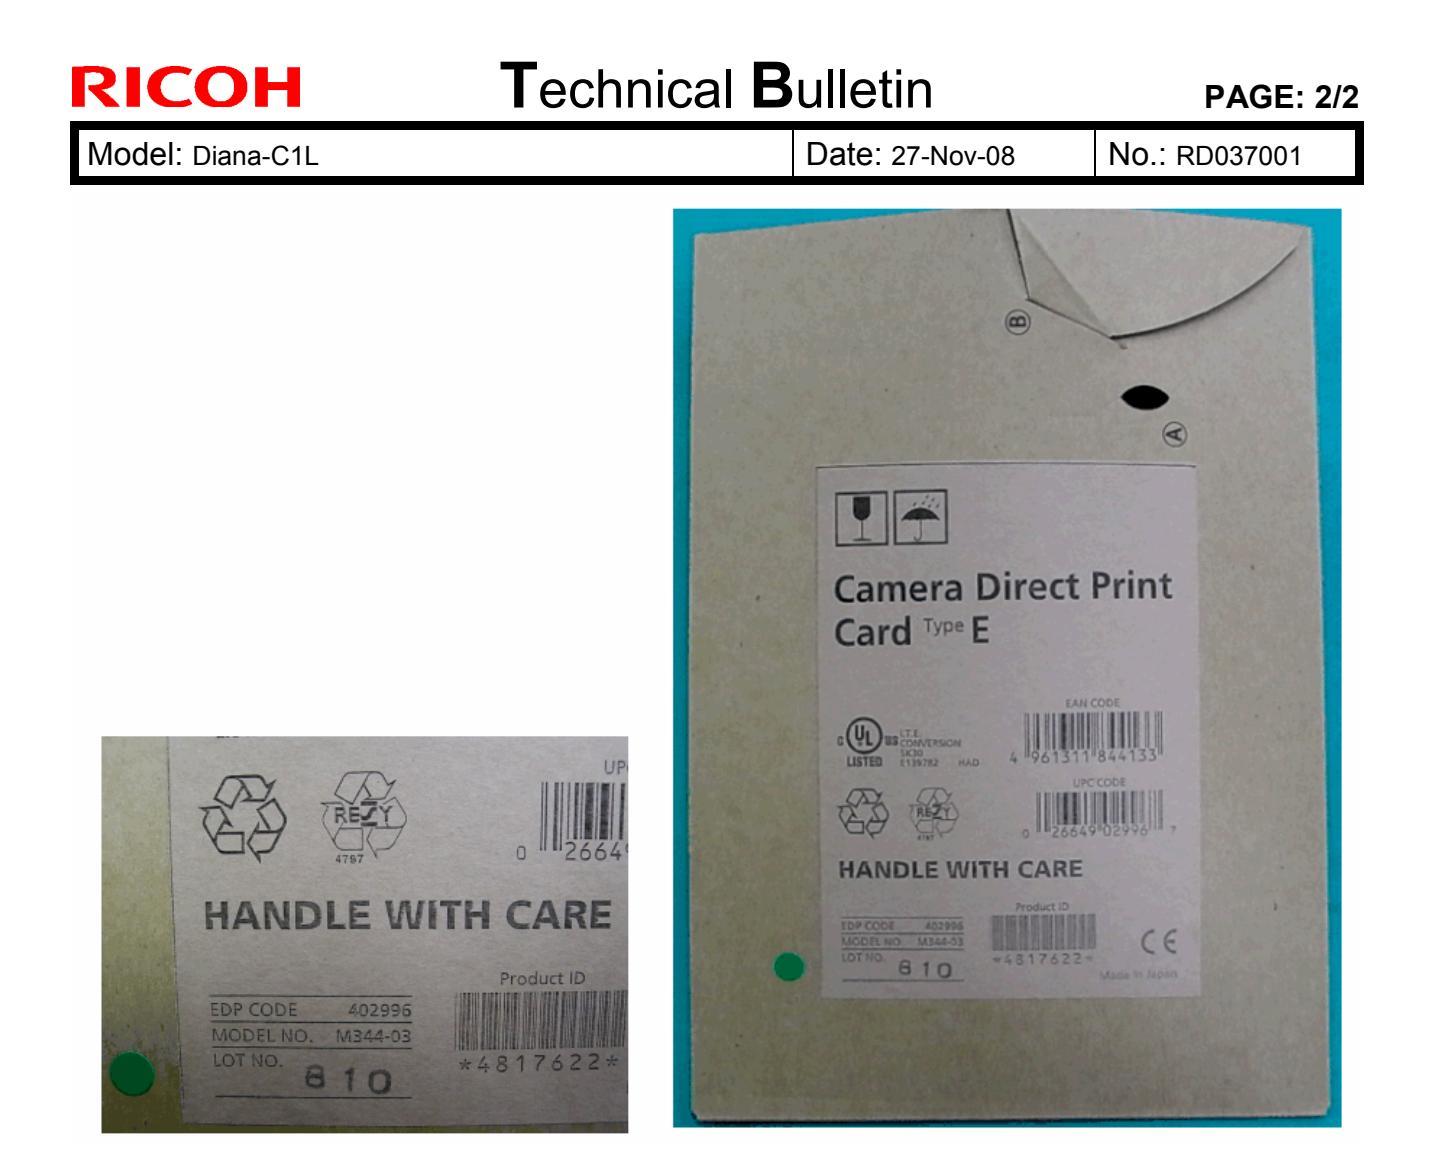
Note: Camera Direct Print Cards (Type E) that already contain version 1.01 or later are marked on the outside of the box with a green circle. See the photo below.

Update the PictBridge firmware to version 1.01.

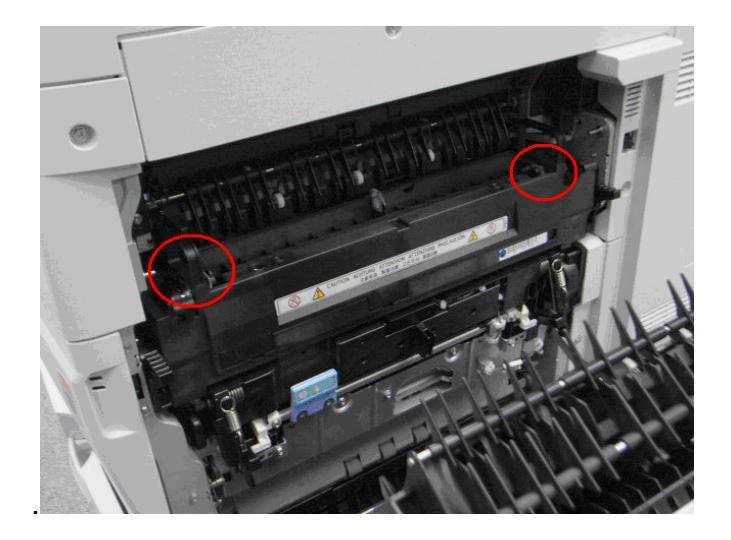
If there is a gap between the metal plates shown in the photo below, this means the pressure roller stay has been bent, so replace the pressure roller stay (P/N D0394183).

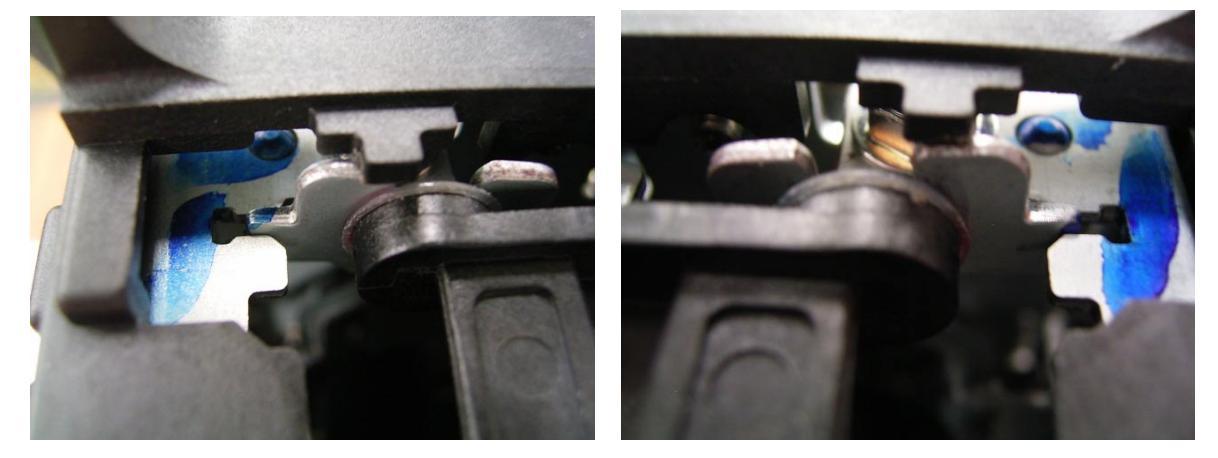
NG (the pressure roller stay has been bent): Notice the gap between the metal plates.

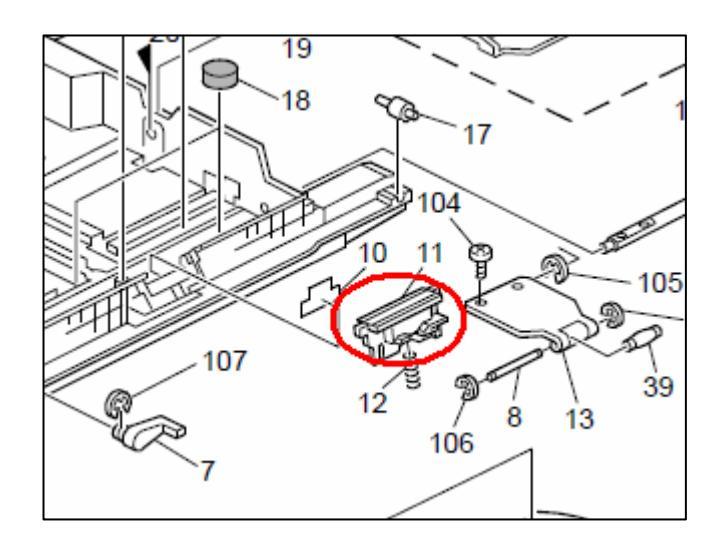
A growling noise (rattling caused by vibration) can be heard coming from the PB3030 Paper Feed Unit when the unit is installed on the Di-C1L.

See the diagram below to check the position of the pad. The pad is numbered 11 and encircled in red.

If this symptom is reported, replace the friction pad with the following:

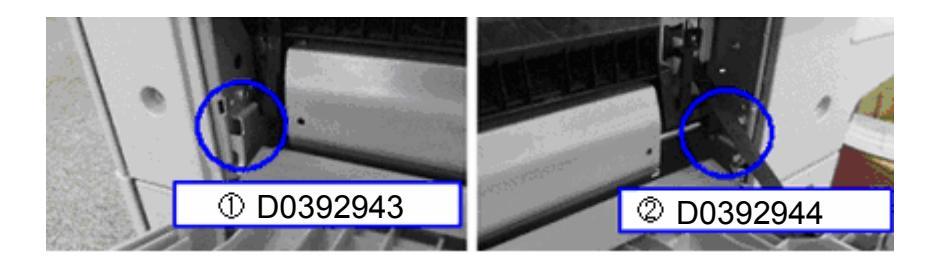
2. If the symptom is reported, and the brackets for the vertical transport covers are damaged or deformed, replace both brackets (Front: P/N D0392943, Rear: P/N D0392944).

Important: Open the lower side cover to access the brackets.

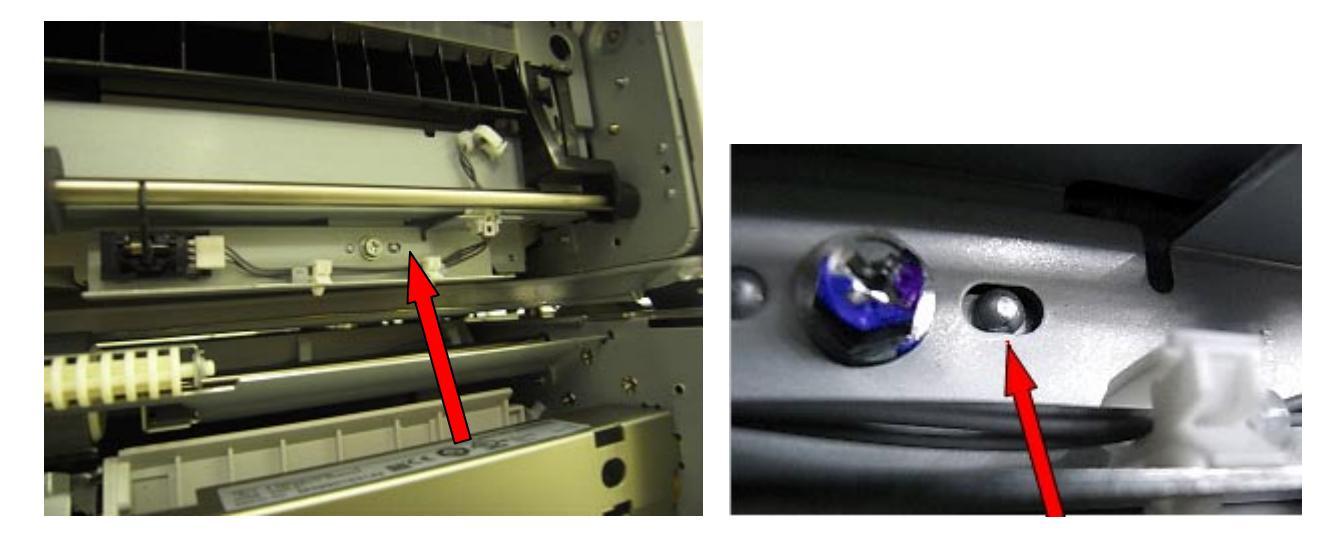
- 1. Press down on the vertical transport sensor bracket in the area around the embossing (bead) shown below.
- 2. If there is some play between this area of the bracket and the frame underneath it, replace the bracket with P/N D0392929.

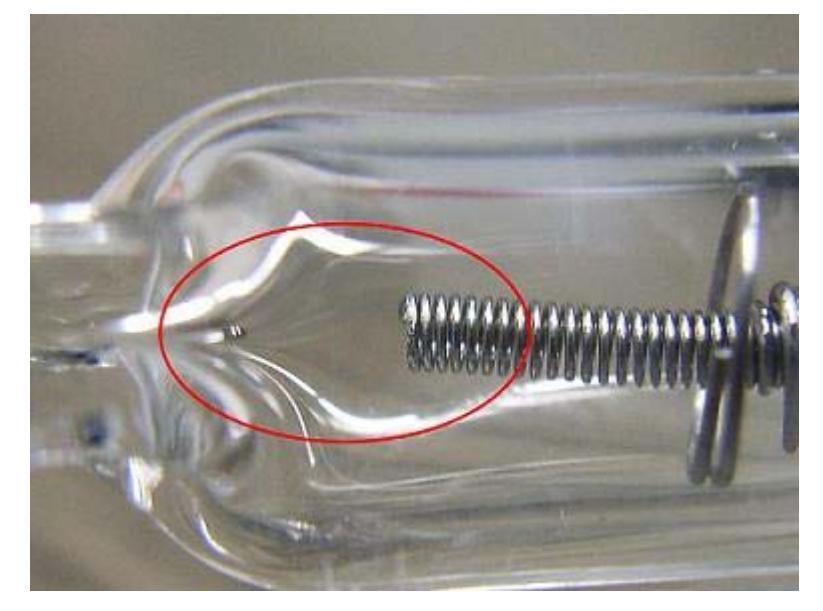
The fusing lamp (P/N AX440292) breaks, triggering SC552 or SC555.

Electricity is passed through a tungsten wire in order to heat up the halogen gas inside the fusing lamp. A stable halogen cycle depends on the right balance of current and halogen tube properties.

If the Auto Off Timer / Panel Off Timer is increased from the default value, the machine will spend a larger amount of time in the Standby (Ready) condition or performing a job, i.e. heating up the halogen in the lamp. In some cases, the electric current applied and properties of the halogen tube were not in the correct balance, causing the tungsten wire to break.

Replace the defective lamp with the modified one:

Upgrade the engine firmware to version 1.51:03 (not required for the new type of lamp, but it is recommended to keep firmware up to date)

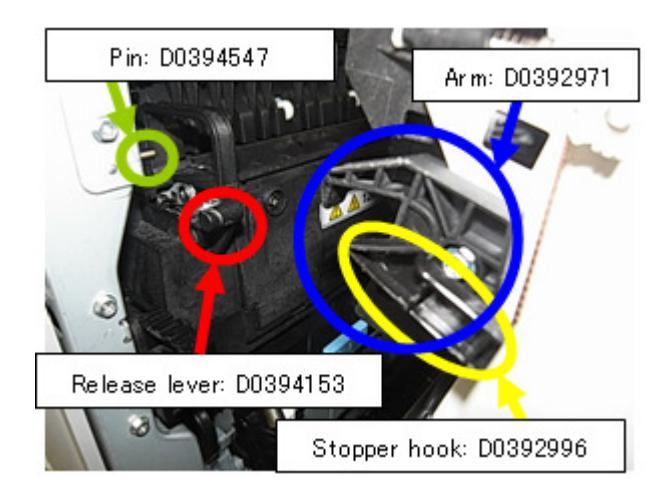
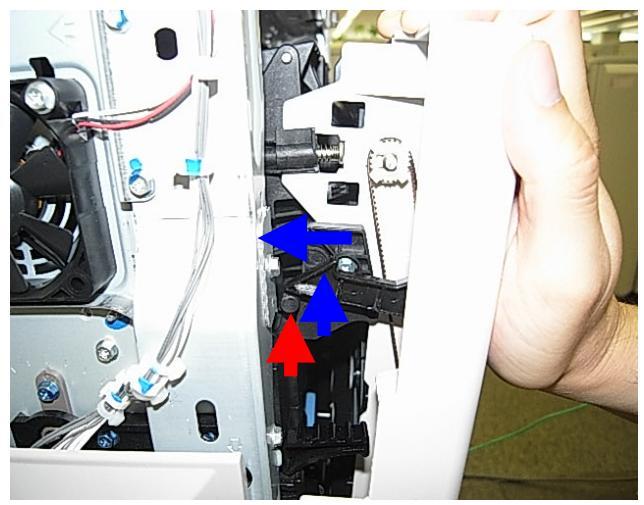
- Side-to-side play in the front pressure release lever
- The user does not push the center of the duplex unit cover when closing the cover. As a result, the cover is angled when closed, sometimes causing the arm to catch on the lever.

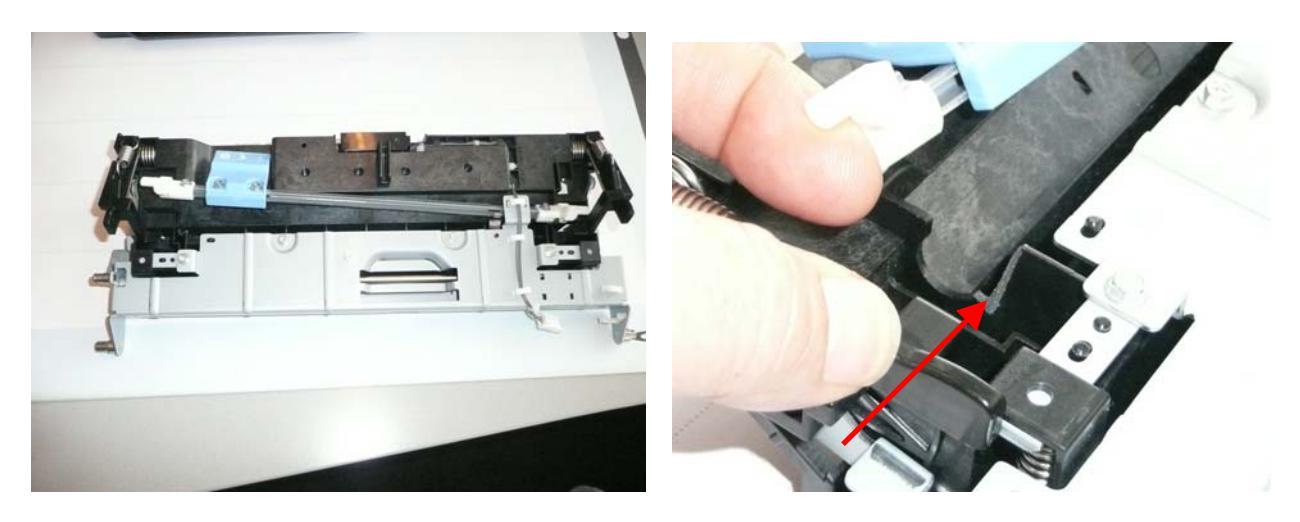
The transfer unit guide plate (P/N D0396221) breaks at the hinge side, moving the blue release grip (P/N D0396239) out of position.
