### Technical Bulletin

Reissued: 02-Nov-15 Model: CH-C1

No.: RD135004c

This RTB has been issued to announce the firmware release information for the Web Uapl.

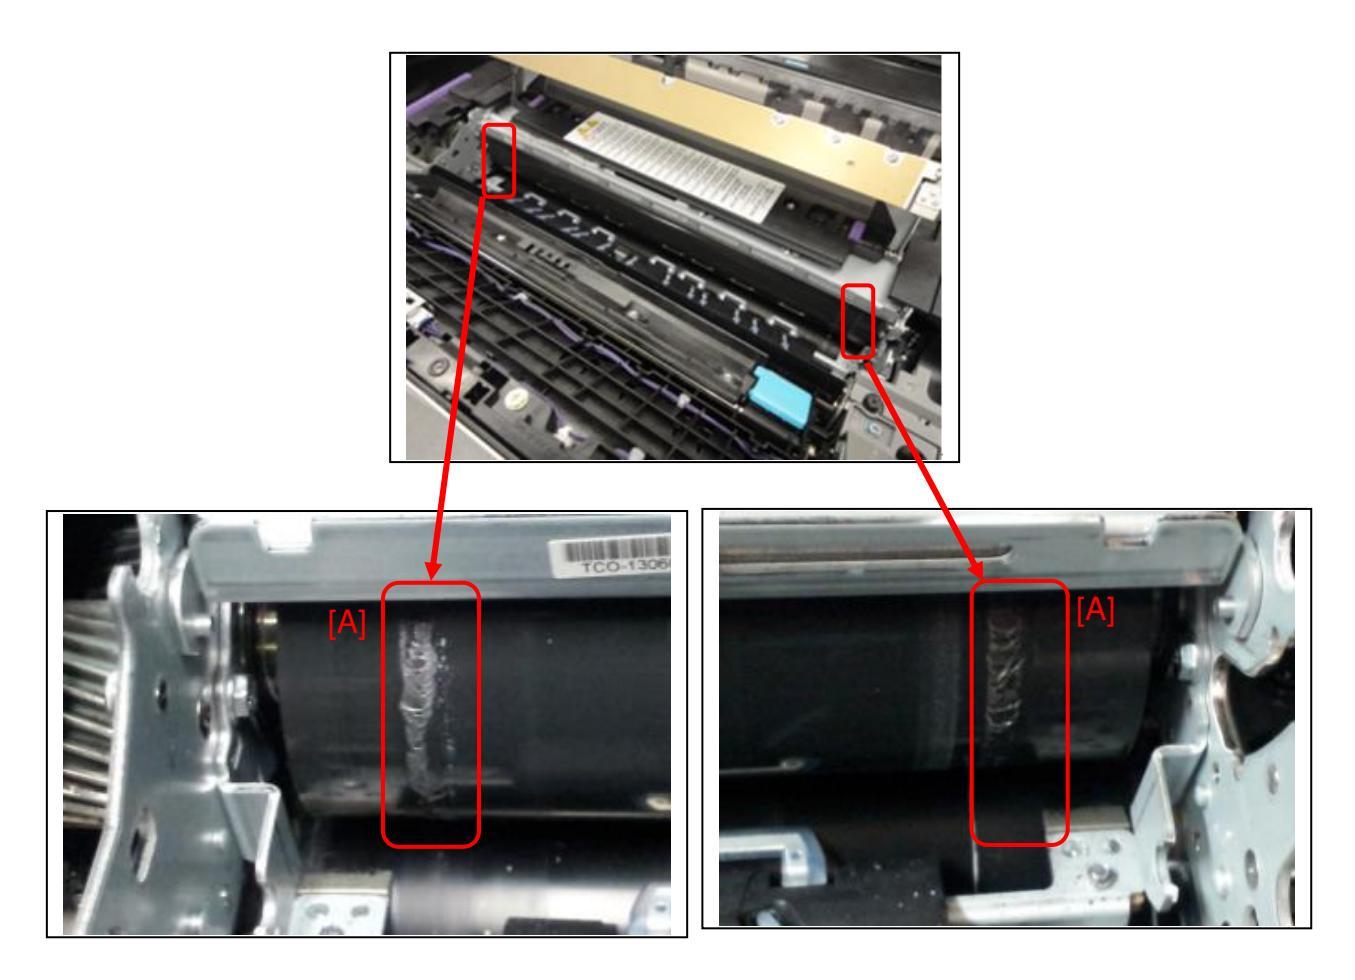
This happens because the stripper plate contacts the fusing belt, which is normal machine operation.

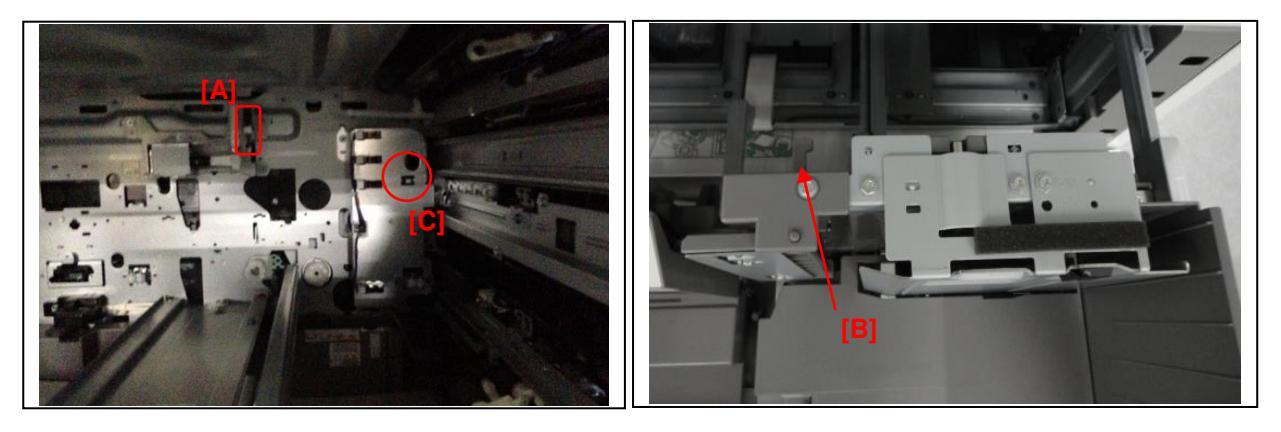
The right tandem tray is not set far enough into the tray, and the set sensor [A] cannot detect the actuator [B] on the end fence. As a result, the machine detects that the tandem tray is not set properly.

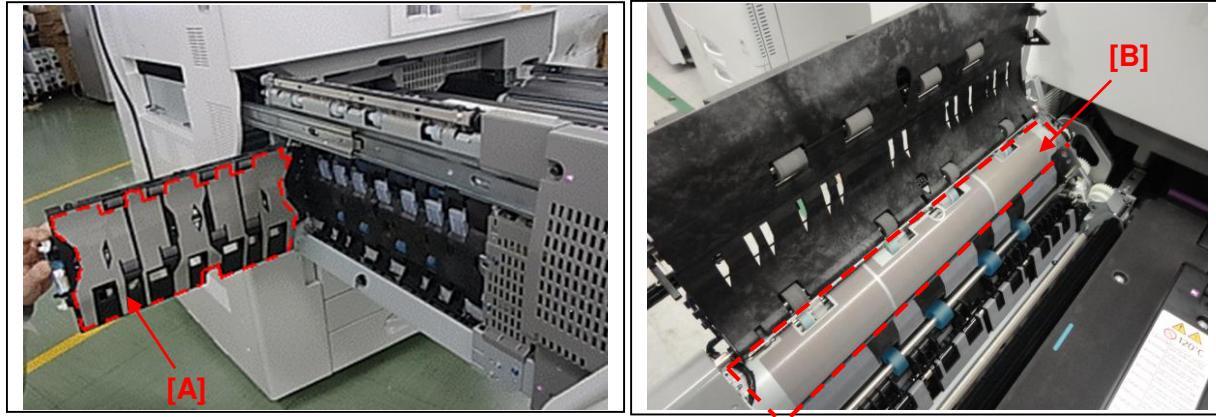
Static electricity causes the paper edge to be attracted to the guide plates (**[A]**, **[B]**). As a result, paper is forcibly stuck in areas [A] and [B] while the paper transfer rollers feed the paper.

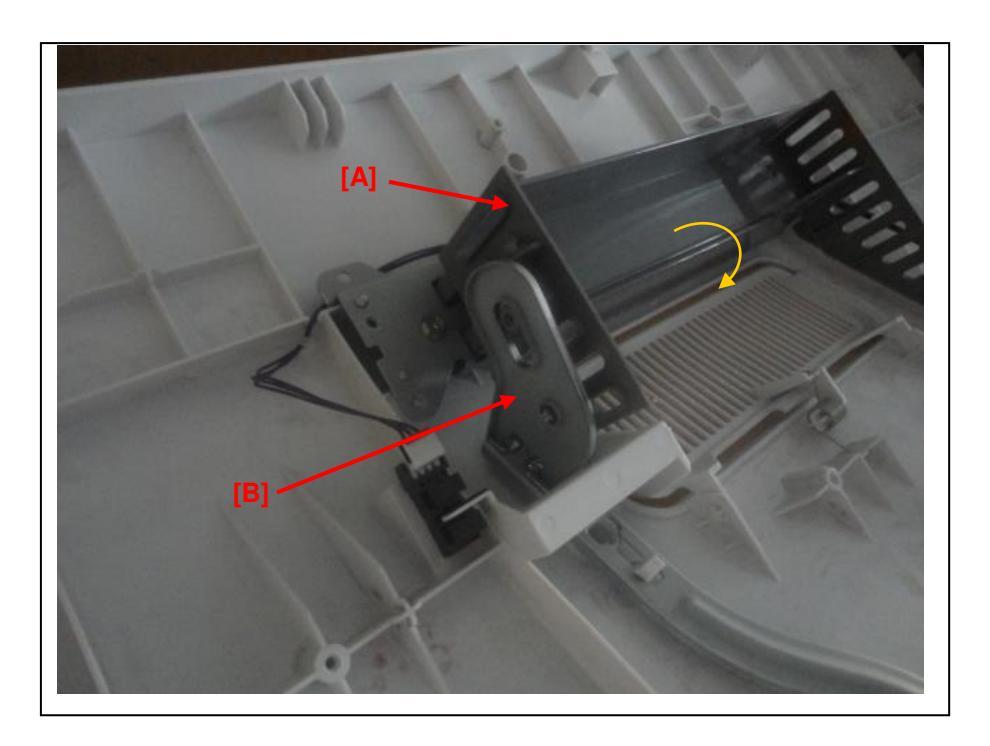
Drawer unit handle [A] may not return naturally to its normal position because the shape of handle [A] and lever [B] is not correct after the user pulled the drawer handle [C] in the arrowed direction below. As a result, the sensor cannot detect the handle in the normal position.

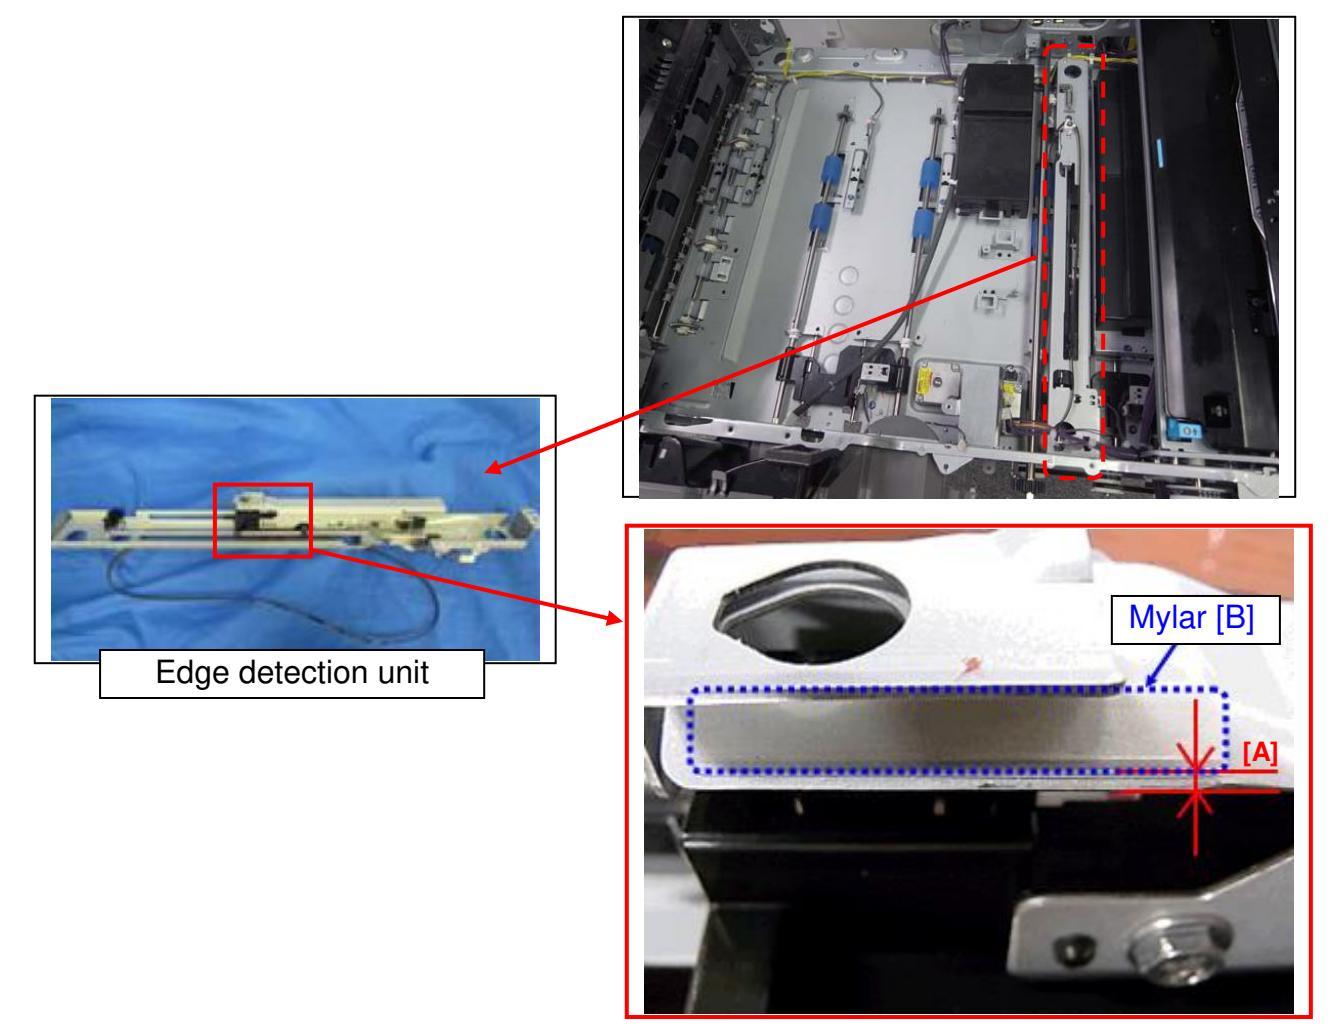
There is a gap [A] between the edge detection unit bracket and the edge of the attached Mylar [B]. The paper edge gets stuck in this gap, triggering JAM 97.

Note: This gap [A] is normally controlled at the factory to within 0.5mm.

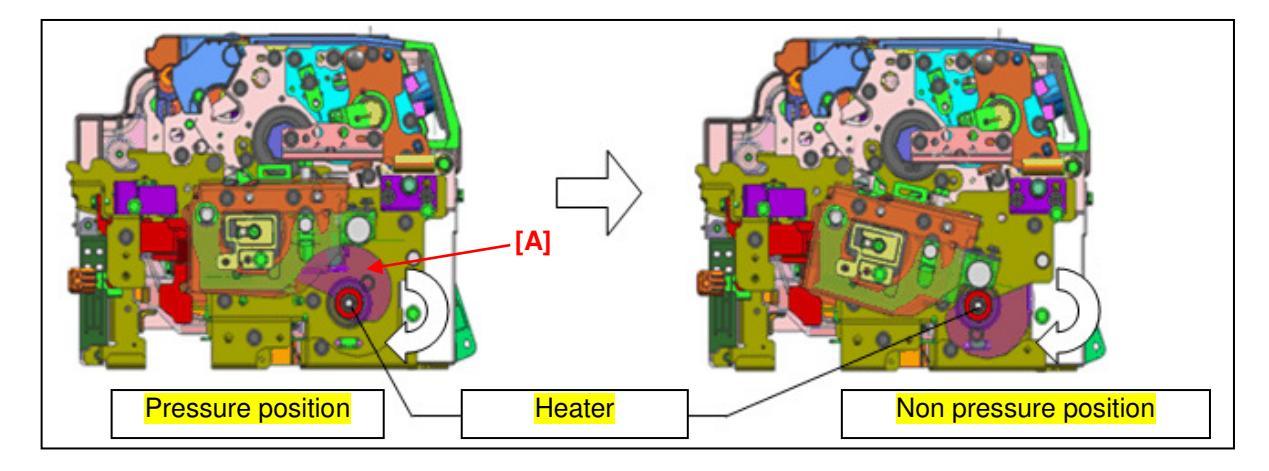
After that, the cam [A] rotates from the pressure position to the non-pressure position. This causes shock to both heater terminals inside the pressure roller and breaks the heating lamp. The shock is caused by the gap between the pressure position (top dead point) and non-pressure position (bottom dead point). As a result, SC555-00 may appear.

**Note:** This symptom occurs on the D135-17 (120V) model only. On all other models, the "Fusing unit set error" message appears and the machine does not start up if the drawer unit is not pushed into the machine enough. This is because the other models have a set detection mechanism.

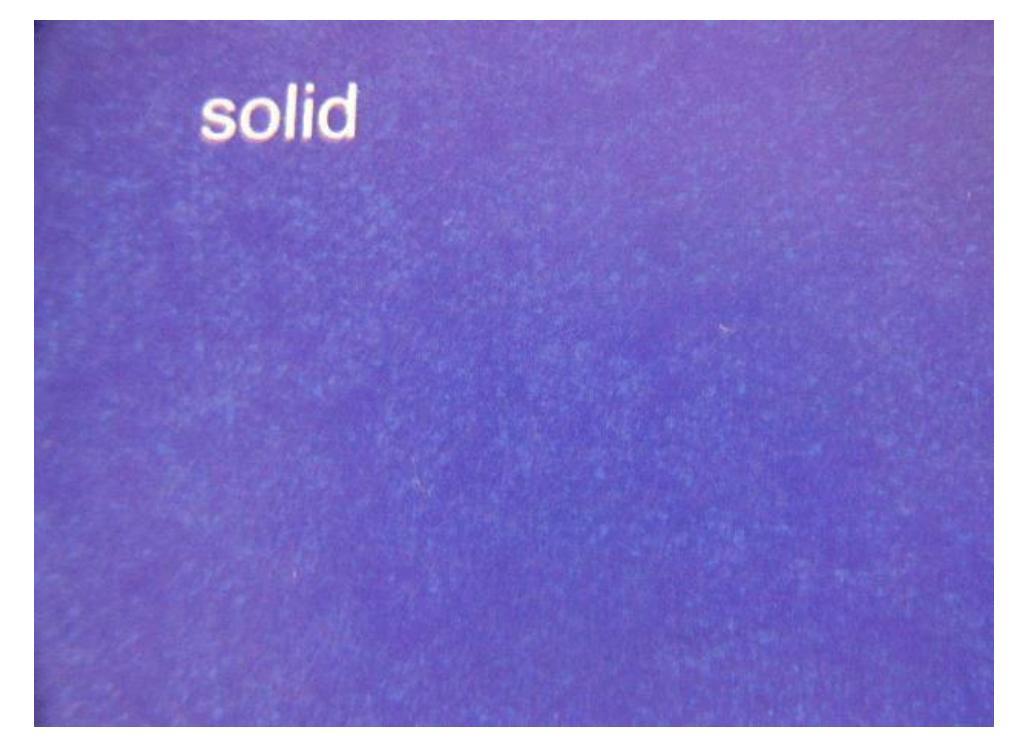
The image density is not uniform across image areas when printing onto paper that is not smooth under high-temperature, high-humidity conditions.

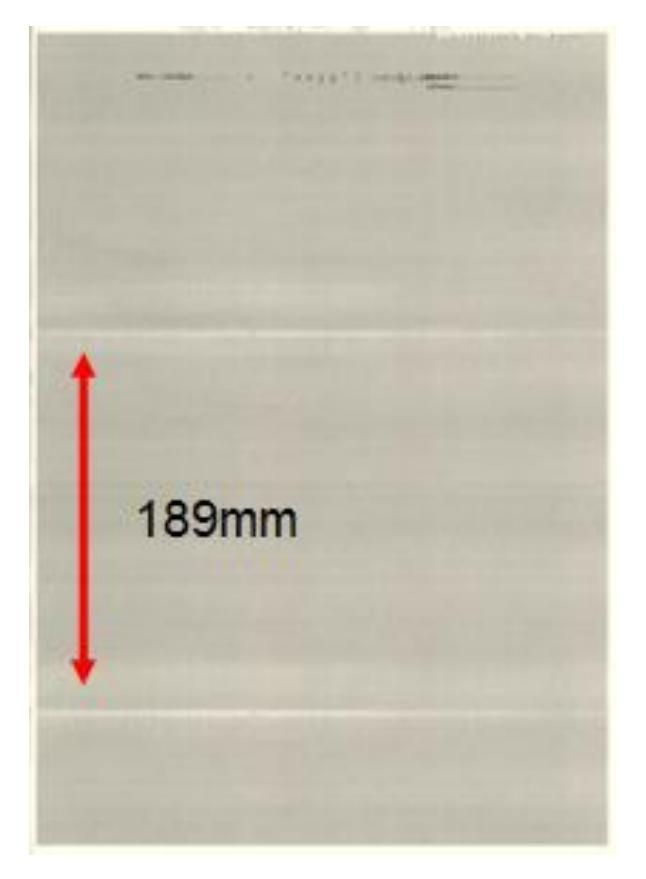
The first few printouts after turning on the machine may have blurred image at 189mm intervals (which corresponds to the OPC drum circumference) on halftone images in a high humidity environment.

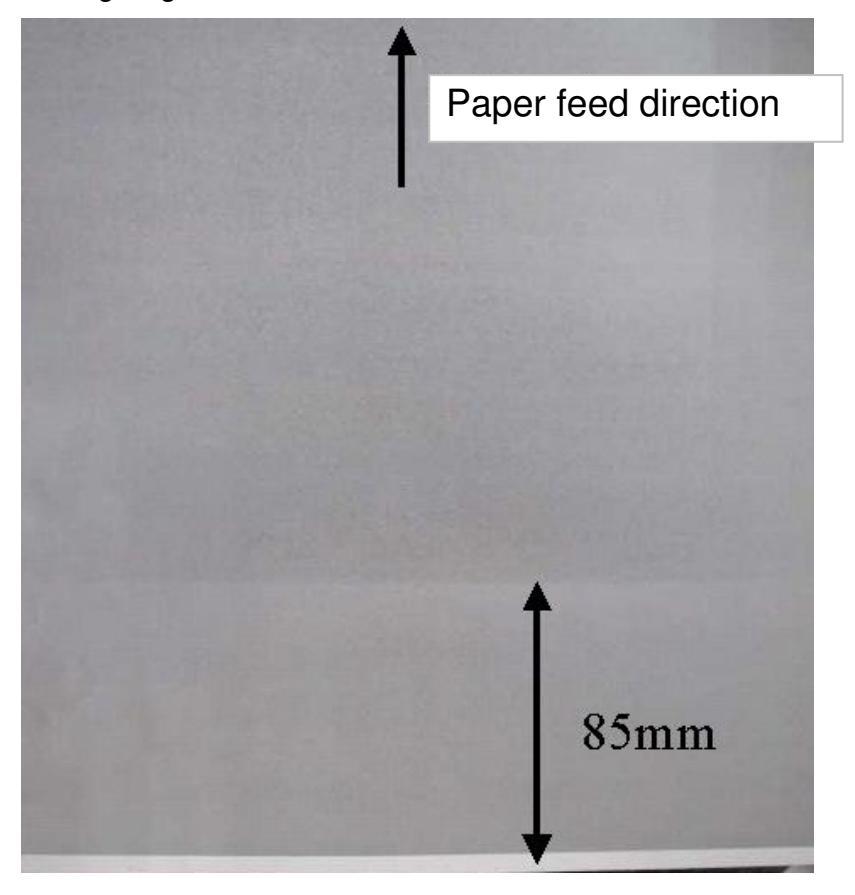
Uneven density of halftone images may appear in the area 85mm from the trailing edge.

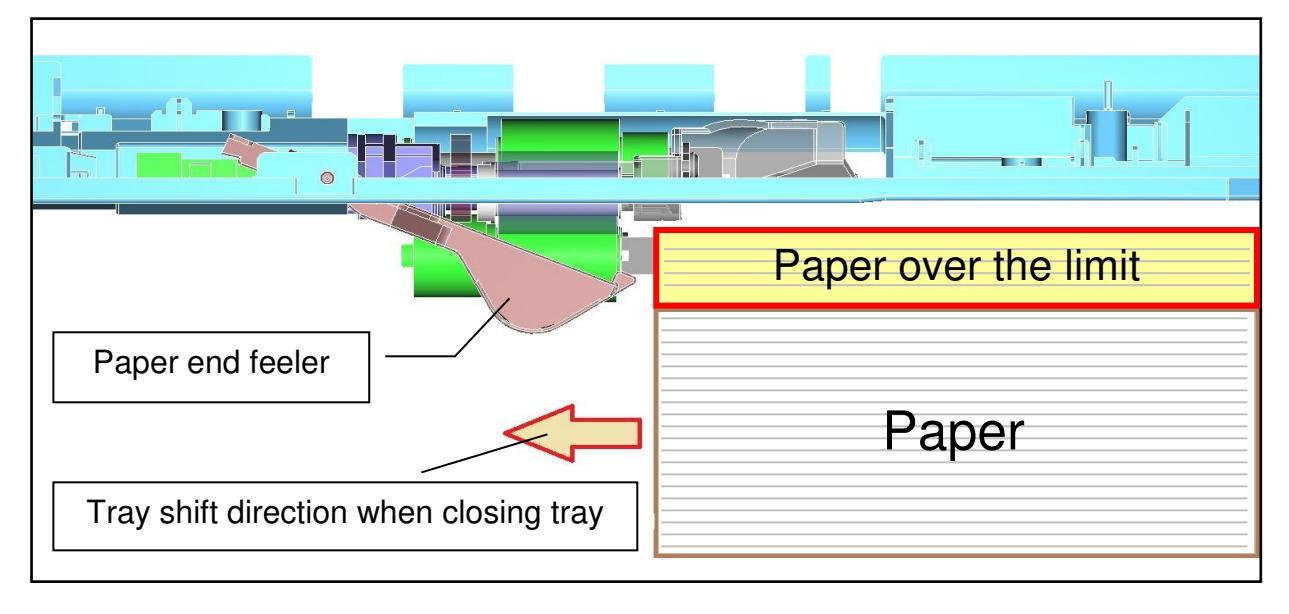
The paper tray is filled over the specification limit, causing the paper stack to hit the paper end feeler with force and knock the feeler off the paper feed unit.

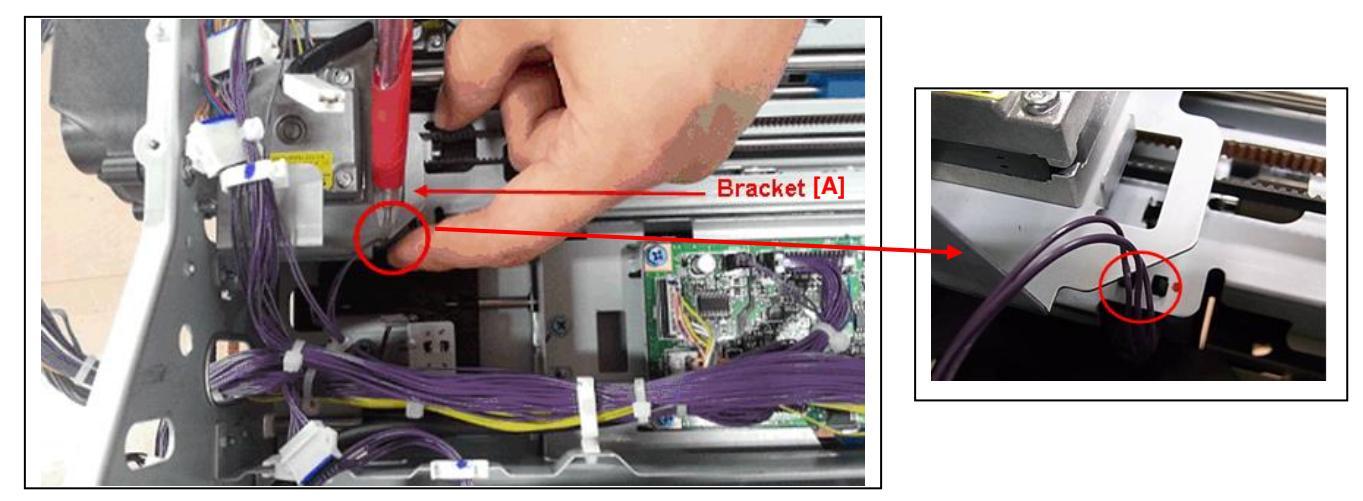
The harness circled in red below is wedged between the paper transfer unit and bracket [A], causing a short.

**Note:** This is not a product safety issue. Even if the harness shorts out, this will not produce any smoke or flame.

- 1. Remove the paper transfer unit from the machine (see FSM pg. 660-663).
- 2. Check if the harness is damaged.
- 3. If it is damaged, bind the damaged harness using Teflon tape.
- 4. Bind harnesses [A] and [B] together using a clamp, as shown below.

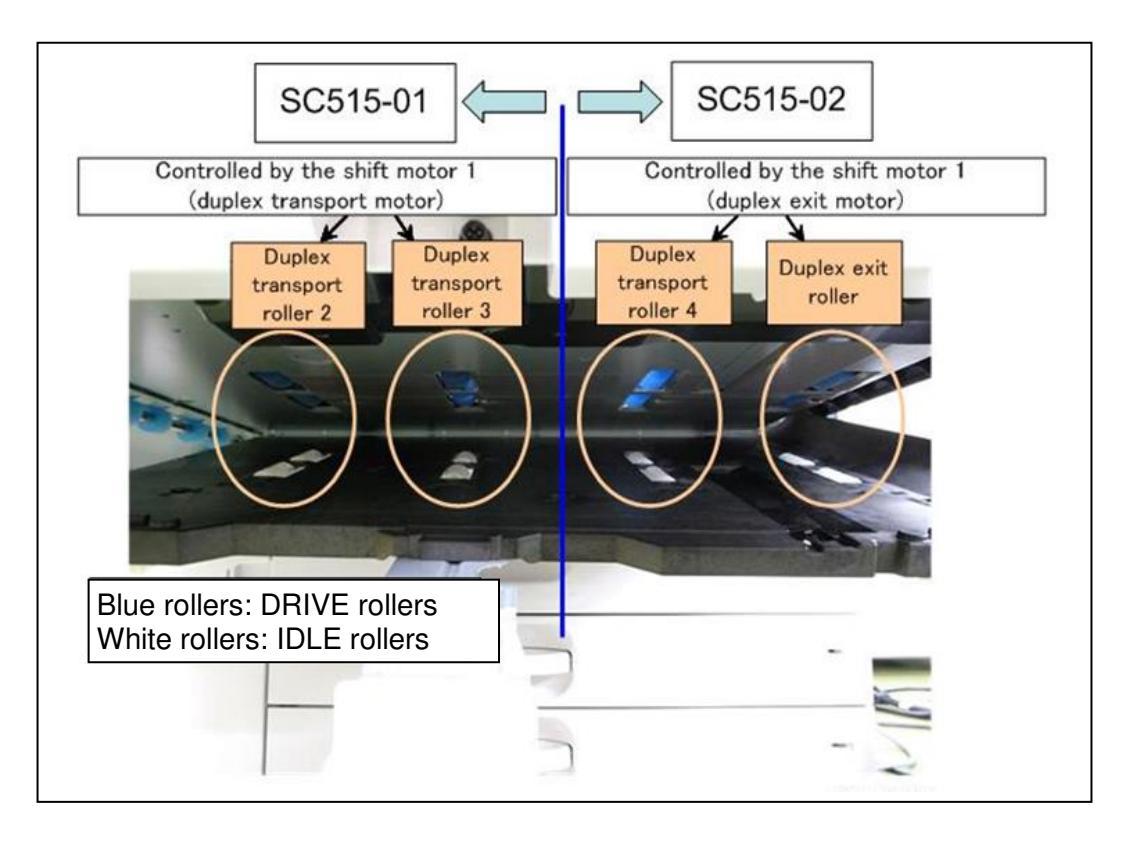
Because the machine is still new, grease is not completely spread across the roller shift motor (duplex transport motor), causing the motor to lose steps.

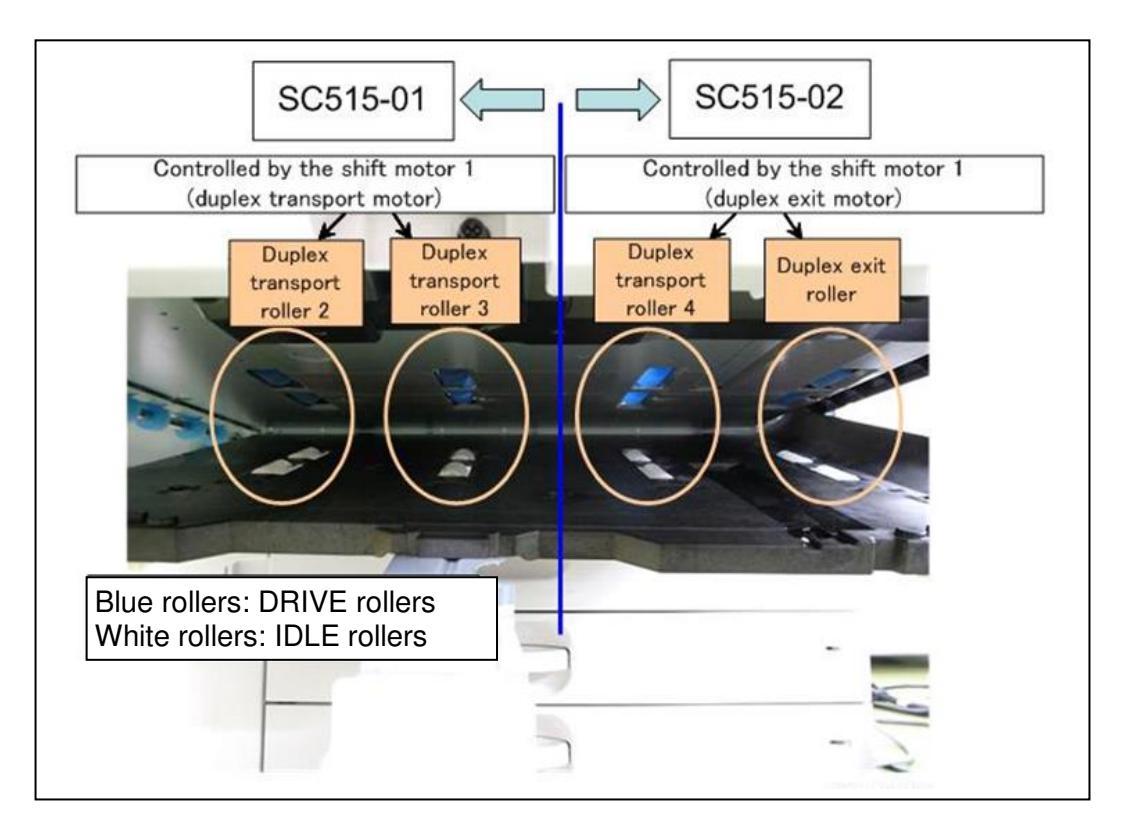
Because the machine is still new, grease is not completely spread across the roller shift motor (duplex exit motor), causing the motor to lose steps.

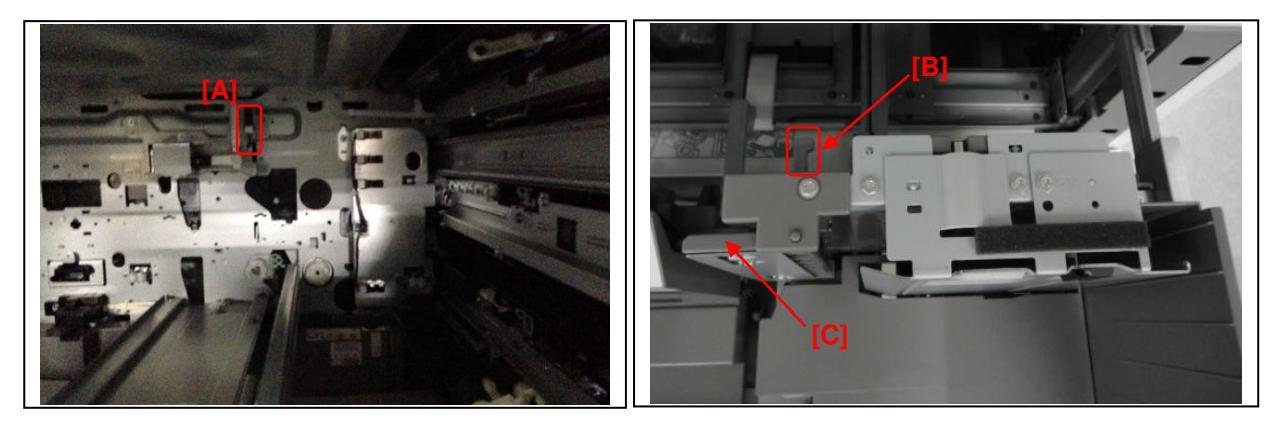
The end fence [C] is not positioned correctly. As a result, the tandem tray set sensor [A] cannot detect the actuator [B].

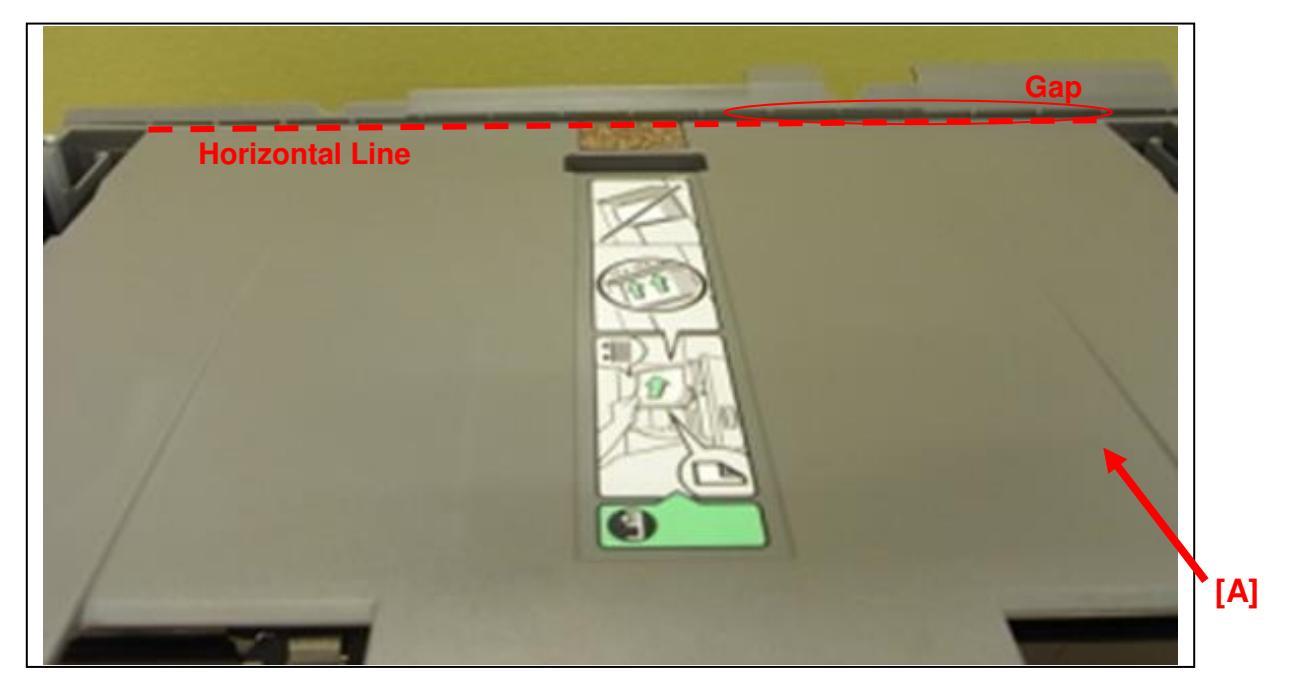
The tandem tray bottom plate [A] is not attached in the correct orientation (see the photo below). As a result, the machine cannot detect the bottom plate in the correct position.

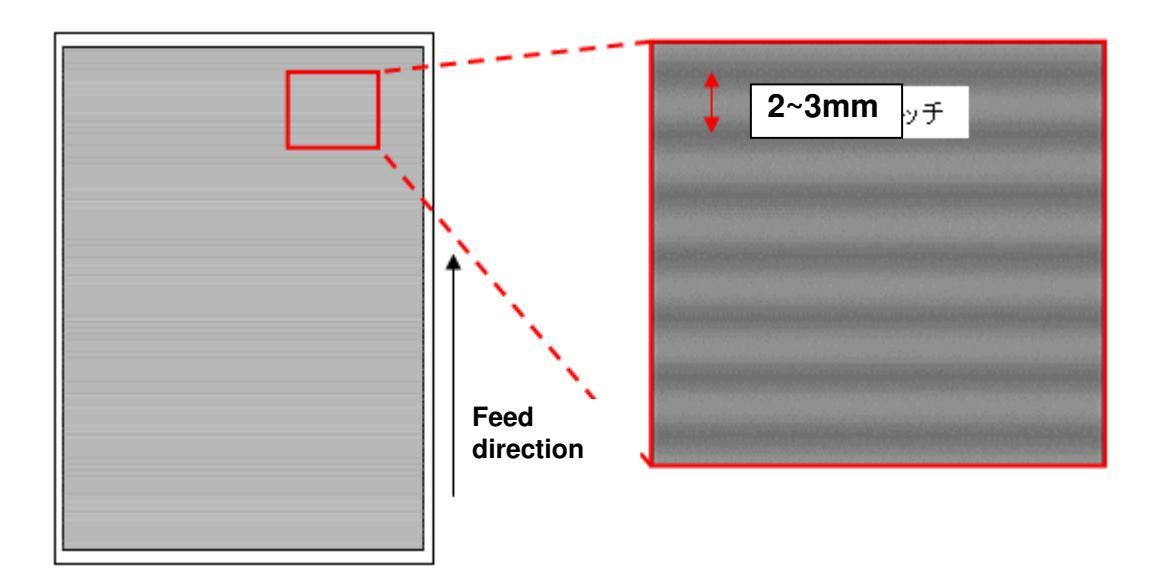
Banding (uneven density) at 2~3mm intervals

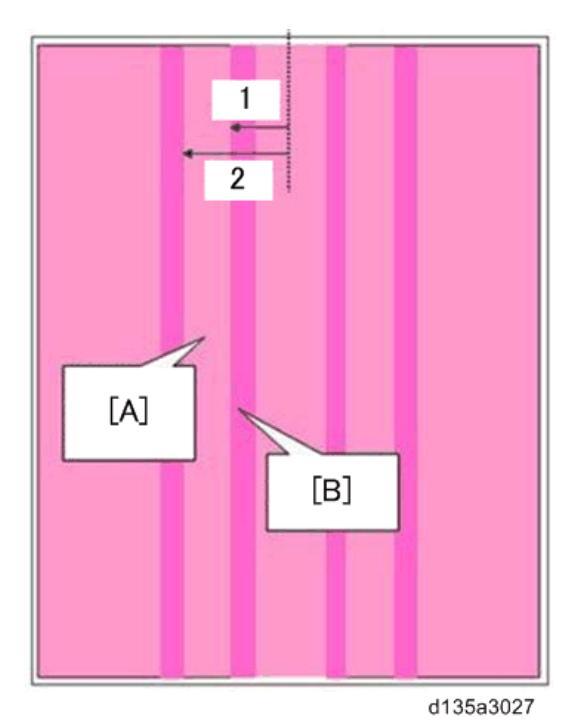
Vertical bands of uneven image density appear in halftone images on the rear side of duplex copies/prints when printing onto coated paper in low-temperature, low-humidity environments (10°C, 15%).

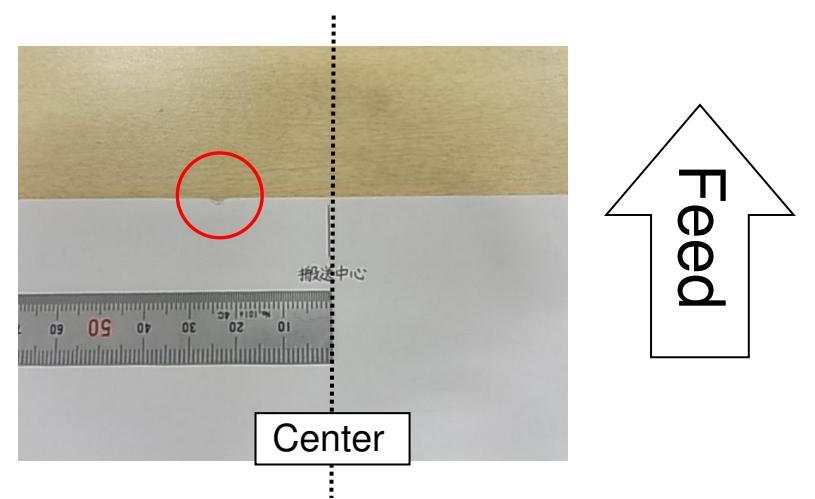
When feeding paper with large curl, the leading edge gets caught in the hole cut out for the duplex entrance sensor located under the duplex horizontal feed path and prevents the sensor from detecting paper.

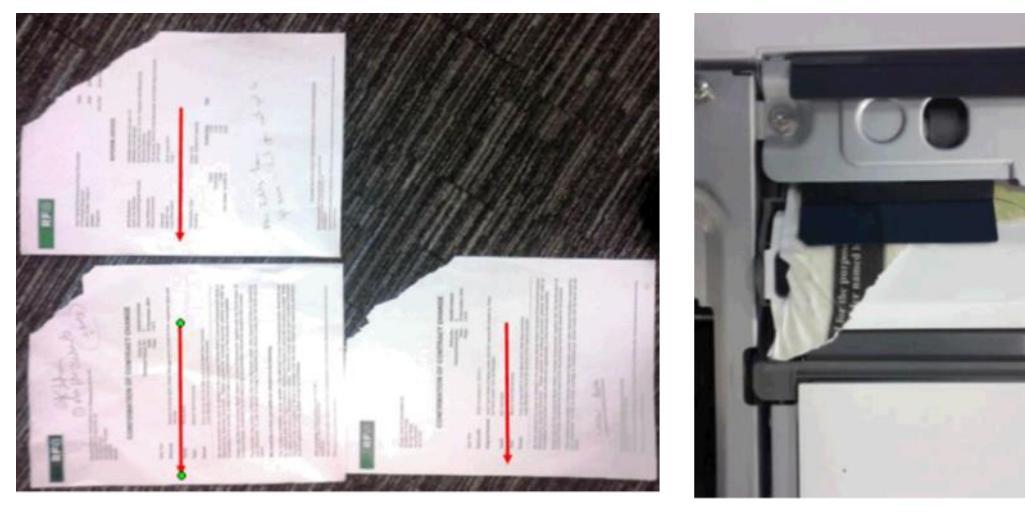
Jam code 66 occurs, the original is torn, or dog ears form in the original when using ADF.

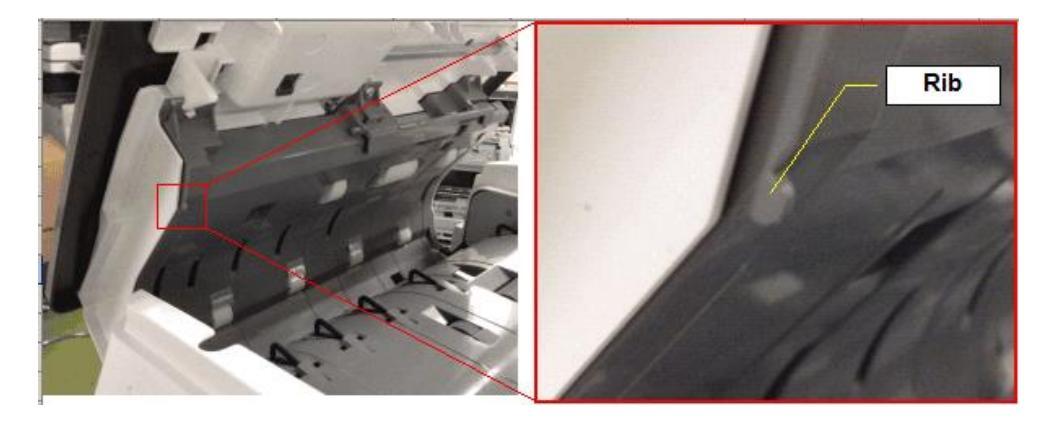
The original contacts the rib on the paper feed guide when it is fed.

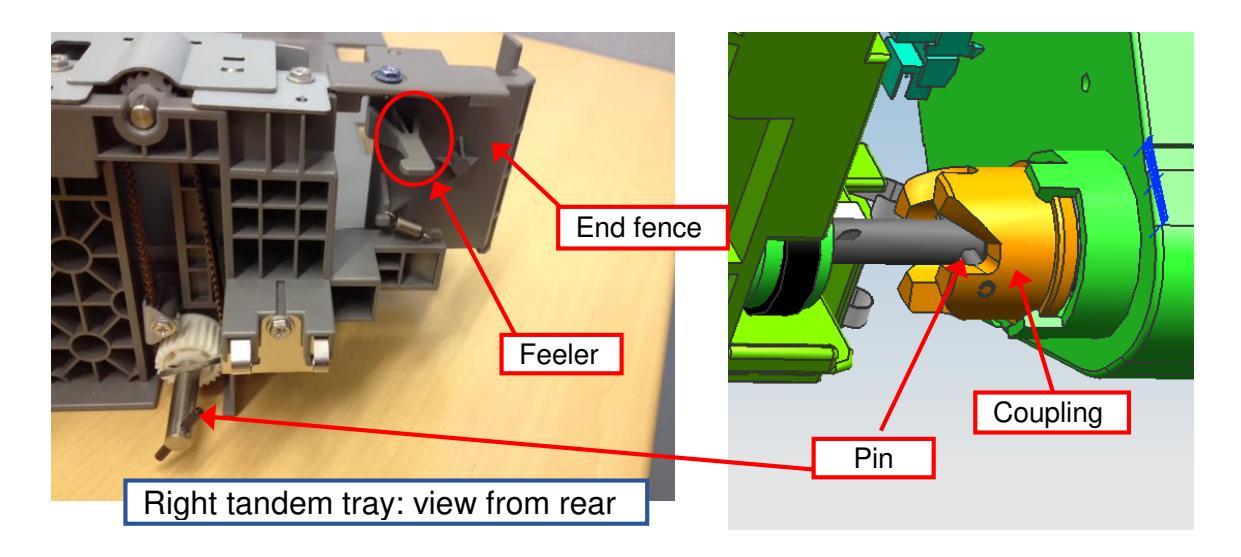
The feeler of the right tandem tray end fence is retracted and prevents the system from detecting proper setting of the tray. This happens because the pin attached to the shaft that rotates to lift up the bottom plate of the tray is not completely engaged with the coupling.

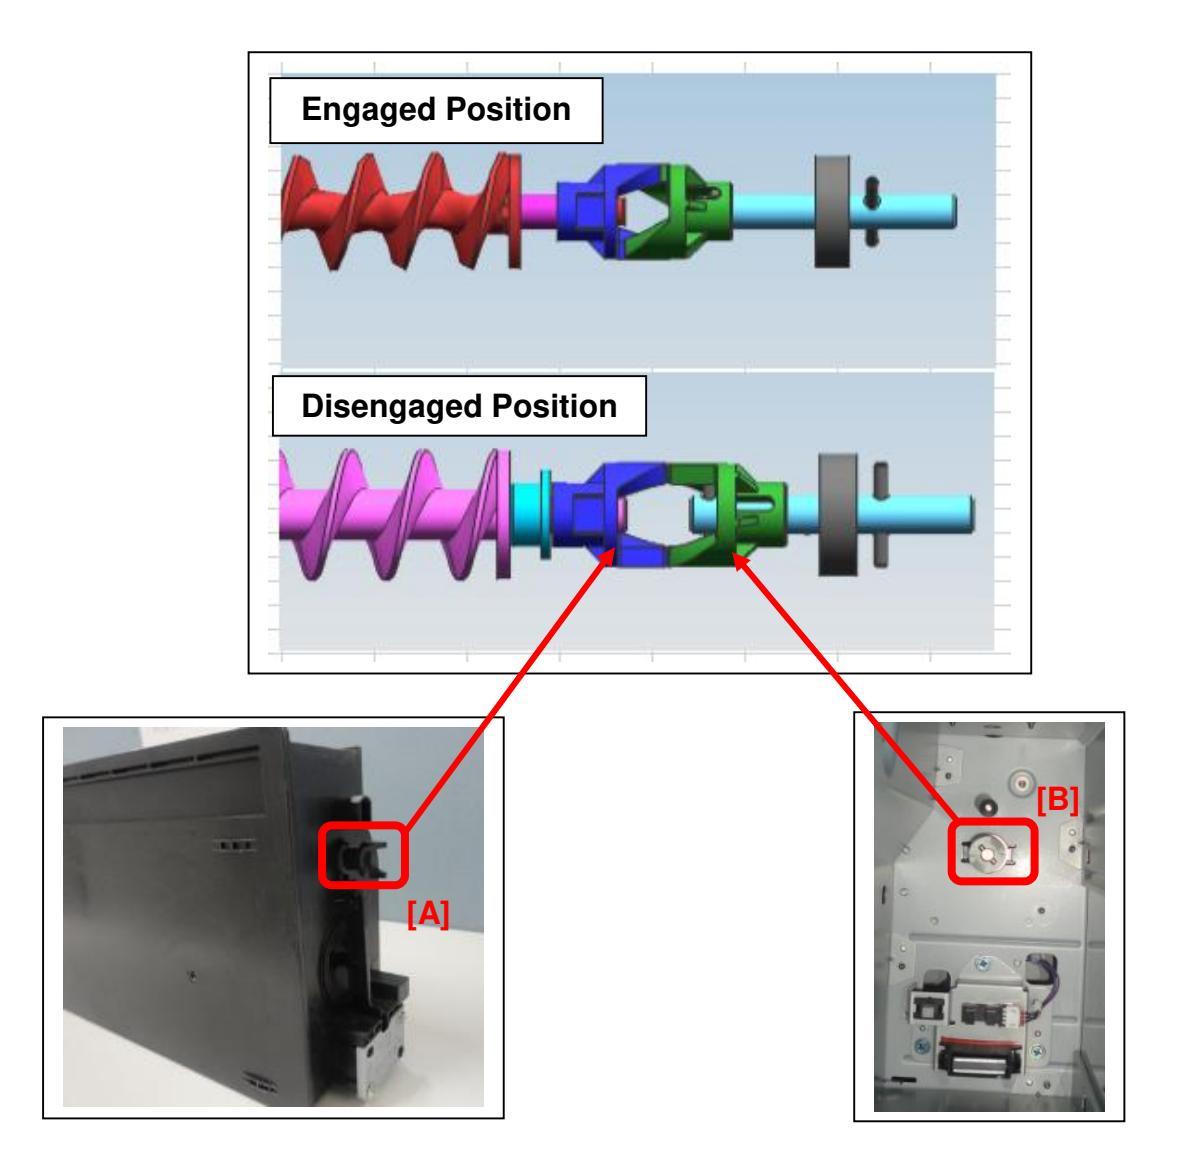
The tips of couplings [A] and [B] contact each other when the waste toner bottle is installed, which prevents them from engaging properly. As a result, coupling [B] is pushed into the machine in the "disengaged position" (see below), preventing the waste toner transport coil from rotating.

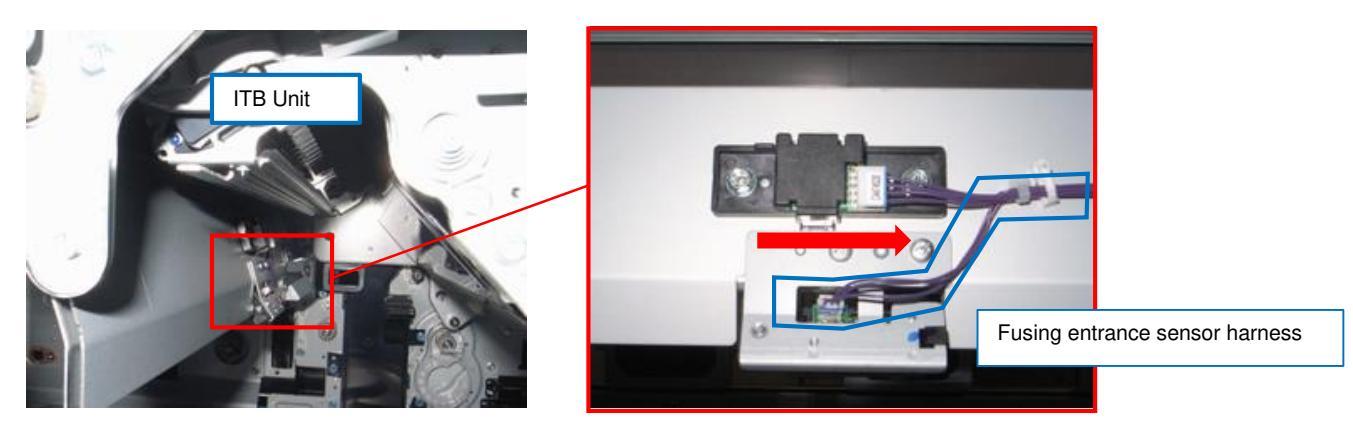
The belt cleaning unit is attached while being slid to the left (toward the fusing unit), causing it to contact the edge of the connector for the fusing entrance sensor harness. As a result, the harness is disconnected at the connector.

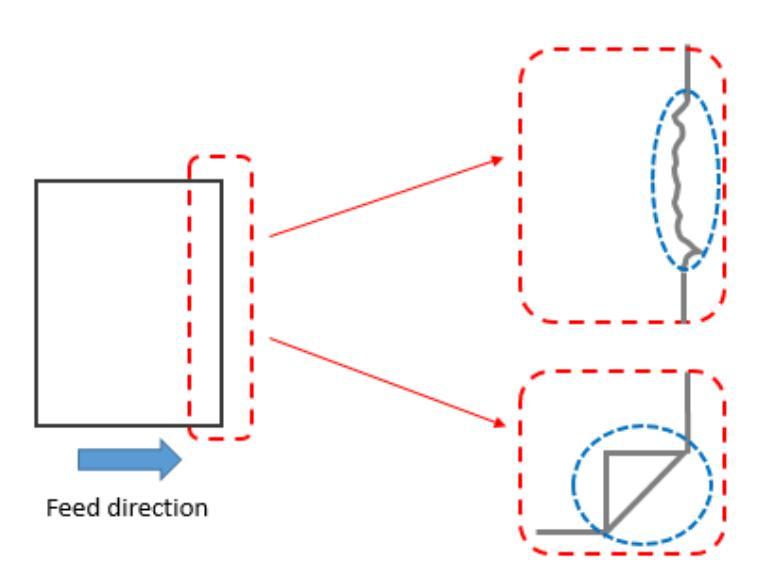
Jam003: Dog-ears and damaged leading edge

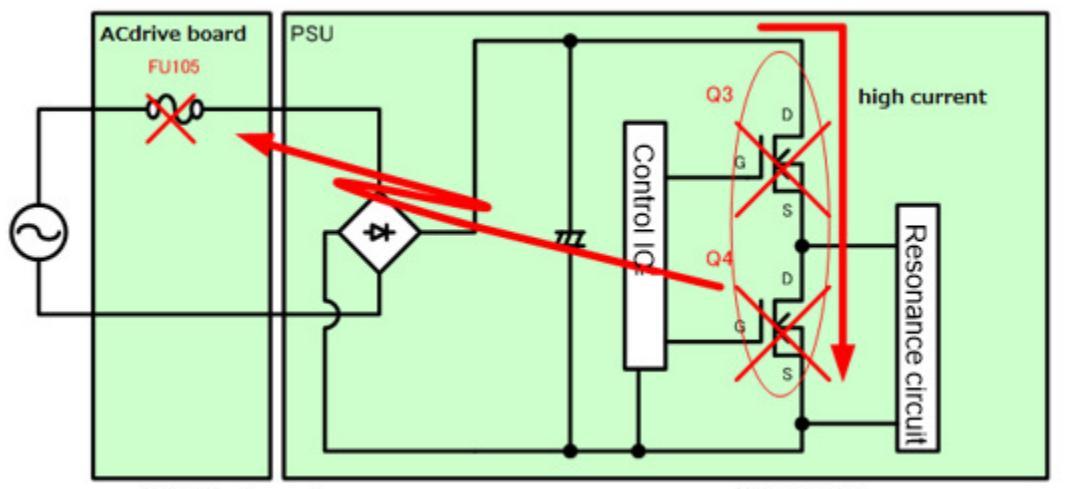
Machine power does not turn on as a result of a damaged PSU-ECO and a blown fuse FU105 on the AC drive board.

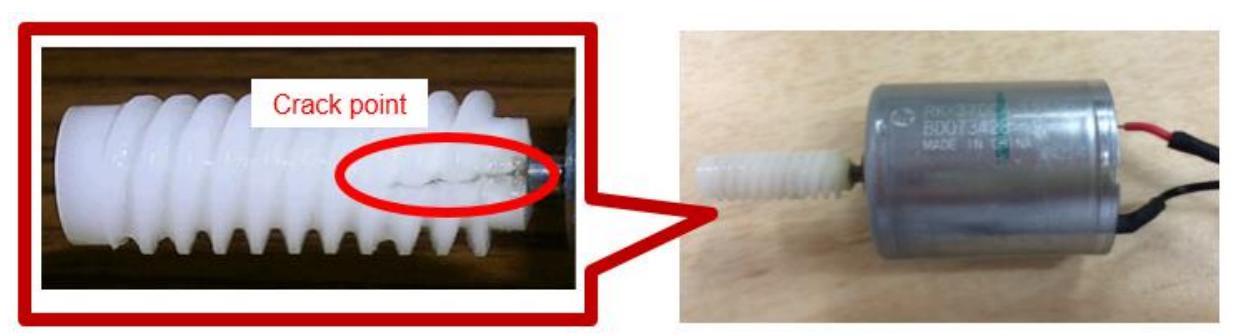
Crack in DC motor worm gear
