**Model BR-C1/P1
Machine Code:
D179/D180/D181
M263/M264
Troubleshooting**

May 2015

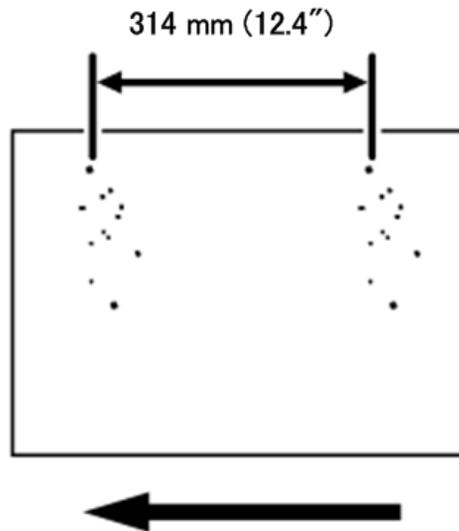
d1798003

Black spots appear at 314 mm (12.4 inches) intervals.

Cause:

The drum is scratched or stained.

Yes	Replace the drum.
No	Consult key operators.

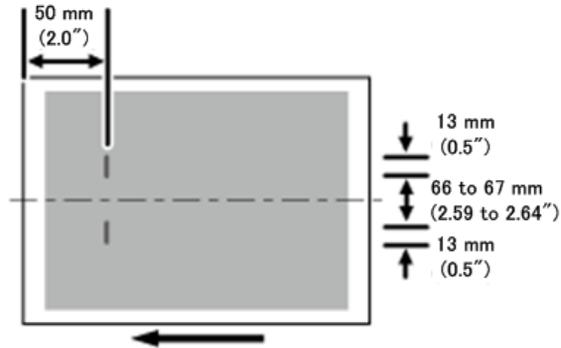
d1798007

Two 13-mm long vertical streaks appear within 50 mm (2.0 inches) from the leading edge.

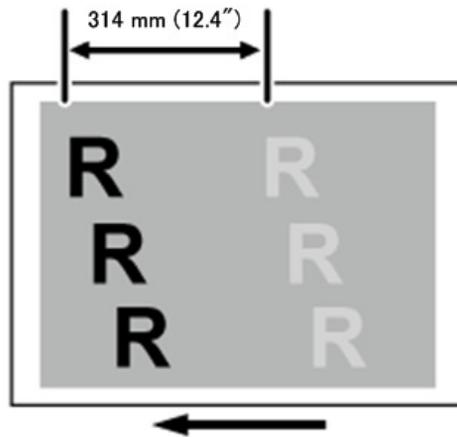
d1798017

A ghost image of an image to be printed appears at a distance of 314 mm (12.4 in.) to the side of the intended image.

Cause:

The image transfer current is transmitted to the drum, where a potential difference occurs between a developed area and non-developed area and causes the intended image to be reproduced.

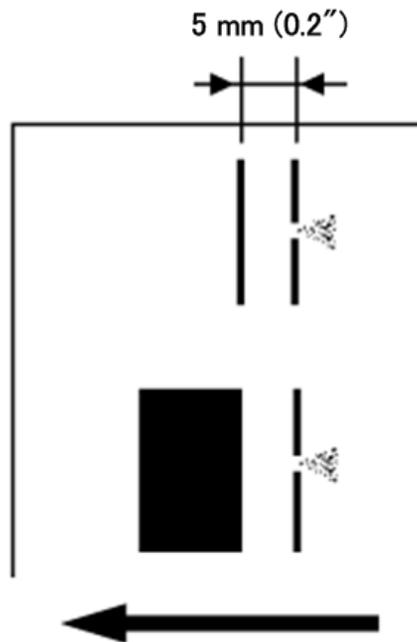
d1798020

Parts of a line that is 5 mm (0.2 inches) or less from an image exhibit splatter.

- Printing is done at high temperature or humidity
- Using coated or other slippery paper
- Printing line images at less than 5 mm (0.2 inches) intervals

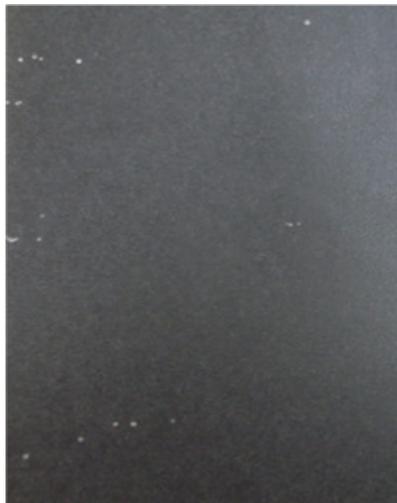
d1808008

Random white specks appear in shaded areas.

Cause:

The charge on the image transfer roller is high, and the problem is caused at the pre-nip and nip area of the roller. This can occur if the machine is in an area where ambient temperature and humidity are very low.

4. Replace the image transfer roller.
5. Print the image. Is the problem resolved?

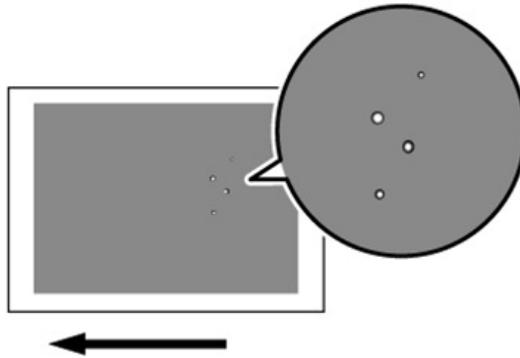
d1798023

White spots 0.3–0.5 mm (0.01–0.02 inches) in diameter surrounded by denser spots (blister-like white spots) appear.

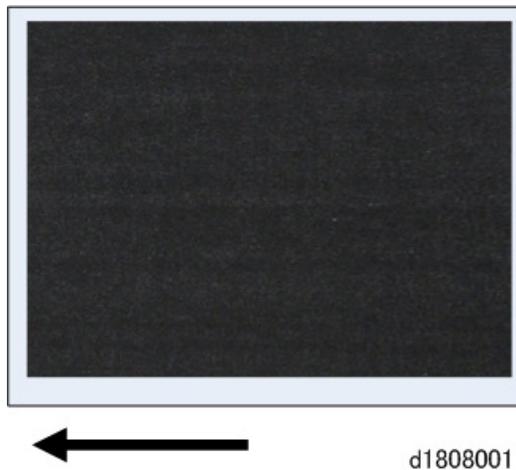
Texture of filled image areas appears rough.

Cause:

Paper with a smaller width leaves more of the roller exposed where there is no paper, and this allows leakage of charge from the transfer electrical field thus reducing the efficiency of image transfer. This effect can also occur when:

- Ambient temperature and humidity are low
- Paper is extremely thick
- Electrical resistance of paper is high
- Duplex printing (occurs on Side 2).

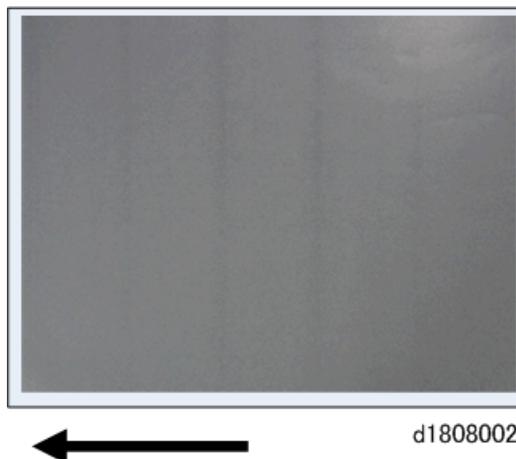
Faint black bands appear at 60 mm (2.4") intervals vertical to the direction of paper feed.

Cause:

Periodically changing the speed of paper feed can affect the elasticity of images and lead to unevenness in image texture in the shape of black vertical lines. This can also occur when:

- Ambient humidity is high
- Thick paper (above Thickness 3) is used
- There are large areas of halftone coverage

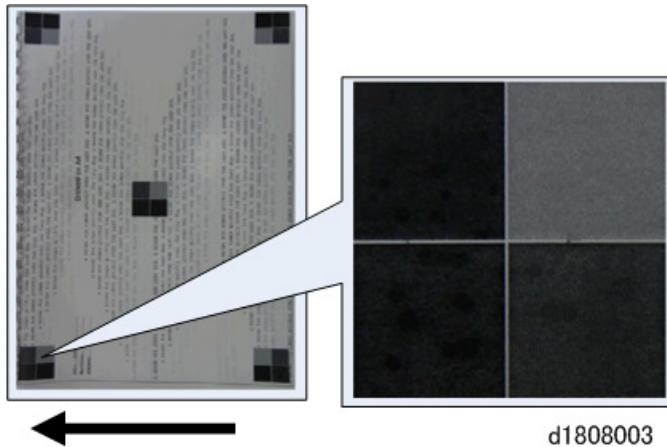
The special properties of the paper (slick surface, electrical resistance, etc.) can cause black spots and specks to appear.

Cause:

Ambient conditions and special paper characteristics (slick surface, electrical resistance, etc.) can cause too much charge in the electrical field and cause dots to appear. This effect can occur when:

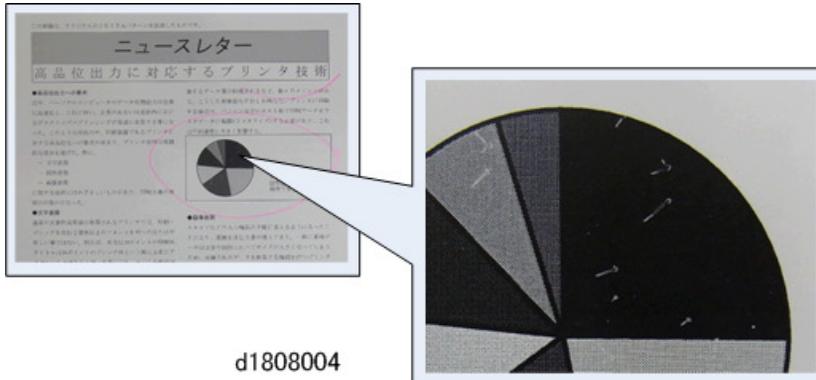
Dirt and paper scraps in or around the image area can cause static trace patterns to appear in the images.

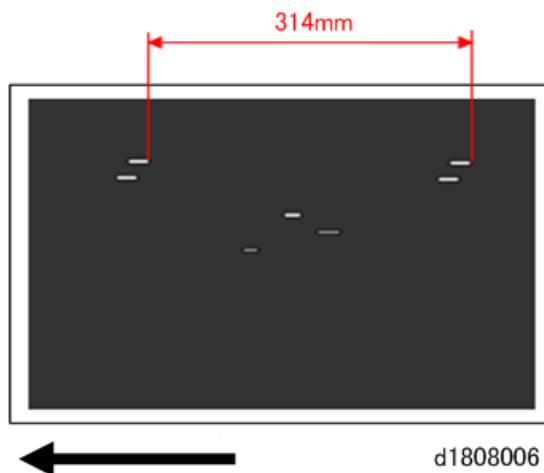
Toner or lubricant powder sticking to and accumulating on the surface of the drum are causing white stripes in images.

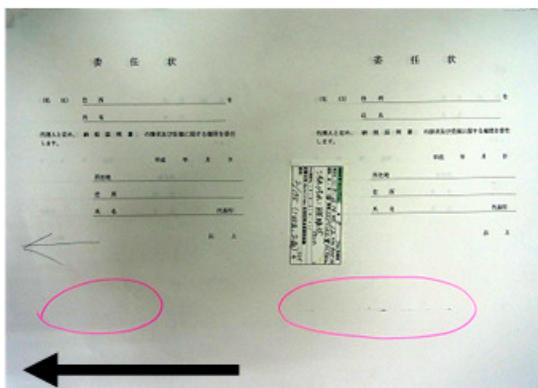
d1808007

Toner falls onto the edge of the image from the image transfer belt.

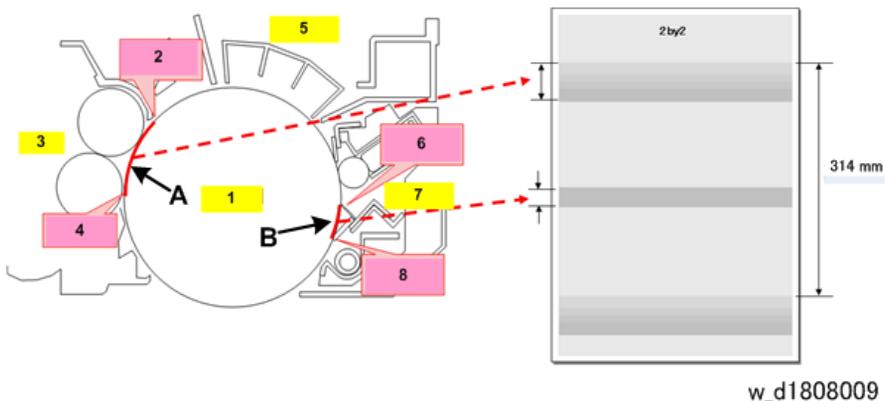
When printing images with half-tone fill, uneven density appears at open space positions.

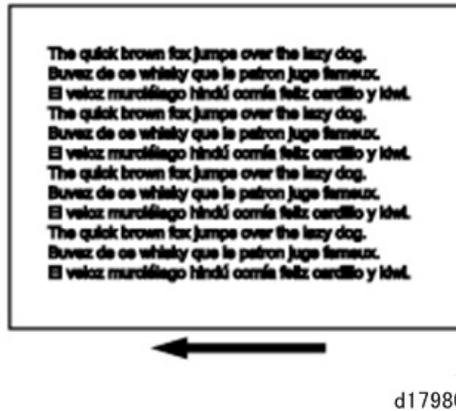
The entire image is denser than normal.

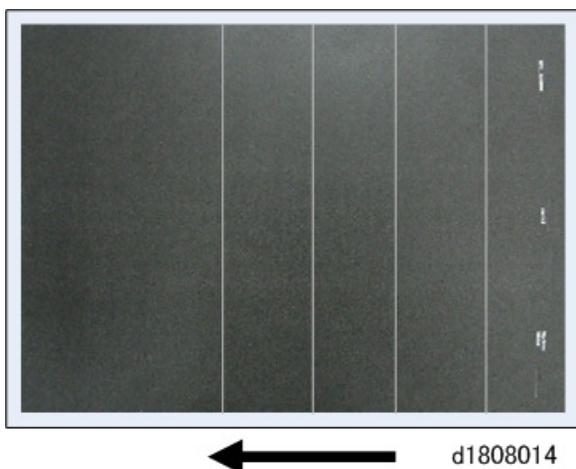
White streaks perpendicular to the paper feed direction appear.

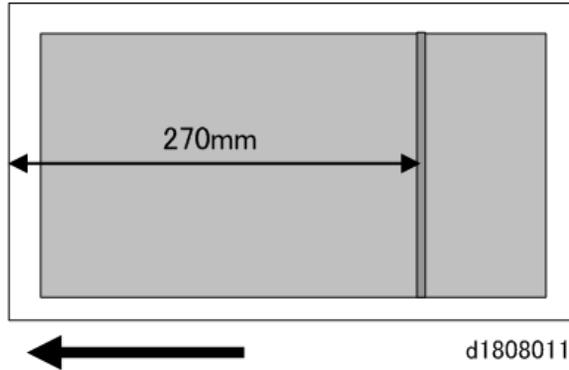
If shock jitter occurs at the arrival of paper at the fusing unit, this can cause horizontal back lines to appear 270 mm (10.5") away from the leading edge of the paper.

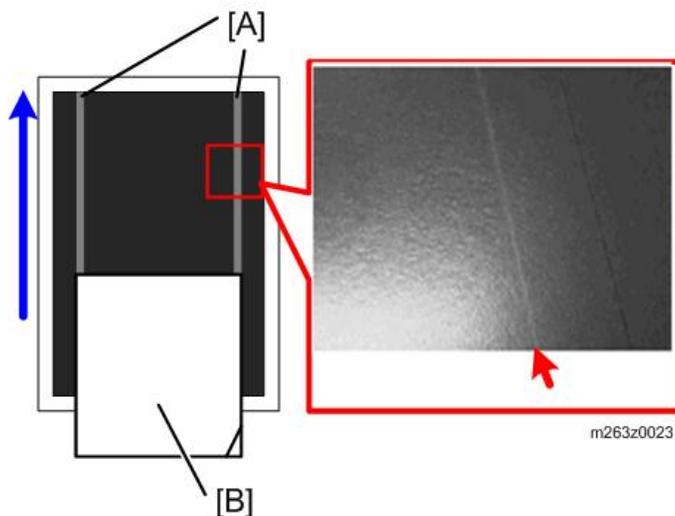
Glossy vertical stripes [A] occur on sheets of a print job using paper smaller than the previous long print job on large size paper [B] with its edges contaminated by strips from cutting.

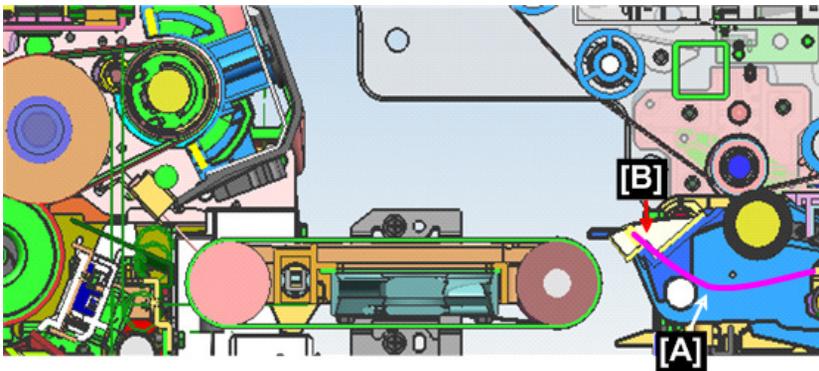
This problem can occur when using paper thinner than Thickness 1.

When very thin paper (less than Thickness 1) feeds, the paper can sag at the at the transfer exit guide plate [A], fail to separate and wrap in the paper transfer unit [B], causing Jam32.

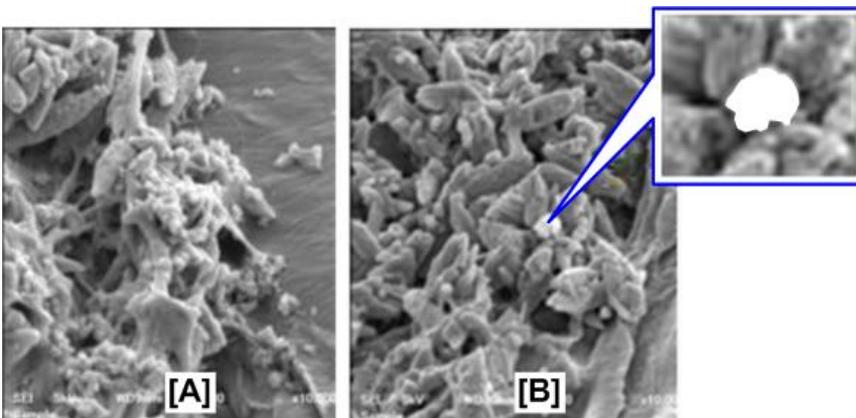
m263b4006

Paper with a high ash content (calcium carbonate) can cause paper feed jams in the paper feed units of the main machine and LCIT RT5070, RT5080. In the photo below, [A] shows normal paper fibers and [B] shows paper fibers contaminated by extremely fine calcium carbonate particles.

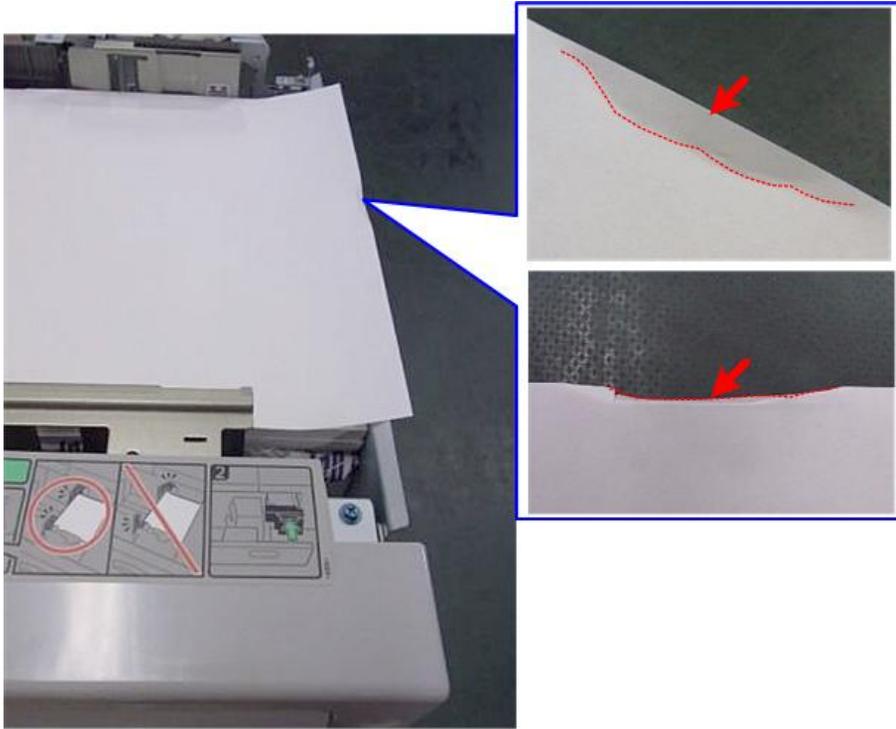
m263b4002

- Paper dust appears powdery, not grainy
- Leading edges of paper appears damaged as shown below

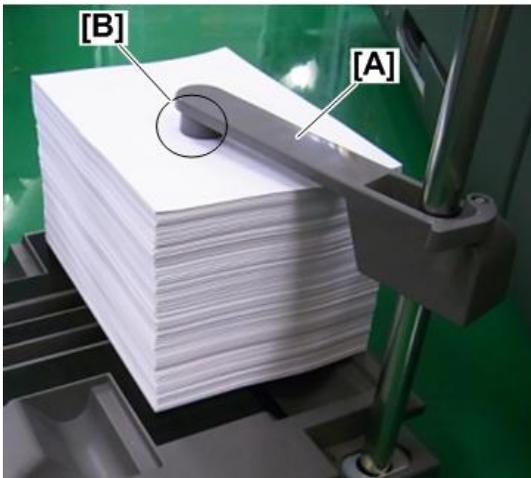
d194d6188

Pressure from the paper holder [A] on the cart may leave marks where the holder pressed down [B].

Marks can be prevented by putting scrap paper in between [A].

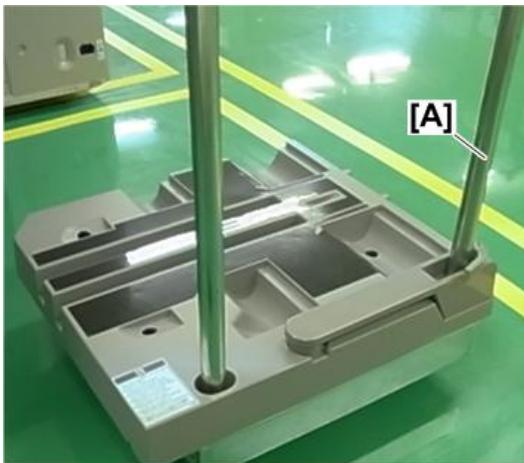
d194d6190

There have been cases of screws [A] to the handle of the cart loosening.

Also, if the locking screws on the side of the handle get loose, re-tighten them.
