Model: Leo-C1

No.: RD194004

Subject: Firmware Release Note: NetworkDocBox			Prepared	d by: Y.Yamada
From: 1st PP Tech Service Sect., PP Tech Service Dept.				
Classification:	Troubleshooting	Part informat	ion	Action required
	Mechanical	Electrical		Service manual revision
	Paper path	Transmit/rec	eive	Retrofit information
	Product Safety	🛛 Other (Firmv	vare)	🛛 Tier 2

# This RTB has been issued to announce the firmware release information for the **NetworkDocBox.**

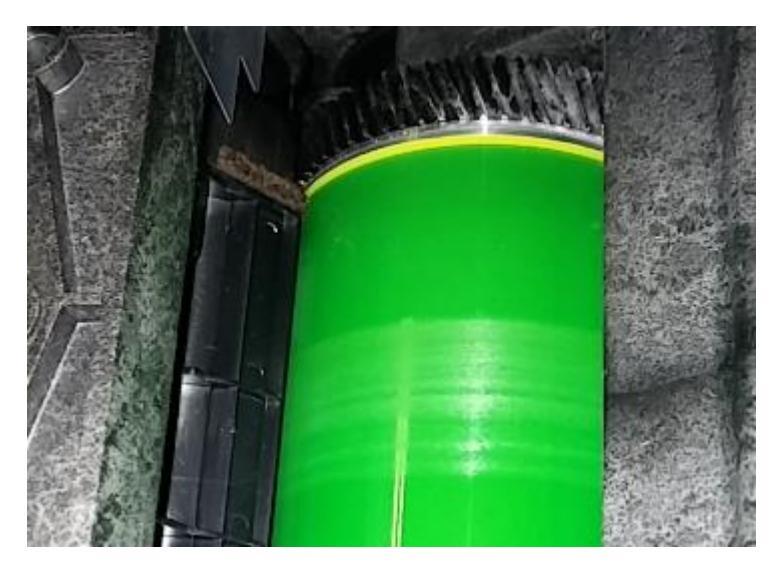
The original developer installation procedure as described in the service manual causes developer to pile up unevenly on the surface of the development roller. Running the machine under this condition generates scratches on the drum.

While the root cause of the problem is still under investigation, RCL engineering is suspecting a fluctuation in the component dimensions of the development unit.

As a preventive measure, please install developer by following the temporary procedure described below (for the 5th station at new site installs and for all other stations whenever the developer needs to be replaced) until a permanent solution becomes available. See the next page for more detail.

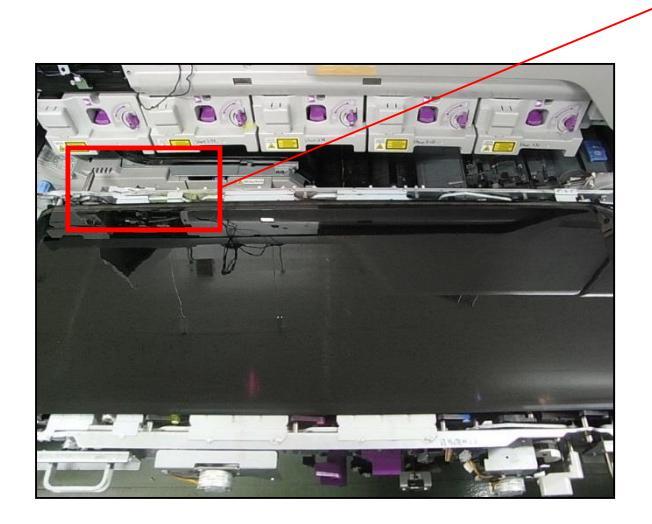
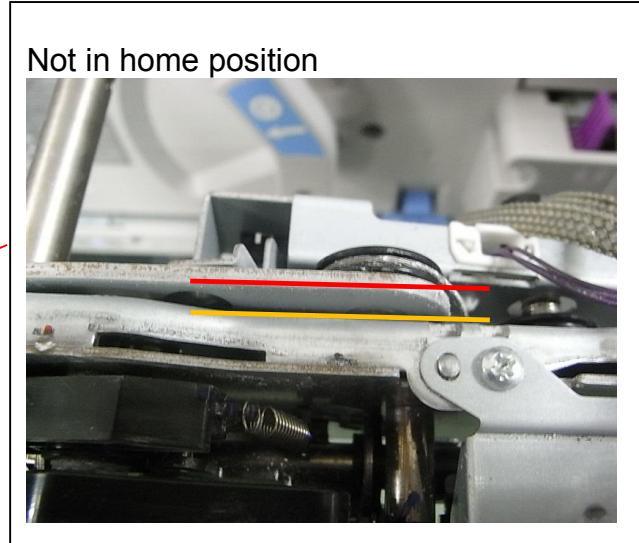
The steering control arm at the back of the ITB unit is not in home position when the machine power is turned on, which is caused by shock from transportation. The SC is detected before the arm retrieves its home position during initialization, because the SC detection is too strict.

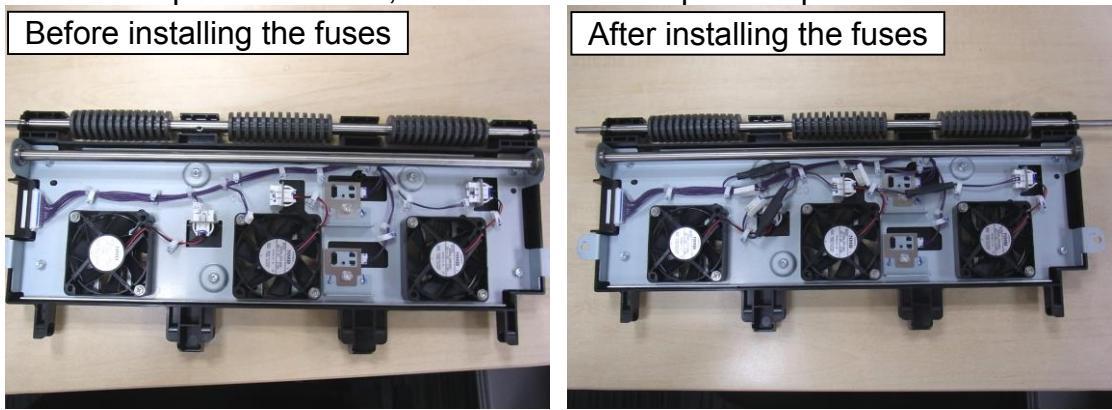
Static electricity built up inside the machine damages the fan(s) in the Paper Transport Belt Unit, which then damages the IOB.

This temporary solution DOES NOT prevent the fan itself from getting damaged and is intended to protect the IOB, which is a rather expensive part.

Replace all 3 fans in the Paper Transport Belt Unit with the modified ones. The modified fans have higher resistance against static electricity.

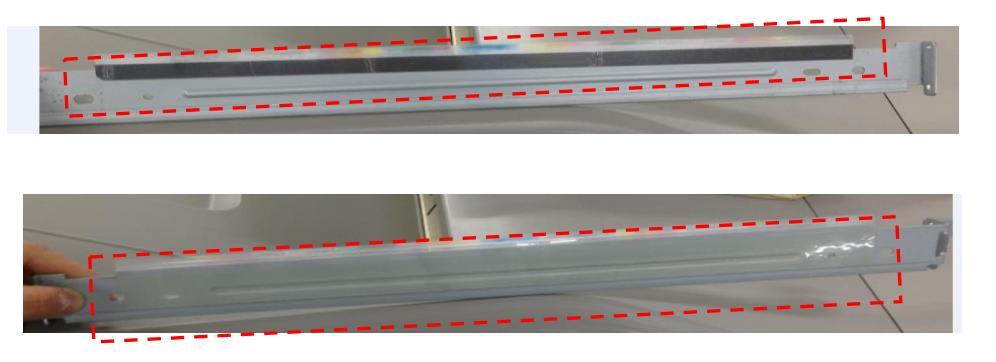
The trailing edge is stained with toner when printing on thick paper.

Feeding thick paper causes its trailing edge to catch the toner accumulated on the ITB guide plate.

Clean both sides of the ITB guide plate.

**IMPORTANT:** Work carefully to prevent the guide plate from bending when cleaning. A bent guide plate will cause scratch marks on prints.

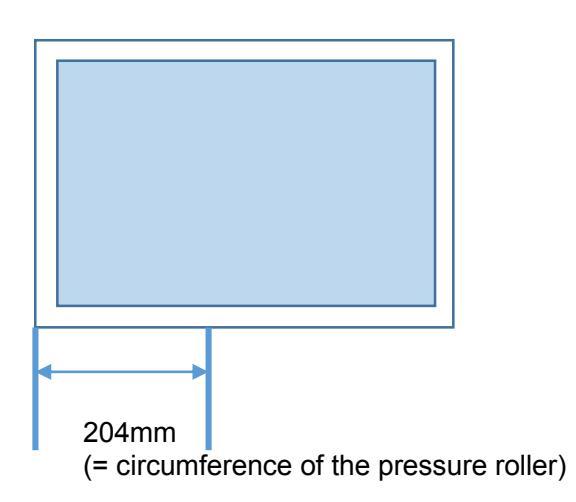
Wax stains appear in an area covering 204mm from the leading edge on the back side of prints. The symptom is noticeable when printing on transparent media.

Running high volume and high coverage jobs causes the wax content of the toner to exude and adhere to the pressure roller via the fusing belt.

- 1. In either #129 [Paper Feed Interval Setting: Productivity] or #130 [Paper Feed Interval Setting: Quality] of the Advanced Settings menu, decrease the value currently applied by "20".
- 2. Print out two sheets to confirm that the wax stains have disappeared.

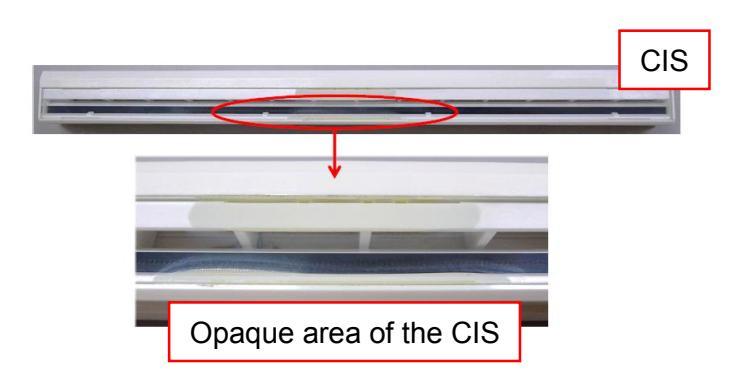
Intensity of the light emitted from the center of the CIS has reduced because the adhesives applied to the CIS have degraded and the CIS has become opaque over time, disabling proper scanning.

NOTE: The jams do not occur with paper sizes larger than A4/LT (SEF) because such sizes are not scanned at the center of the CIS.

Since the CIS cannot be disassembled to remove the degraded adhesives, increase the light intensity of the CIS by performing the procedure described on the following pages.

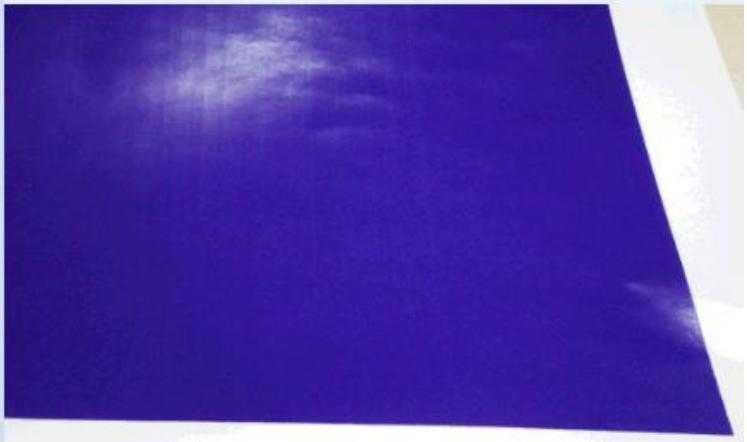
White bands along the feed direction (sub scan direction) appear when printed in FCS mode.

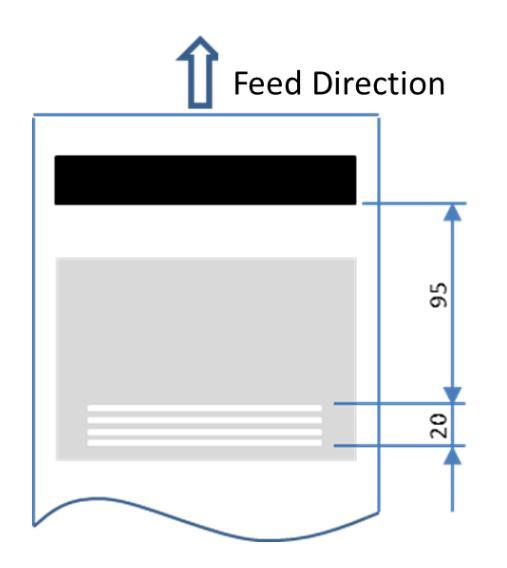
If a halftone image follows a solid image regardless of whether they are on the same page or not, bands across the feed direction (main scan direction) approximately 20mm (0.8inch) in width appear in the halftone area 95mm (3.7inch) away from the solid image.

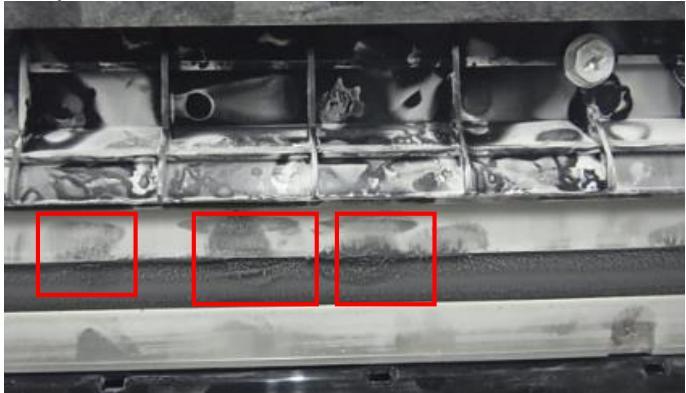
There have been cases reported from the field where the toner shield glass was frequently dirty with toner. According to our investigations, the operator had deformed the development unit entrance seal when performing special color replacement, causing toner to spill.

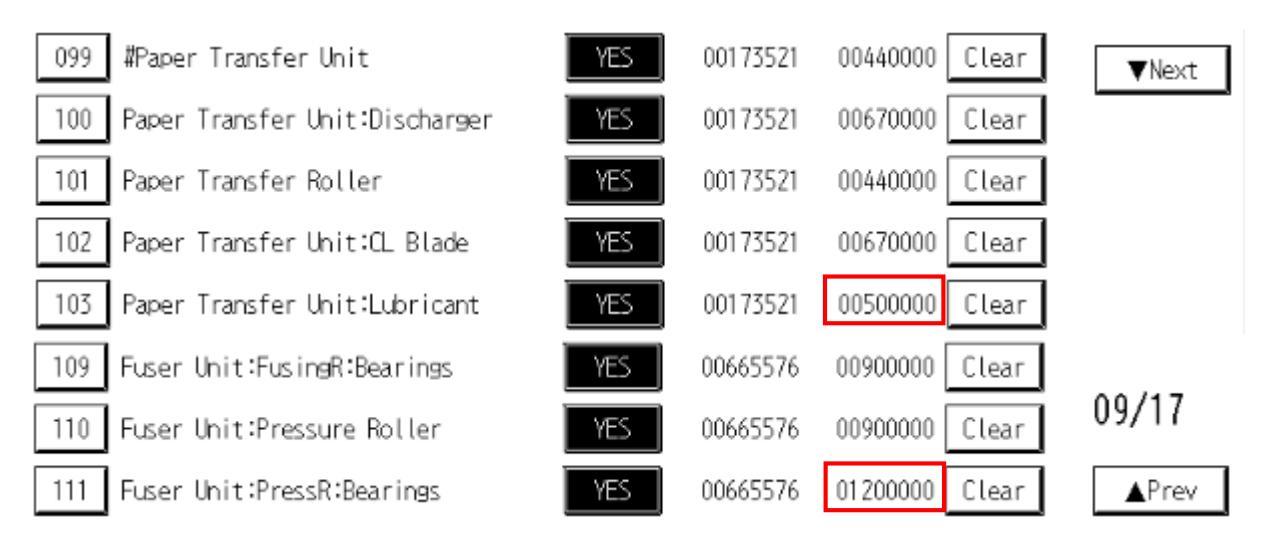
The "Target" values displayed for the pressure roller bearings and paper transfer unit lubricant are incorrect.

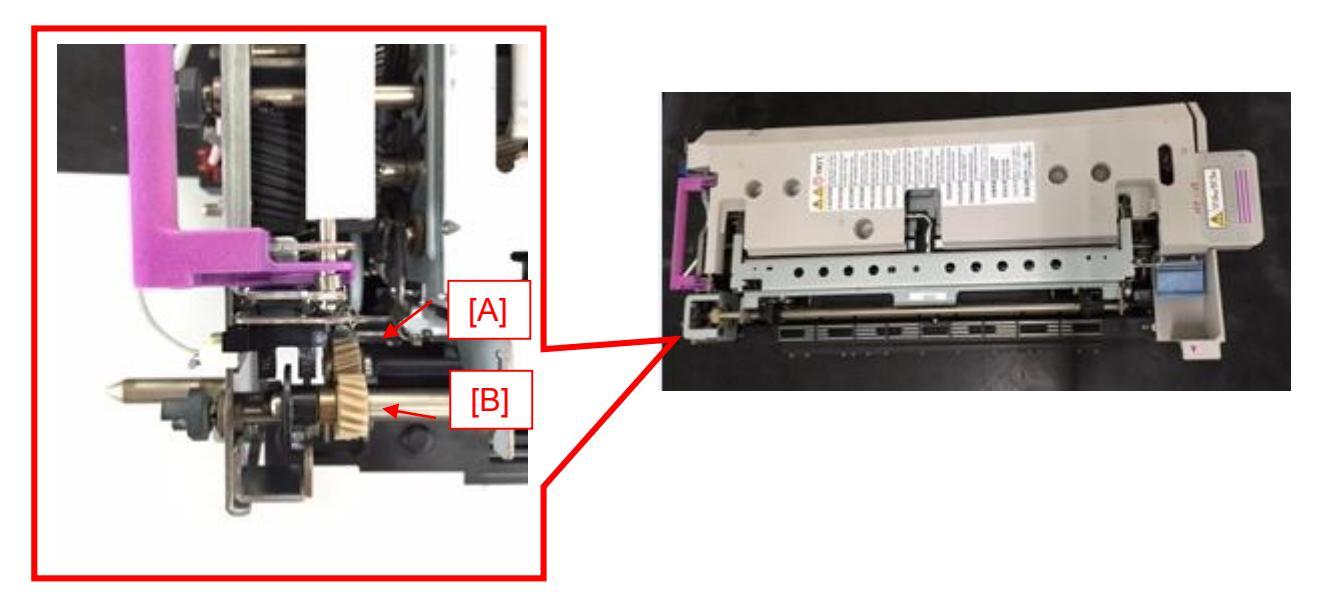
- 1. Home position of the belt smoothing roller is not detected, because the feeler is positioned incorrectly, not reaching the sensor.
- 2. The gears marked [A] and [B] in the photo below are not tightly engaged, preventing sufficient drive of the components.

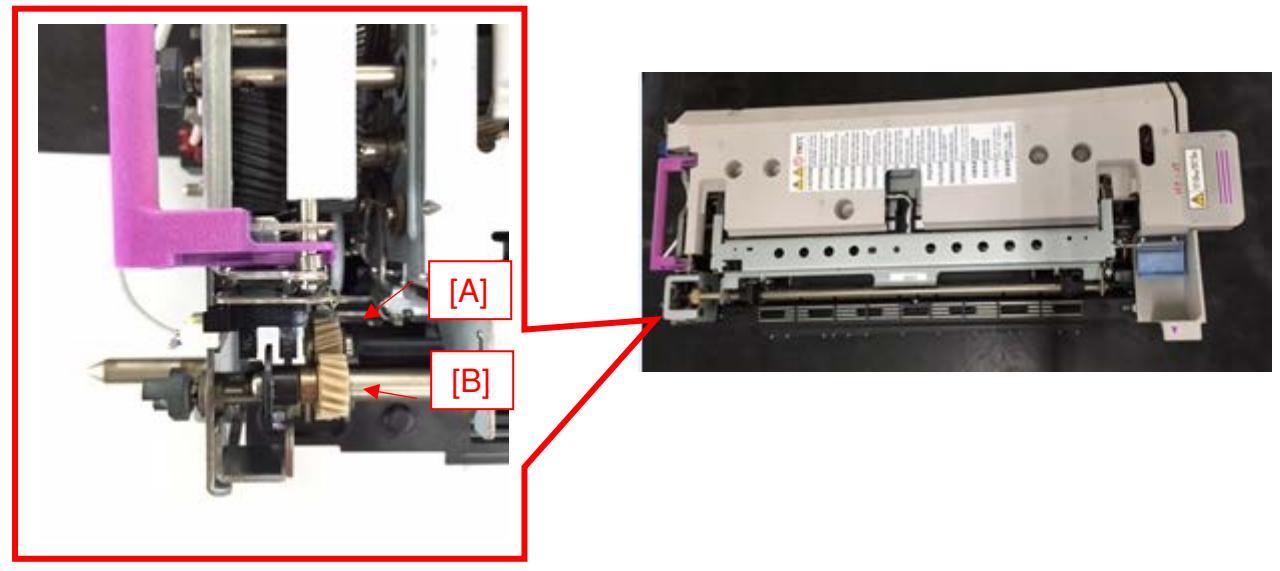
- 1. Home position of the belt smoothing roller is not detected, because the feeler is positioned incorrectly, not reaching the sensor.
- 2. The gears marked [A] and [B] in the photo below are not tightly engaged, disabling sufficient drive of the components.

### SOLUTION Production line:

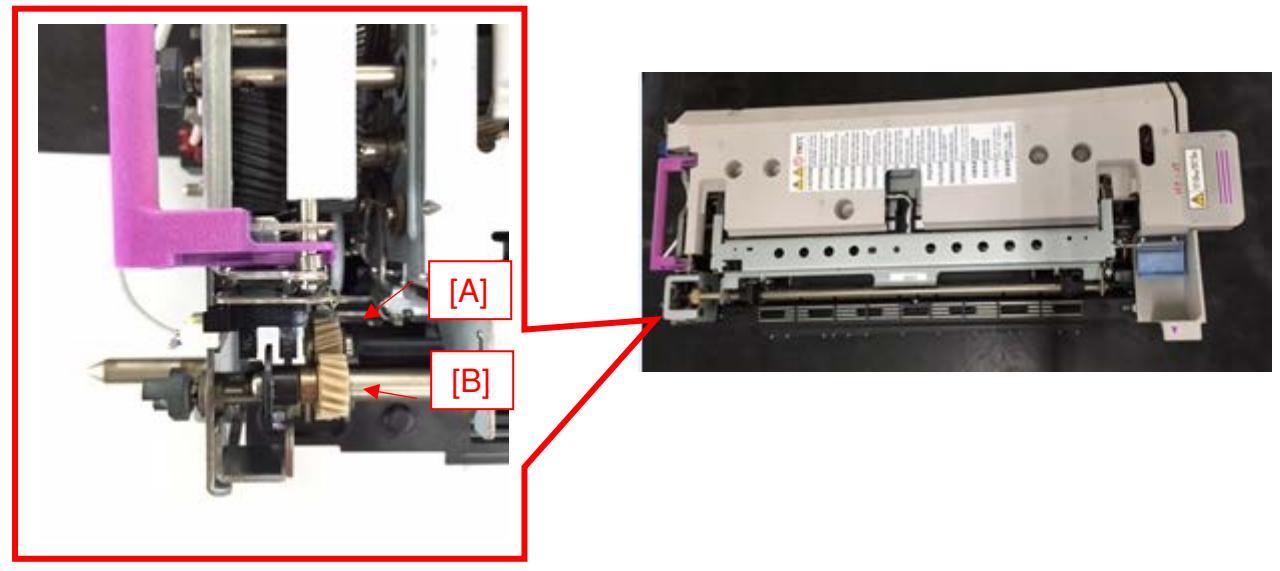
- 1. Home position of the belt smoothing roller is not detected, because the feeler is positioned incorrectly, not reaching the sensor.
- 2. The gears marked [A] and [B] in the photo below are not tightly engaged, disabling sufficient drive of the components.

### SOLUTION Production line:

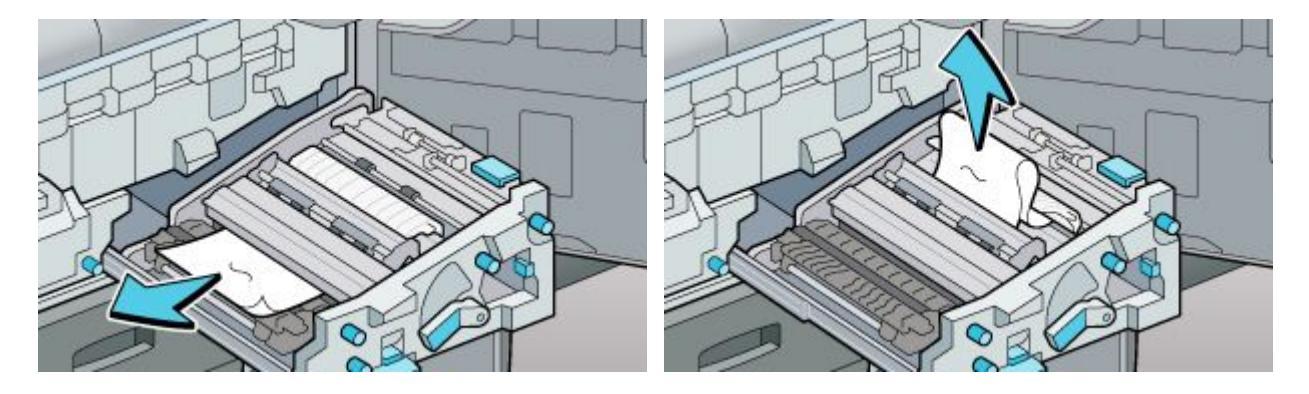
Jammed paper is pulled out with force, which causes the motors in the right drawer unit to turn manually. In some cases, the electricity generated is strong enough to damage element(s) on the DRB.

## SOLUTION

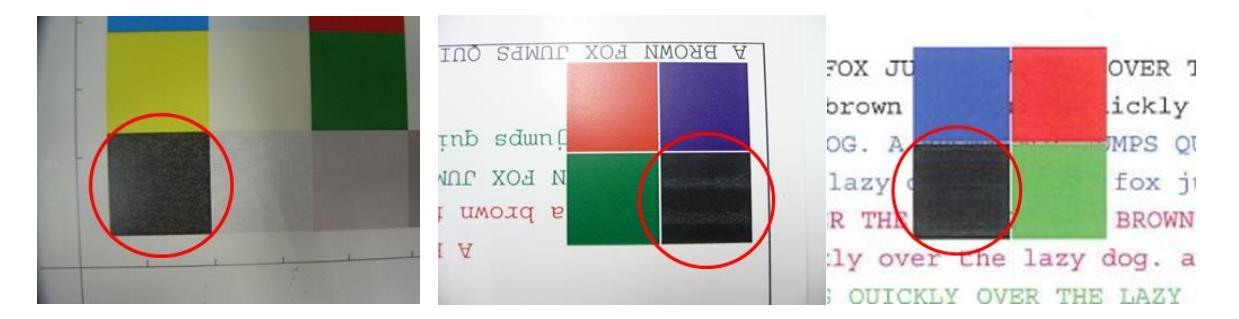
Low image density occurs in solid black image areas.

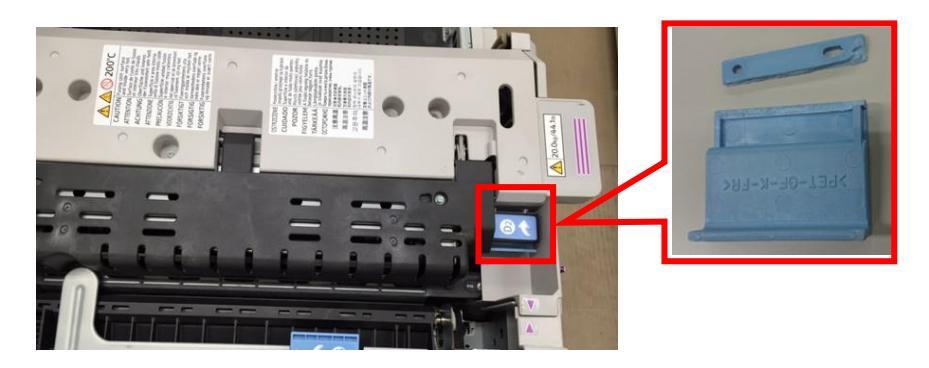
The grip plate (B1324168) of the fusing separation unit breaks.

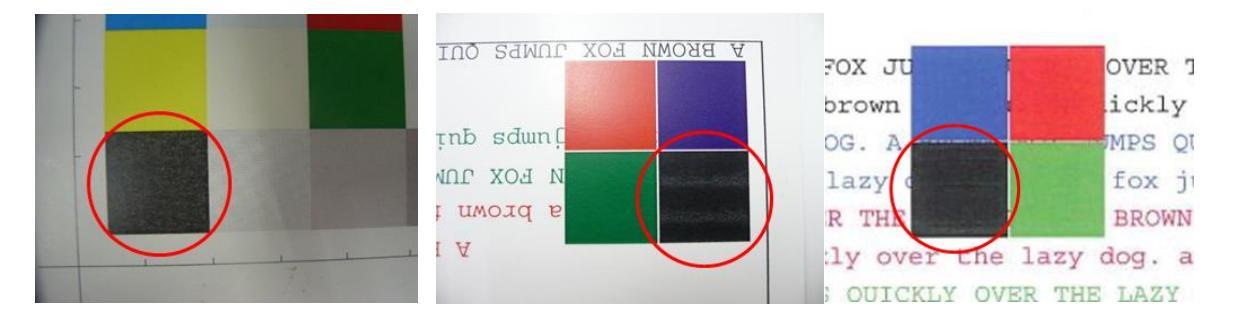
Low image density occurs in solid black image areas.

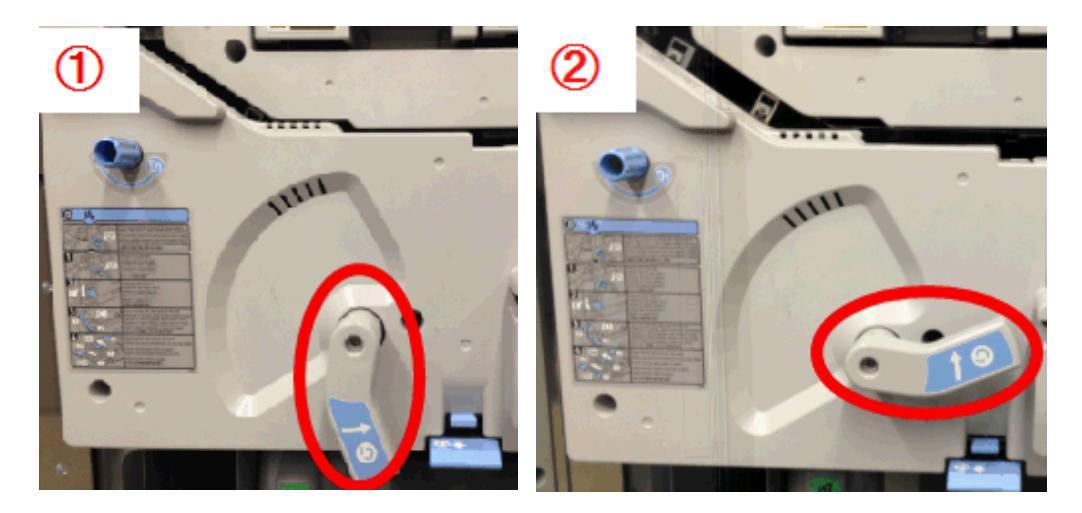
- 1) The left drawer lever (C1 lever) is loose (Photo 1) or,
- 2) The lever is locked in the incorrect position (Photo 2)

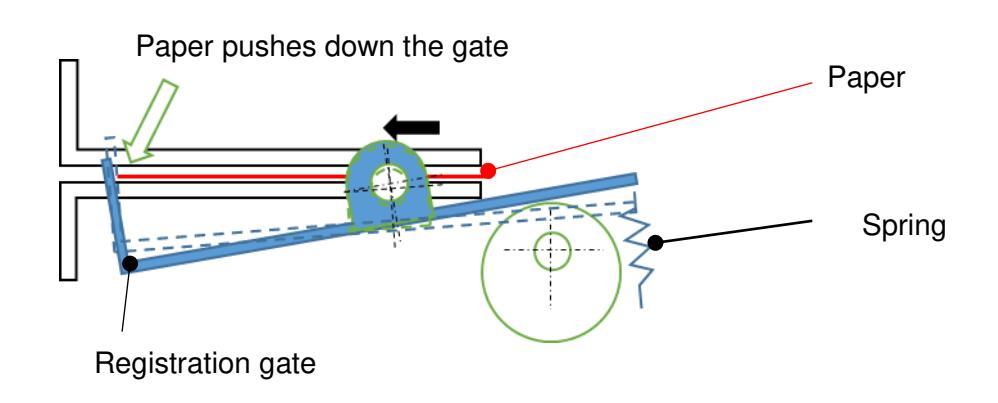
The spring that holds the registration gate in place is relatively weak. As a result, when the paper bumps the gate, the paper is not slowed down sufficiently and arrives at the transfer timing sensor too soon.

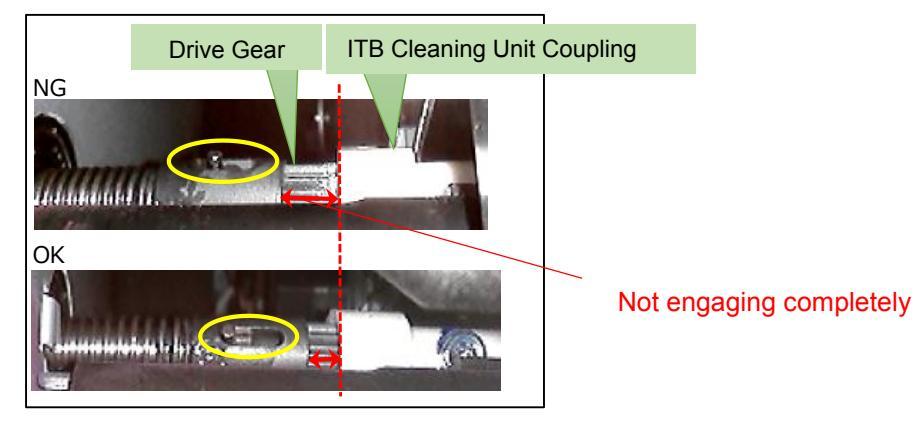
In very rare cases, due to variations in the manufacturing process, the ITB cleaning unit coupling and its drive gear in the mainframe do not engage completely. This can cause banding at an interval of about 5-6mm.

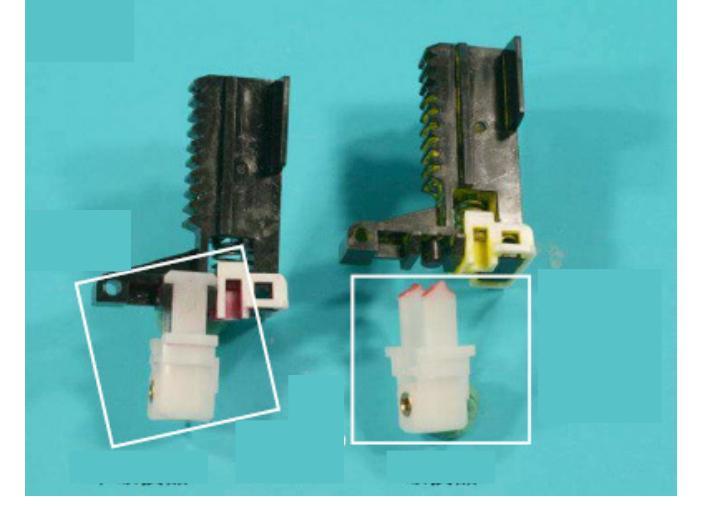
Normal toner chuck (left) and broken toner chuck (right):
