Troubleshooting: ORU

Model Name: Pro C900S/Pro C900

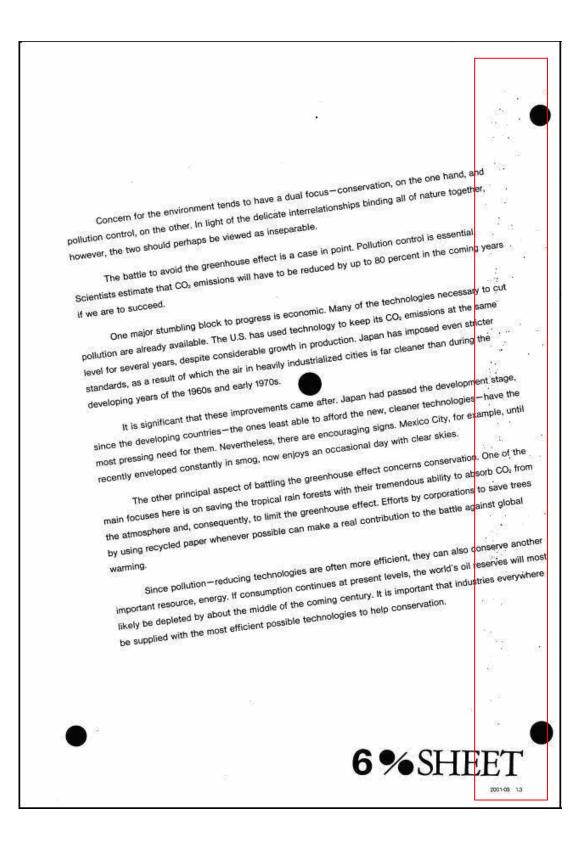
3.1.2 PROBLEM 2: SHARP SPOTS

These spots mark the page with very sharp dots at 314 mm (12 in.) intervals in the direction of paper feed.

CAUSE: The drum unit has worn out or the drum is scratched.

- **Step 1** Print three full-page A3 or DLT sheets in each colour (cyan, yellow, magenta, and black).
- Step 2 If these sharp spots appear on the sheets, <u>replace the drum unit</u>.
- **Step 3** If replacing the drum unit does not solve the problem, call for service.

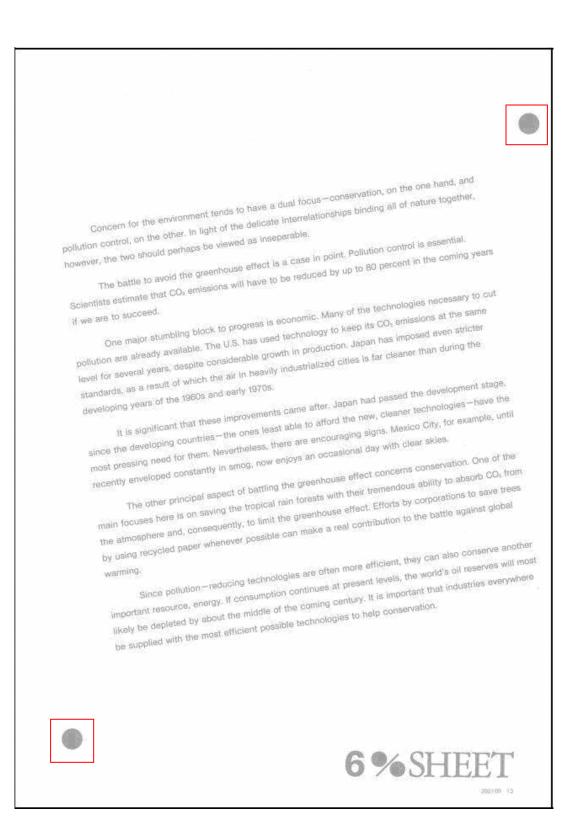
3.1.4 PROBLEM 4: DENSITY TOO LOW

Sheets are too light, especially in areas of solid fill.

CAUSE: The density setting is too low.

- Step 1 In [Adjustment] menu, carry out 3-820-002 (Execute Density Adj).
- **Step 2** If adjusting the density does not solve the problem, call for service.

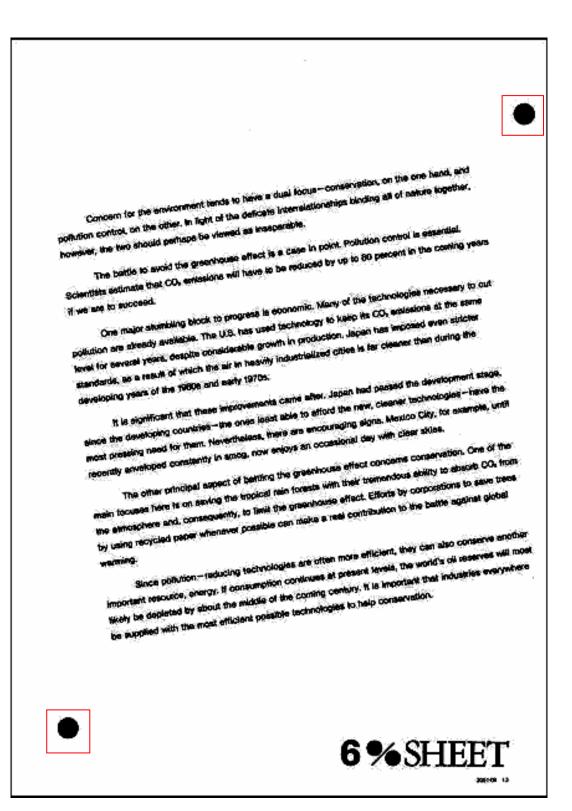
3.1.5 PROBLEM 5: DENSITY TOO HIGH

Sheets are too dark, especially in areas of solid fill.

CAUSE: The density setting is too high, or the developer has deteriorated.

- Step 1 In [Adjustment] menu, carry out 3-820-002 (Execute Density Adj).
- **Step 2** Print a few sheets. Does the image density appear darker?

- No <u>Replace the developer.</u>
- **Step 3** If changing the developer does not solve the problem, call for service.

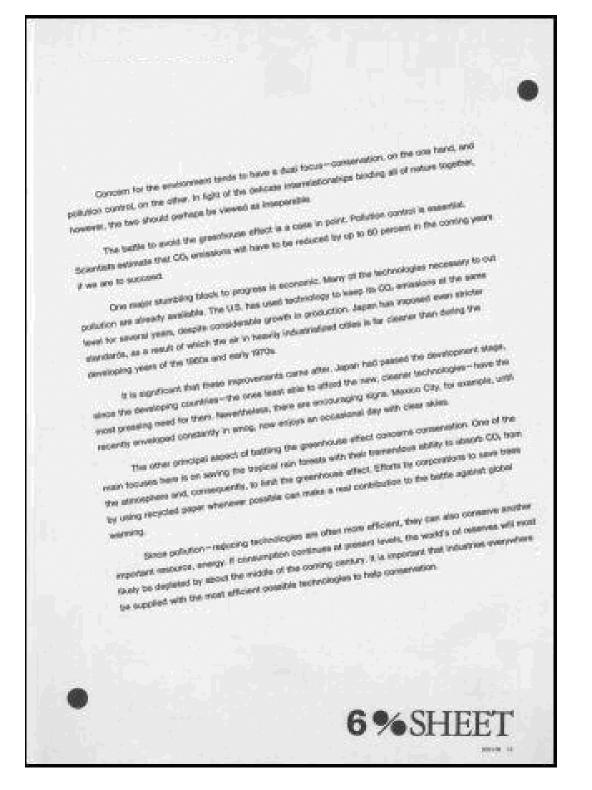
3.1.6 PROBLEM 6: DIRTY BACKGROUND

Random "powdered" dots appear, creating a dirty background.

CAUSE: The developer has deteriorated.

Step 1 Replace the developer.

Step 2 If changing the developer does not solve the problem, call for service.
