# **Troubleshooting: TCRU**

Pro C900S/Pro C900

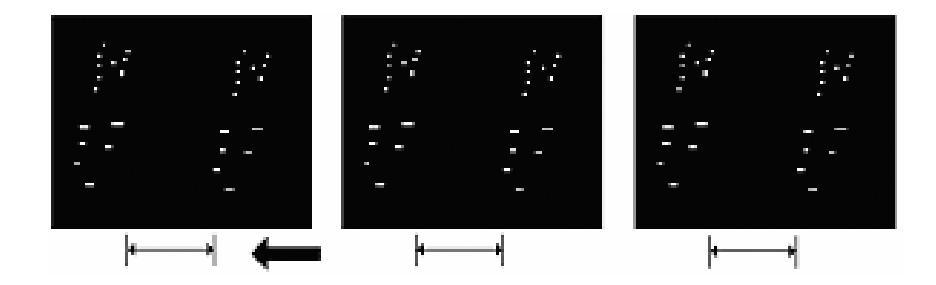
#### 3.1.1 PROBLEM 1: WHITE SPOTS

White dots or small lines appear, spaced at 314 mm (12 in.) intervals in the direction of paper feed.

CAUSE: The drum is stained.

- **Step 1** Print three full-page A3 or DLT sheets in each color (cyan, yellow, magenta, and black).
- Step 2 If you can see these white spots, <u>replace the drum unit</u>.
- **Step 3** If unit replacement does not solve the problem, call for service.

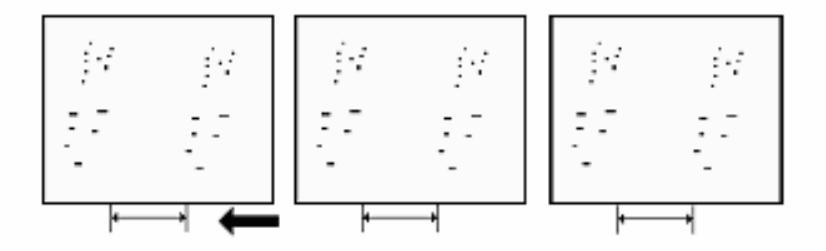
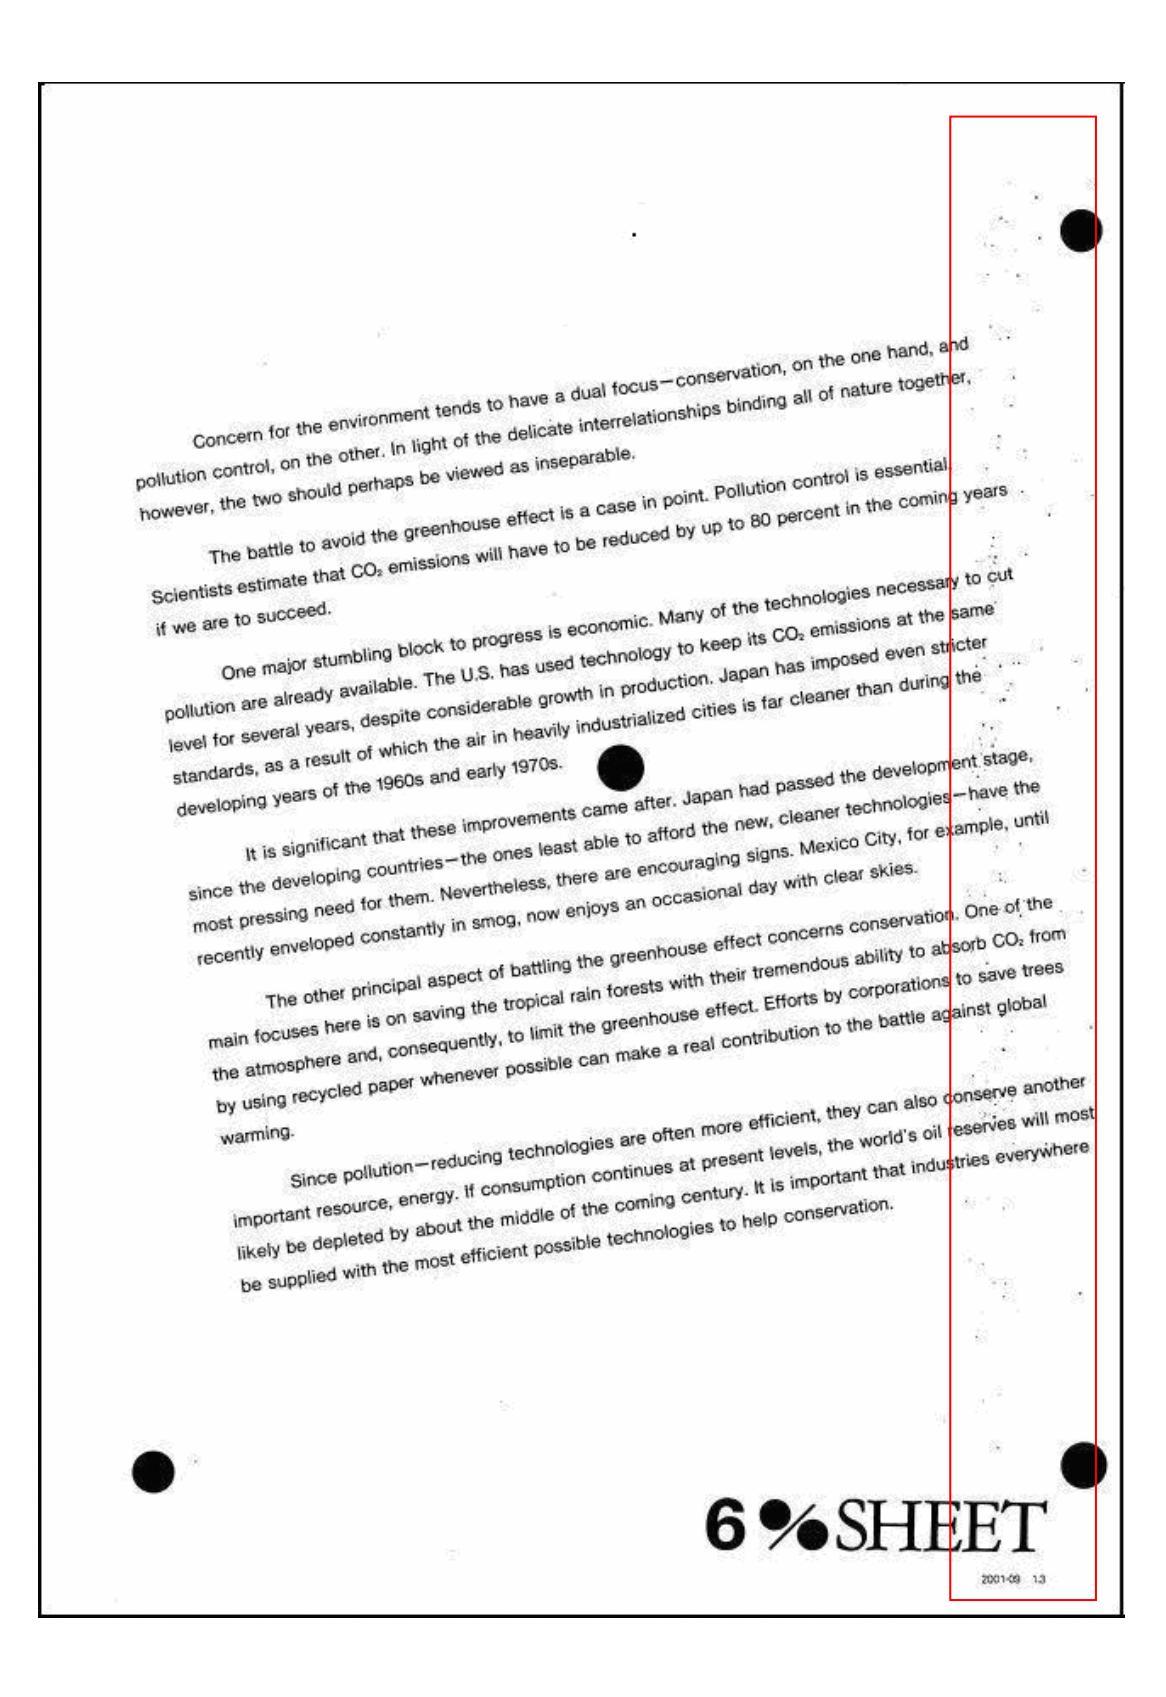
### 3.1.2 PROBLEM 2: SHARP SPOTS

These spots mark the page with very sharp dots at 314 mm (12 in.) intervals in the direction of paper feed.

**CAUSE**: The drum unit has worn out or the drum is scratched.

- **Step 1** Print three full-page A3 or DLT sheets in each color (cyan, yellow, magenta, and black).
- Step 2 If these sharp spots appear on the sheets, <u>replace the drum unit</u>.
- **Step 3** If replacing the drum unit does not solve the problem, call for service.

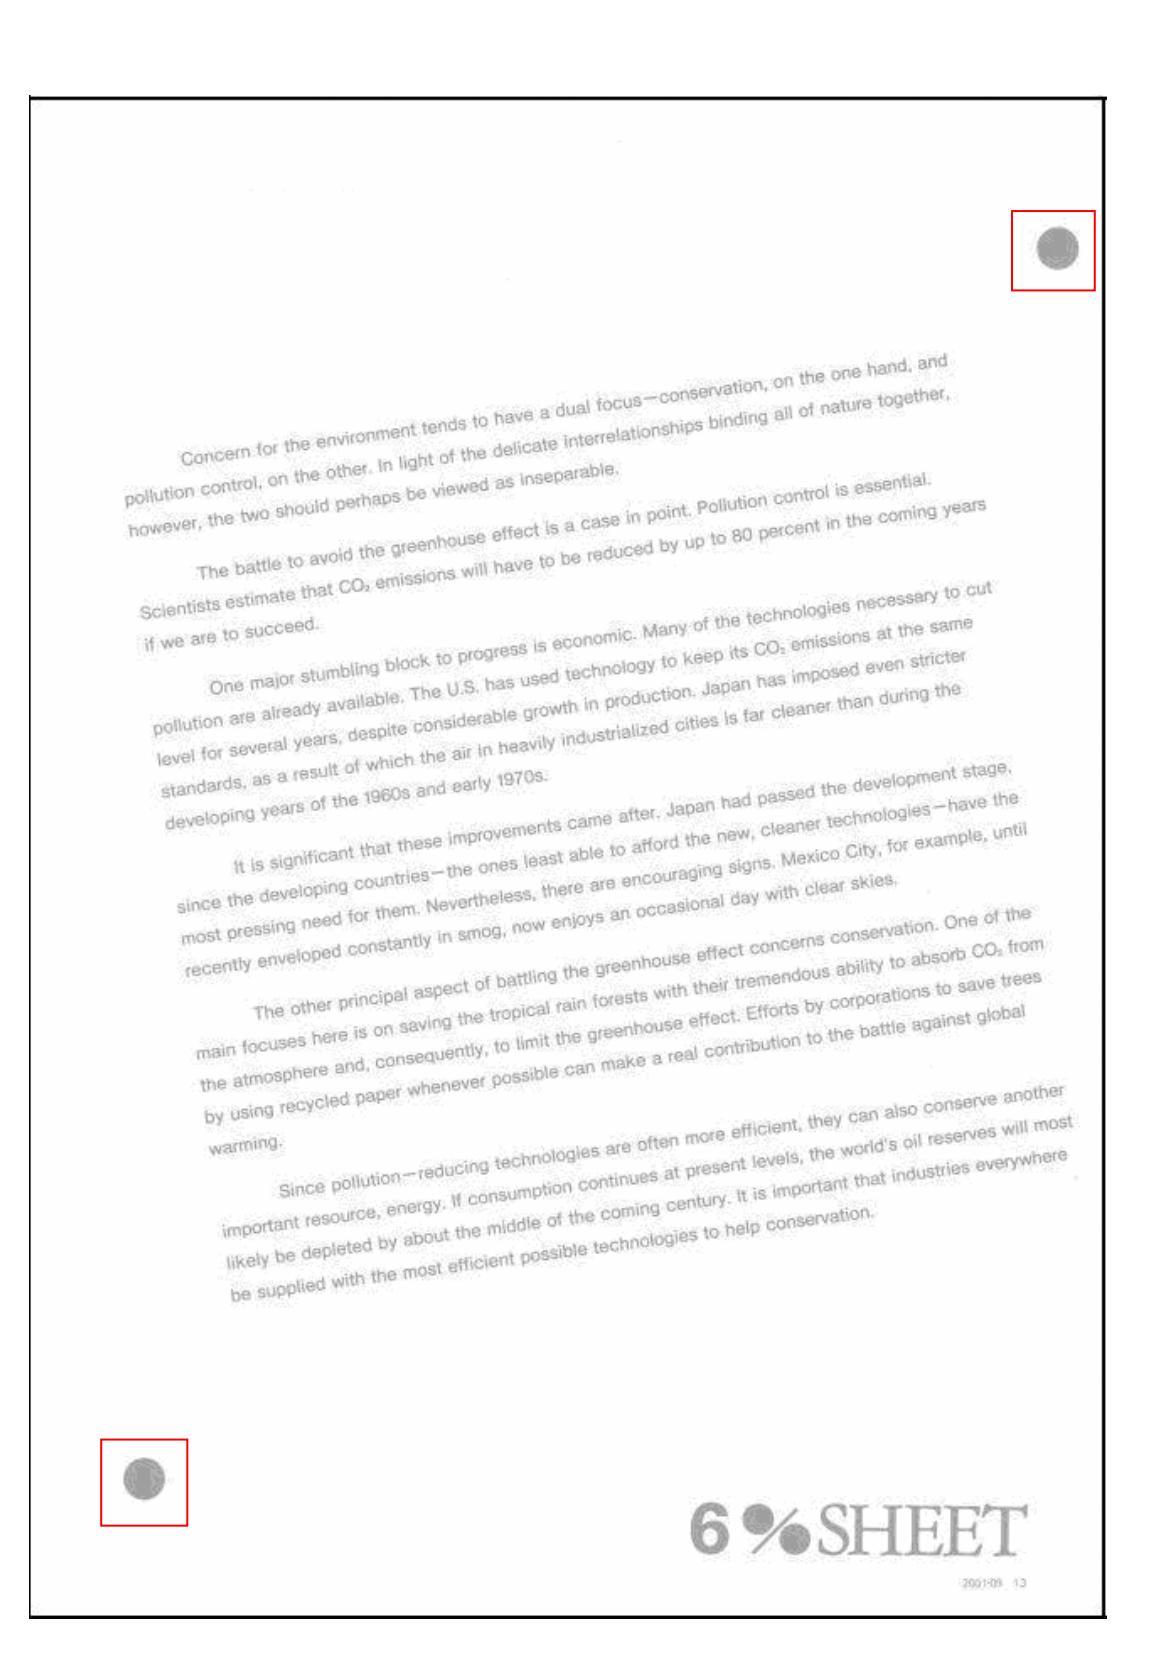
## 3.1.4 PROBLEM 4: DENSITY TOO LOW

Sheets are too light, especially in areas of solid fill.

**CAUSE**: The density setting is too low.

- Step 1 In [Adjustment] menu, carry out 3-820-002 (Execute Density Adj).
- **Step 2** If adjusting the density does not solve the problem, call for service.

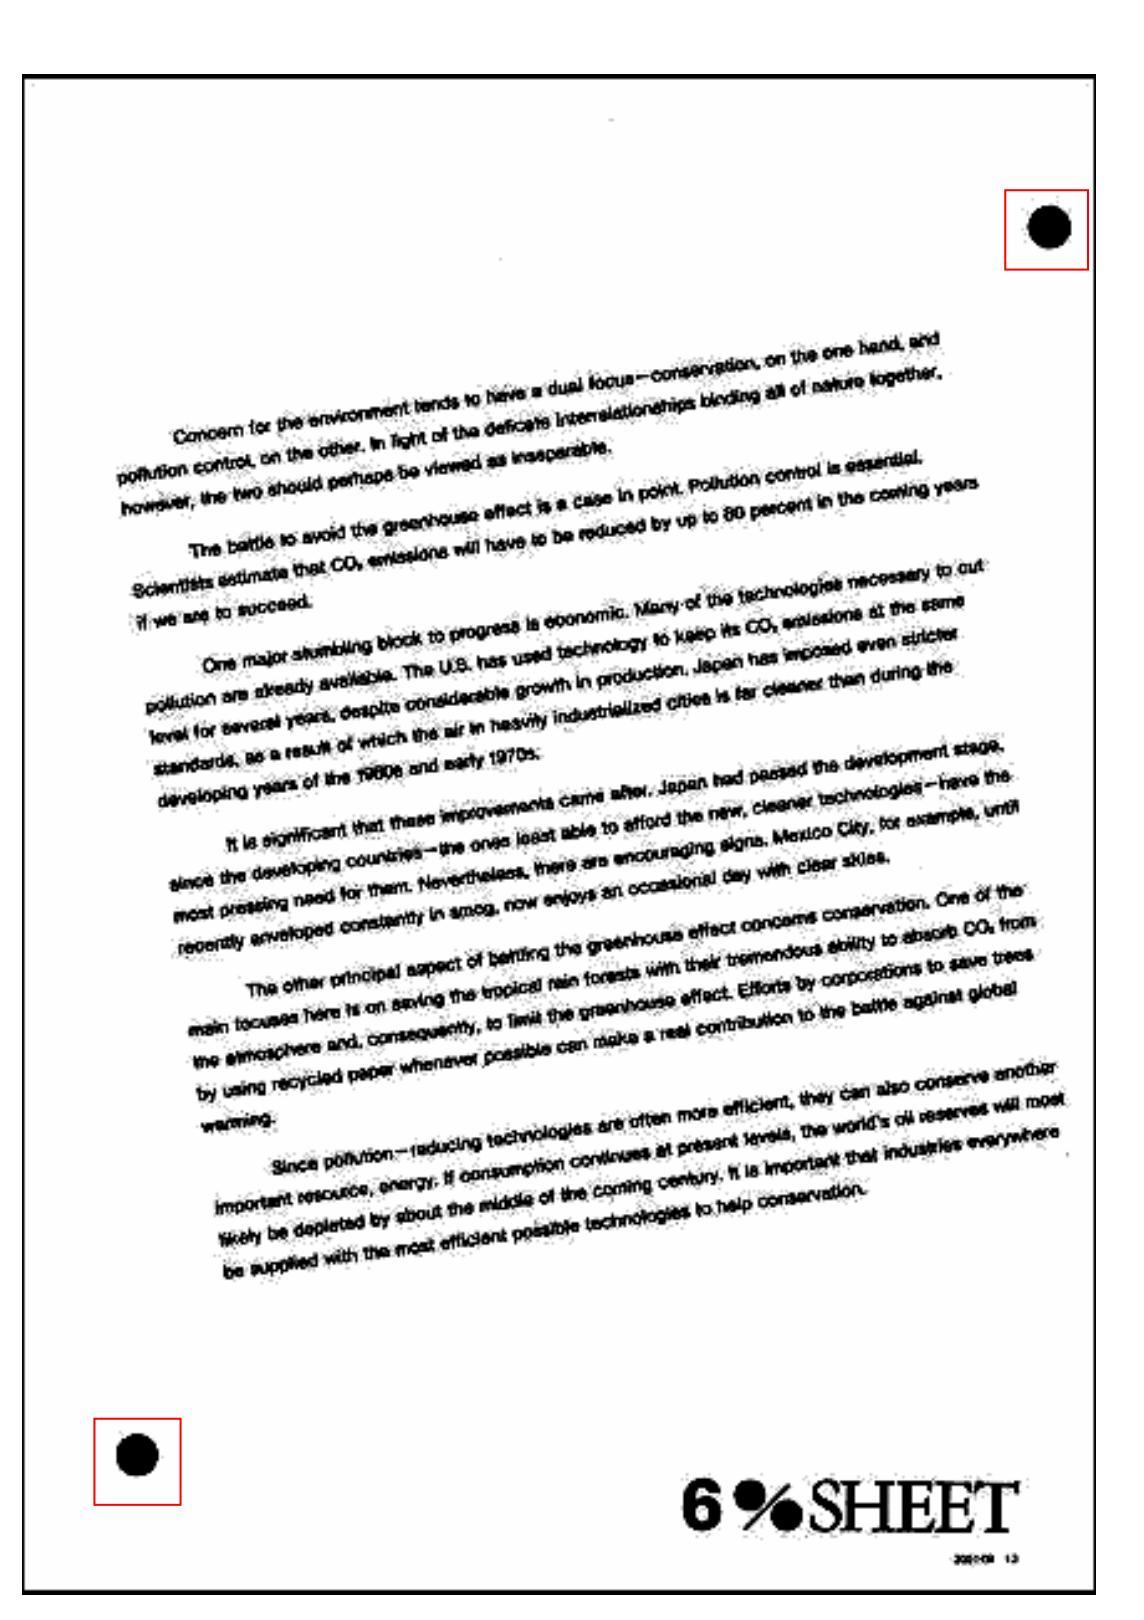
## 3.1.5 PROBLEM 5: DENSITY TOO HIGH

Sheets are too dark, especially in areas of solid fill.

**CAUSE**: The density setting is too high, or the developer has deteriorated.

- Step 1 In [Adjustment] menu, carry out 3-820-002 (Execute Density Adj).
- **Step 2** Print a few sheets. Does the image density appear darker?

- No <u>Replace the developer.</u>
- **Step 3** If changing the developer does not solve the problem, call for service.

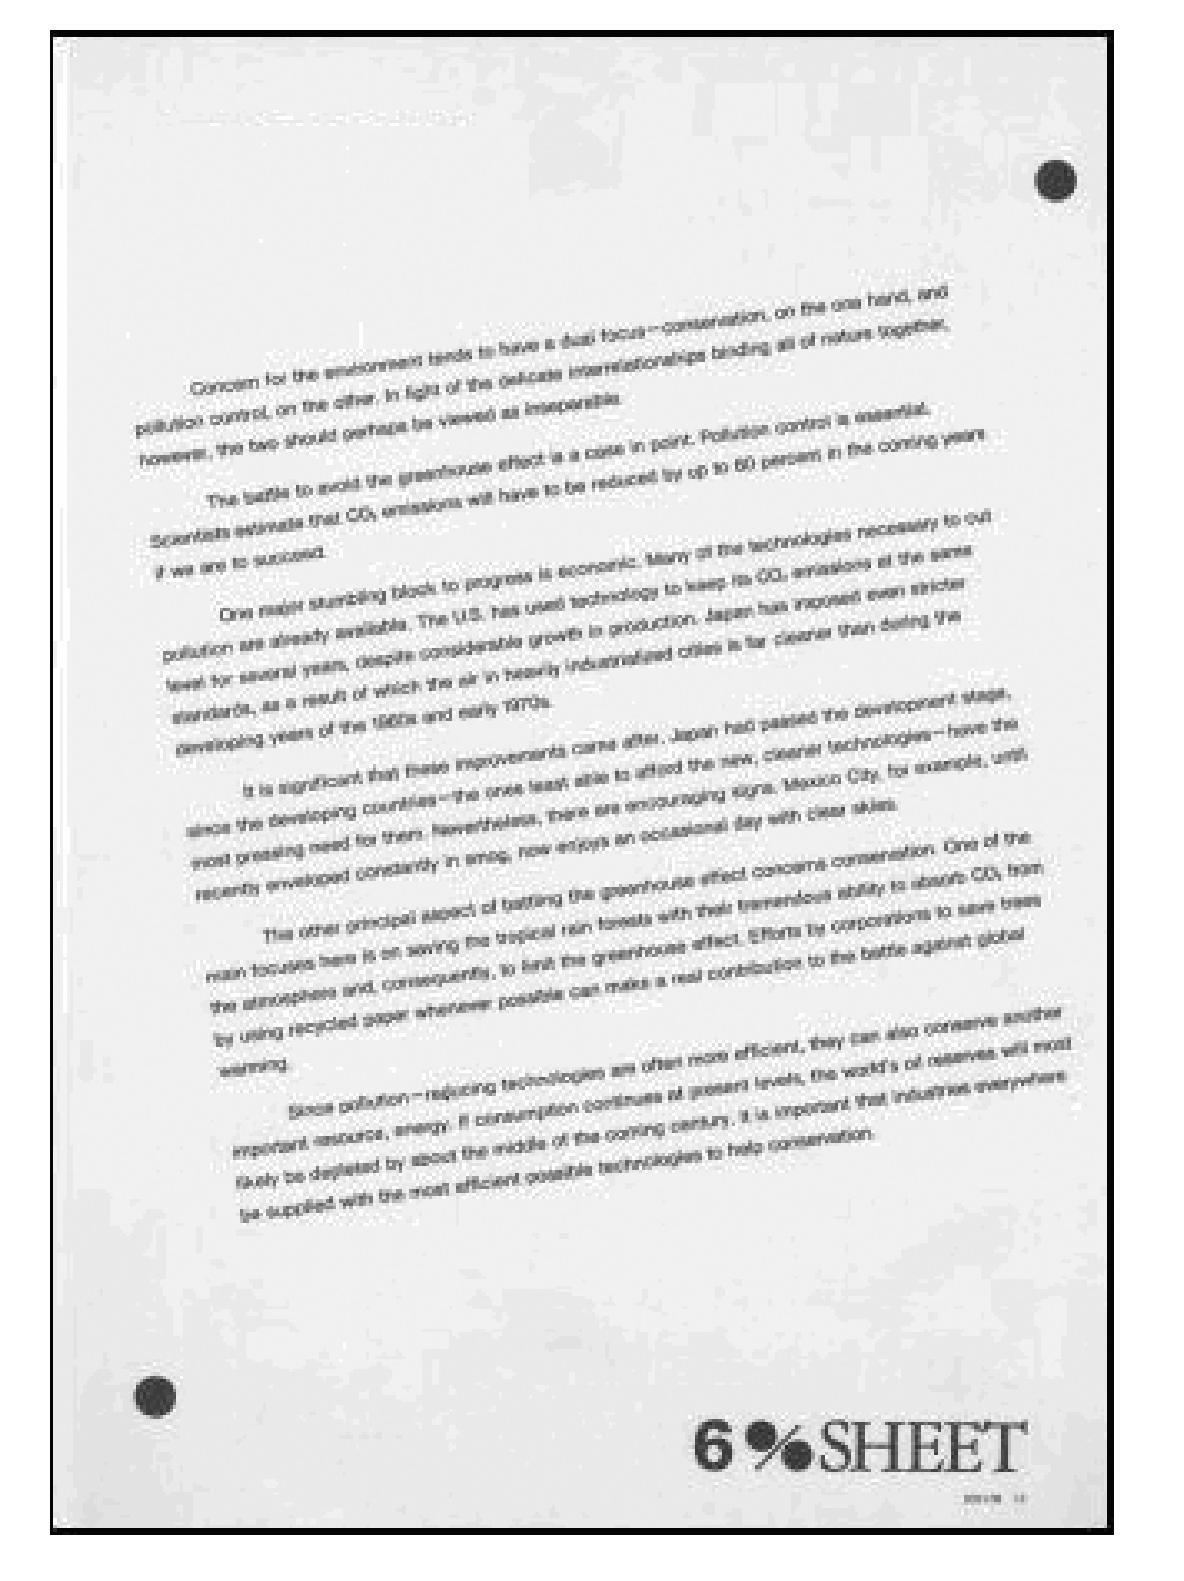
## 3.1.6 PROBLEM 6: DIRTY BACKGROUND

Random "powdered" dots appear, creating a dirty background.

**CAUSE**: The developer has deteriorated.

#### Step 1 <u>Replace the developer.</u>

**Step 2** If changing the developer does not solve the problem, call for service.

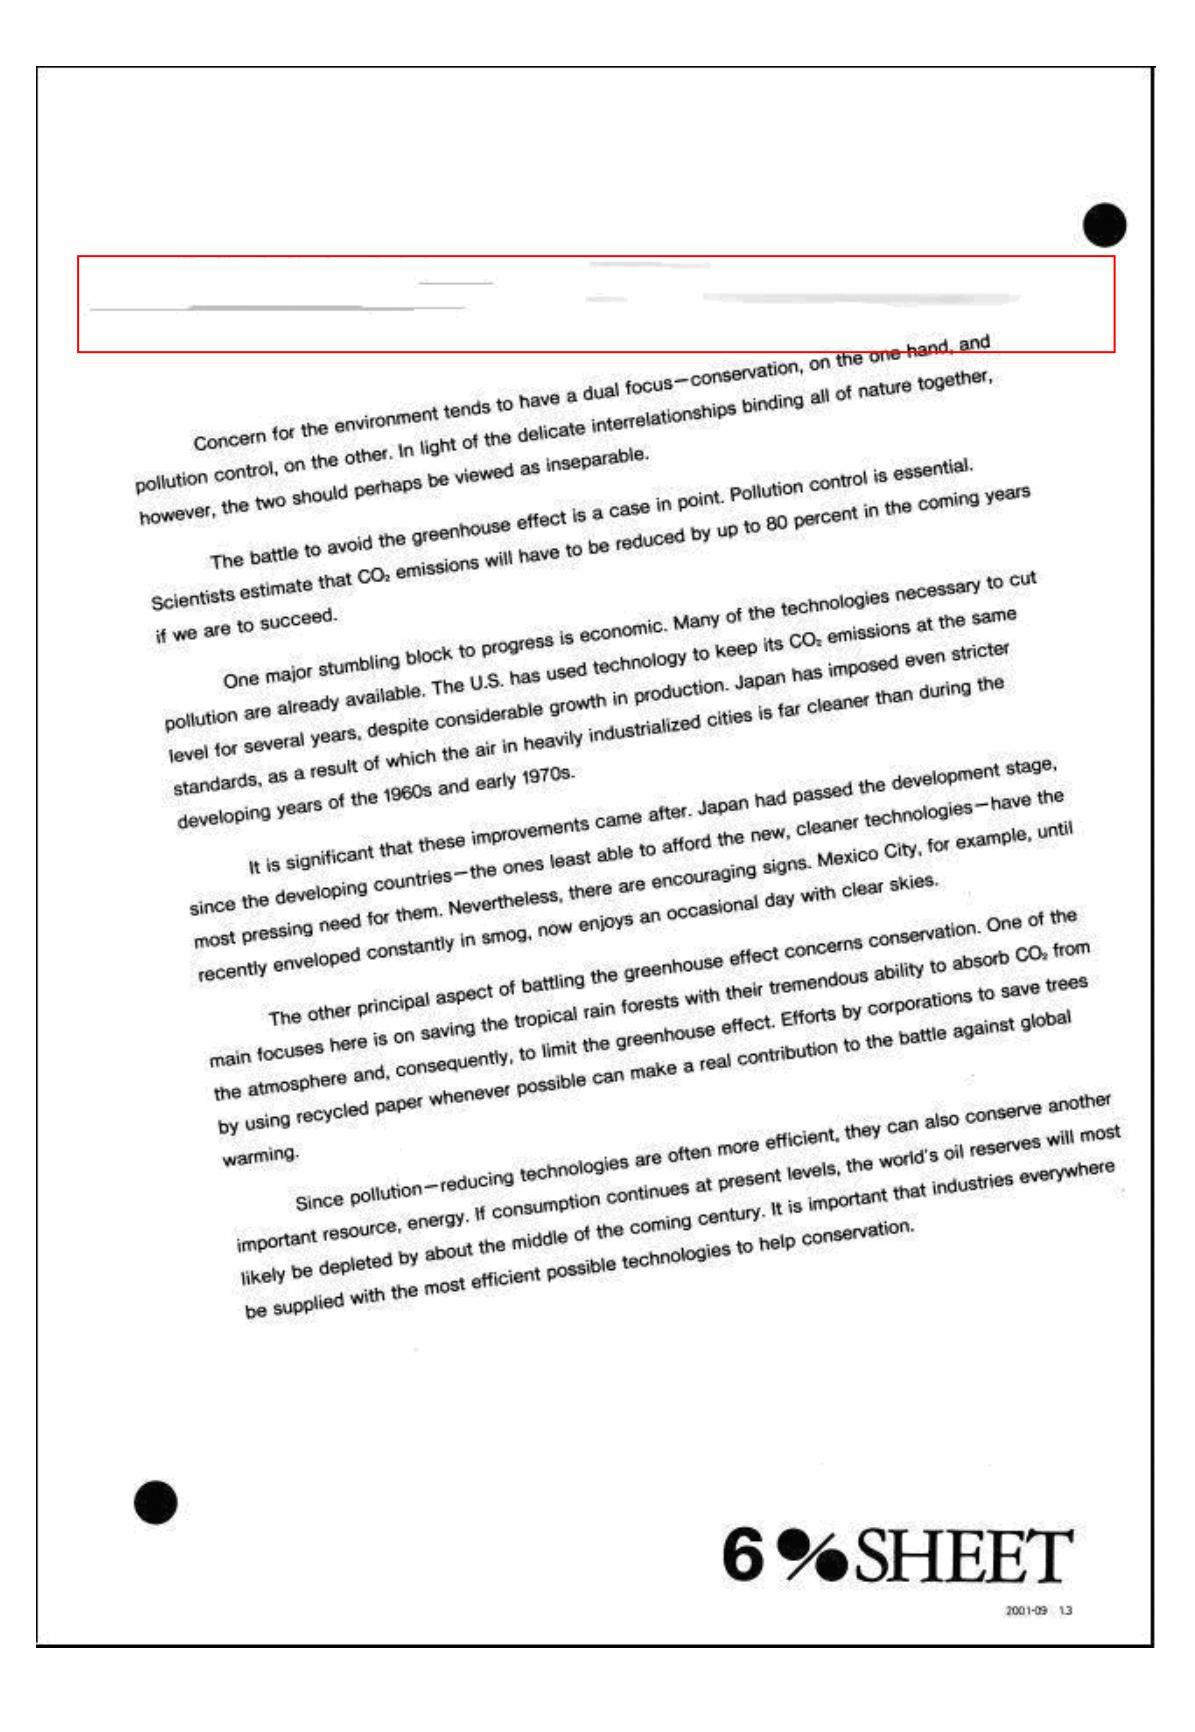
## 3.1.8 PROBLEM 8: STREAKS (1)

Wide streaks appear in the direction of paper feed.

**CAUSE**: The electrical discharge from the charge corona unit is not constant.

- Step 1 In [Adjustment] menu, carry out SP 3-820-002 (Execute Density Adj).
   NOTE: If you carry out "Execute Density Adj", the machine cleans the charge corona unit.
- Step 2 Print a few sheets. Is the problem solved?

No <u>Replace the charge corona unit.</u>

**Step 3** If replacing the charge corona unit does not solve the problem, call for service.

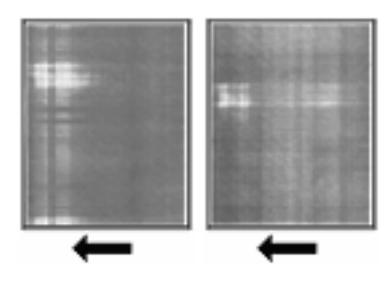
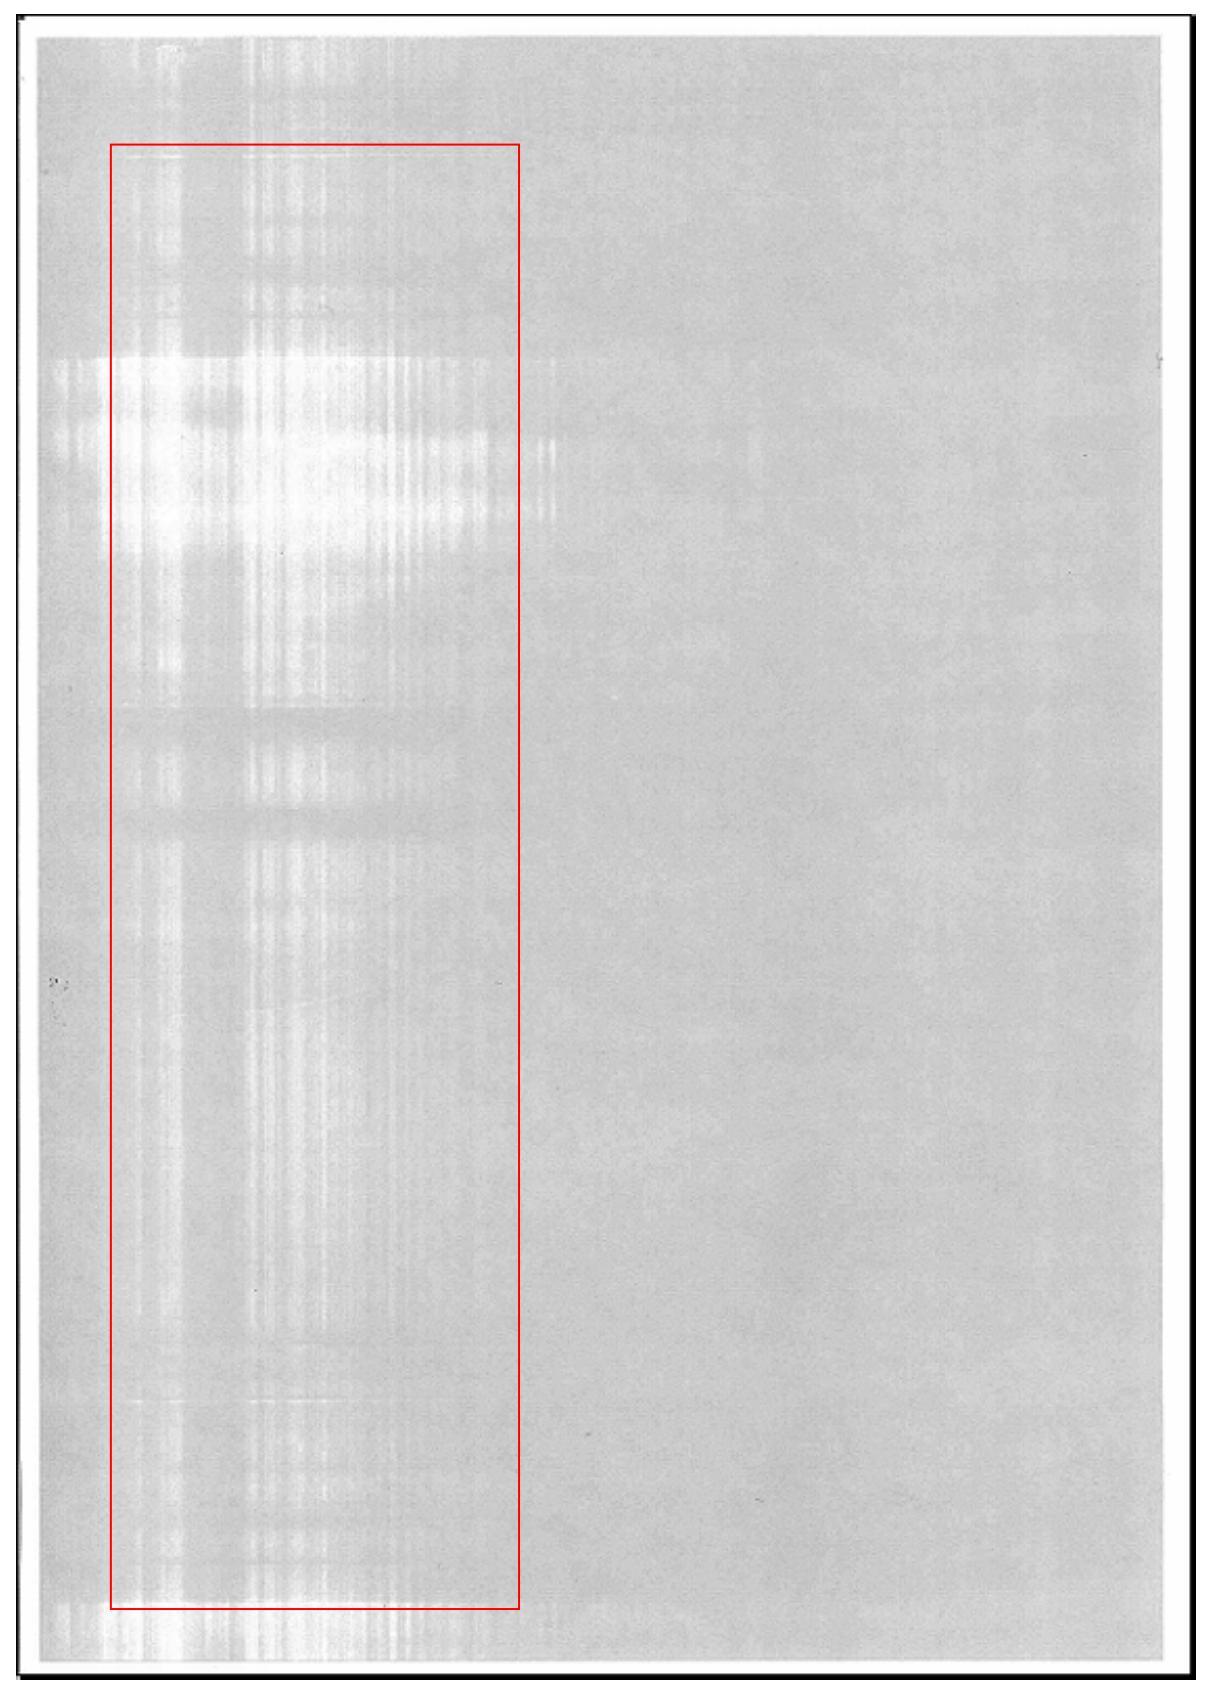
White lines

White strips (about 314 mm, 12.4 inches wide) or drag marks appear on prints, or if fine white lines appear on the front of prints.

**CAUSE**: There is dirt or oil on the surface of the drum unit.

- Step 1 In [Adjustment] menu, apply 2-810-001 (Clear blurred img).
- Step 2 Enable 3-309-010 (Oil removal mode).
- Step 3 Apply 2-810-001 (Clear blurred img) again.
