# Aries Trouble Shooting

## Index

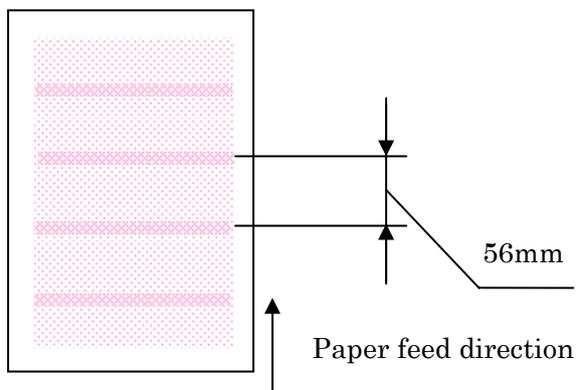
## 56mm pitch banding

56mm pitch banding occurs. The banding is clearly seen on the halftone image.

The machine was not used for a long time, the place where the drum cleaning brush roller contacts the drum; the creases are left in the brush roller.

The load changes at the creases, which creates the banding.

**Step 1:** Print out 2 dot independent (SP 2-109-002) and check if 56mm pitch bandings are occurring.

**Step 2:** Replace the drum cleaning brush roller of that specific color

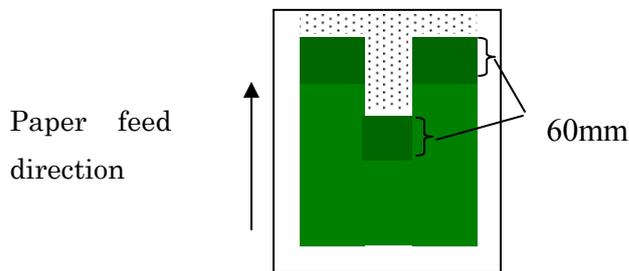
## Ghosting

60mm from the leading edge appears darker compare to other.

Toner accumulates on the surface of the development rollers, which extra toner adhere onto the ITB, when processing the image.

**Step 1:** Click on the “Rotate 180” in CWS

**Step 2:** Check the Image coverage rate using SP 2-281 for each color.

**Step 3:** Print out solid image, A3/ DLT 200 sheets of color that ghosting occurring or the color that the coverage is more than 40%.

**Step 4:** execute “density adjustment” SP3-820-002 then print out A3/ DLT 200 sheets of solid color.

Replace the developer that the ghosting appears, or the coverage rate is more than 40%.

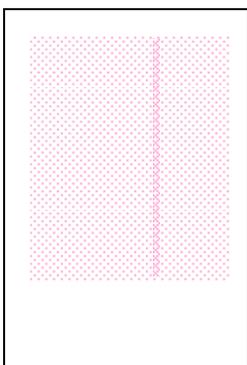
## **Streaks on Halftone Images (Stained Corona Charger)**

Streaks of 5-6mm wide appear on halftone images.

One of the charges is stained.

**Step 1:** Print three full page A3 /DLT halftone image for each color (SP 2-109-002-16)

**Step 2:** In the Adjustment Settings for Skilled Operators menu, select “0210: Execute Charger Cleaning” for color affected by streaks.

**Step 3:** Replace the corona charger for the color affected by streaks.

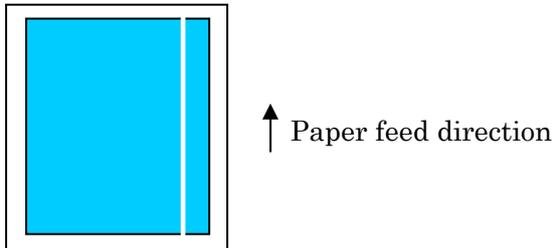
## White line(s)

White line appears on sub scan direction.

The white line could be caused by one of the following.

1. Dirty dust shield glass.
2. Dirty corona charge or the corona charge reaches to the life time.
3. Contamination inside the developer unit.

**Step 2:** Clean the dust shield glass for the specific color.

**Step 3:** Exchange the corona charger with different color station where there is no white line.

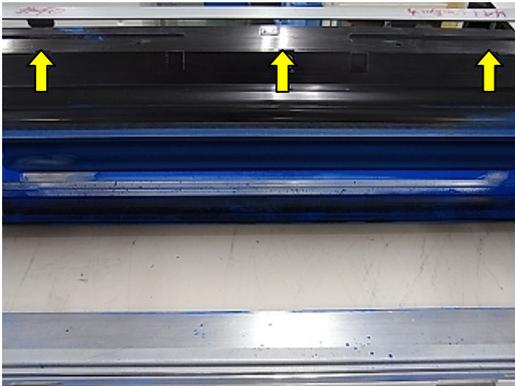
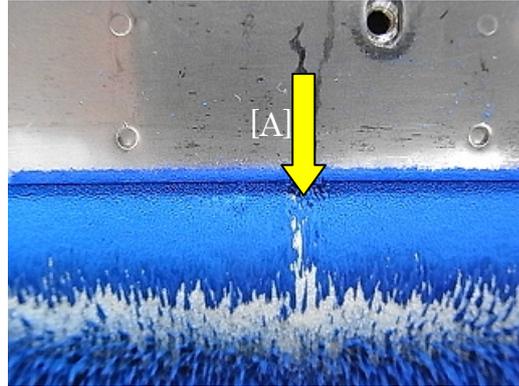
[A] developer is missing

**Step 5:** Rotate the auger until there is no developer on the auger, then insert a piece of paper between the upper developer roller and shaft, try to remove the developer and vacuum it.

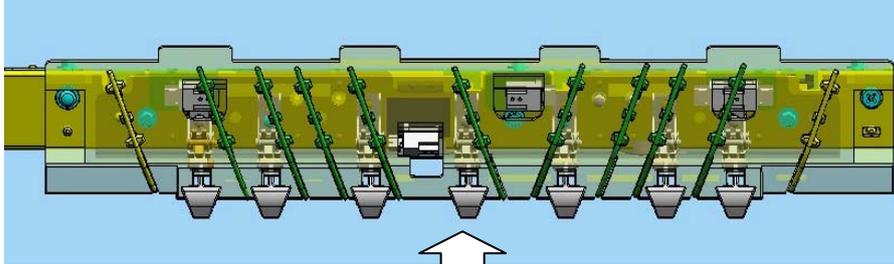
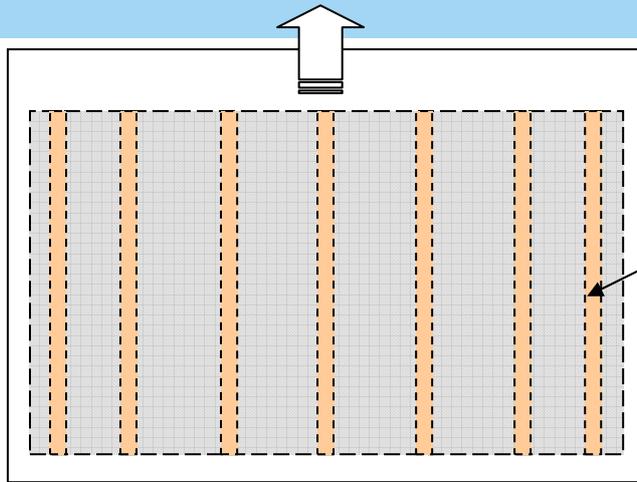
**. Contamination at Pressure Roller Stripper Pawl Unit Position**

Paper dusts adhere on to first five papers, especially on the second side of duplex.

Areas where the contamination might occur. Same position as Pressure Roller Stripper Pawls

Sample of contamination

When using paper contains paper dusts, the paper dust accumulate on the Pressure Roller Stripper Pawls.

The paper with back curl picks up the paper dust on the Pressure Roller Stripper Pawls, and pressed by the roller on the downstream peripherals.

**Step 1:** Remove the paper dust accumulated on the Pressure Roller Stripper Pawls using cloth.

**Step 3:** Remove the Pressure Roller Stripper Pawls Unit from Fuser Unit, and clean the Stripper Pawls Unit.

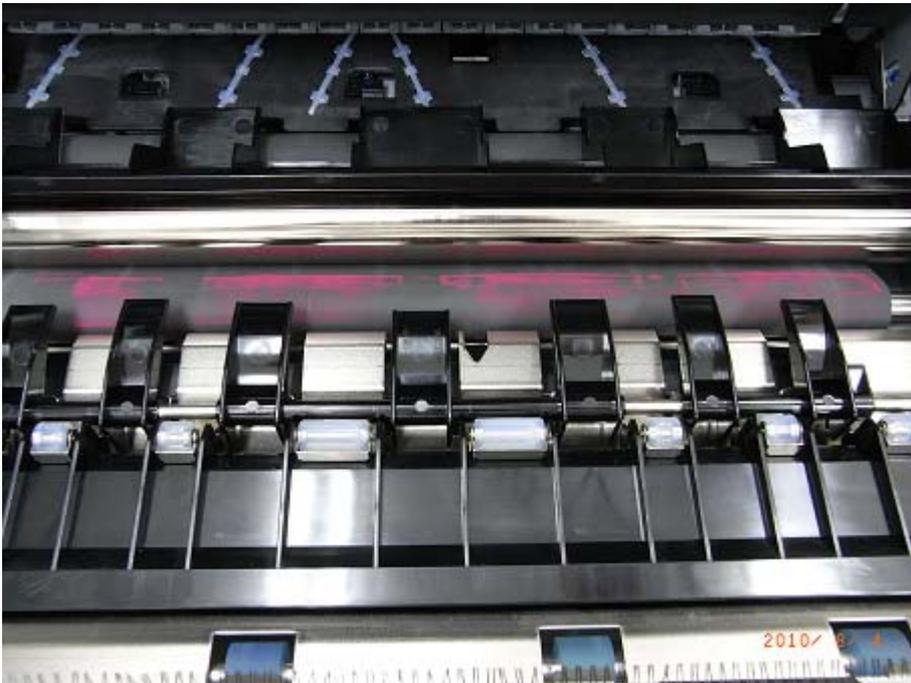
## **Dirty Cooling Belt**

Cooling belt becomes dirty with toner and; therefore, the paper gets dirty.

If the JAM 39 occurred machine stops printing. When using the paper larger than A3 /DLT some images close to the trailing edge has not been fused yet. By following the instruction displayed on the panel to remove the JAM, unfused images pass through the Cooling pipe. The toner on the cooling pipe adhere onto the Cooling belt

Clean the Cooling pipe and the Cooling belt with wet cloth.

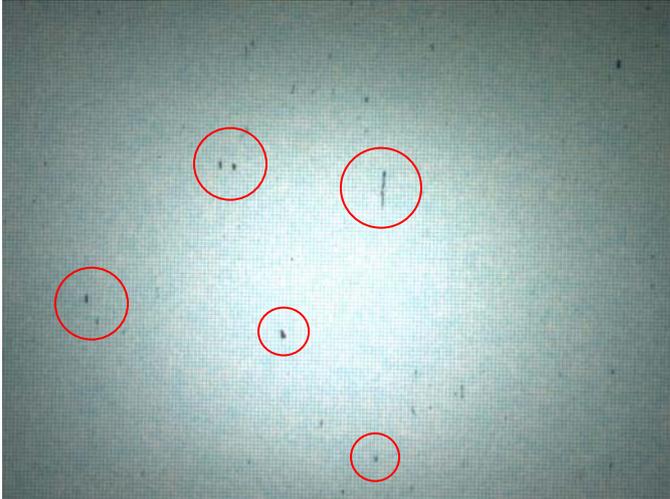
## Waste toner adheres to the paper

The waste toner slipped through the cleaning web and adheres onto the paper.

0.5 to 1mm solids (dots and lines) adheres onto the paper.

Toner particles have slipped through the cleaning web.

Add few pages\* of waste paper after the main job.

**Step 2:** Increase the heat roller temperature by 5 degrees, maximum 10 degrees. If the gloss strips or Jam occurred, set back the heating roller temperature.

**Step 3:** Set [41: Adjust Cleaning Web Motor Interval] to 0.01 in [Advanced Settings] for the custom paper in use.

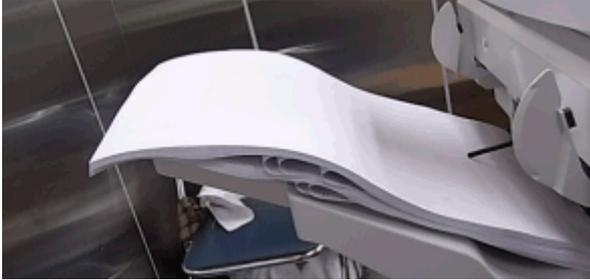
## Stapled paper stuck curled up on the tray

The stapled paper stuck curled up when it exit from the finisher.

When the stapled paper stuck is exit from the finisher, if the paper is back curl, the leading edge of the papers contacts the shift tray and curled up.

**Step 1:** Check whether the paper is back curl, and if the Decurler Unit (DU5000) is attached.

**Step 2:** In the skilled operator adjustment, under “Adjust paper curl” select "Adjust ^ Curl Weak"

**Step 3:** In the skilled operator adjustment, under “Adjust paper curl” select "Adjust ^ Curl Strong"
