# Technical Bulletin

No.: RD016001j Date: 29-Jan-09

Subject: Firmware Release Note: Engine			Prepared by: H. Matsui	
From: PPBG Ser	vice Planning Dept.			
Classification:	Troubleshooting	Part informat	tion	Action required
	Mechanical	Electrical		Service manual revision
	Paper path	Transmit/rec	eive	Retrofit information
	Product Safety	🛛 Other (	)	Tier 2

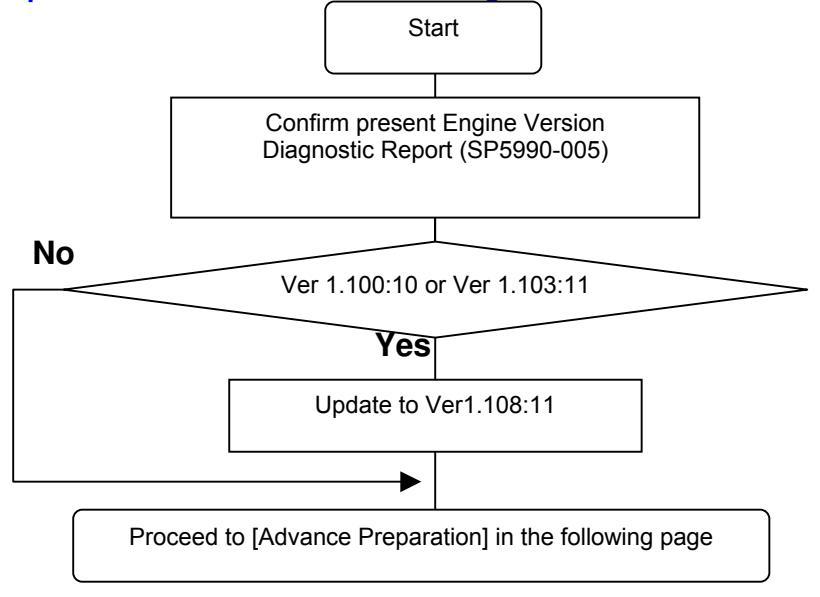
1.103:11, WatchDogTimeOut ERROR(\*1) could occur resulting in a non-functioning of the operation panel, and the machine will stop. As replacement of the BCU board will be required to resolve this error, please ensure to follow this correct procedure.

NOTE: This problem will not occur with the Aegis-C1.

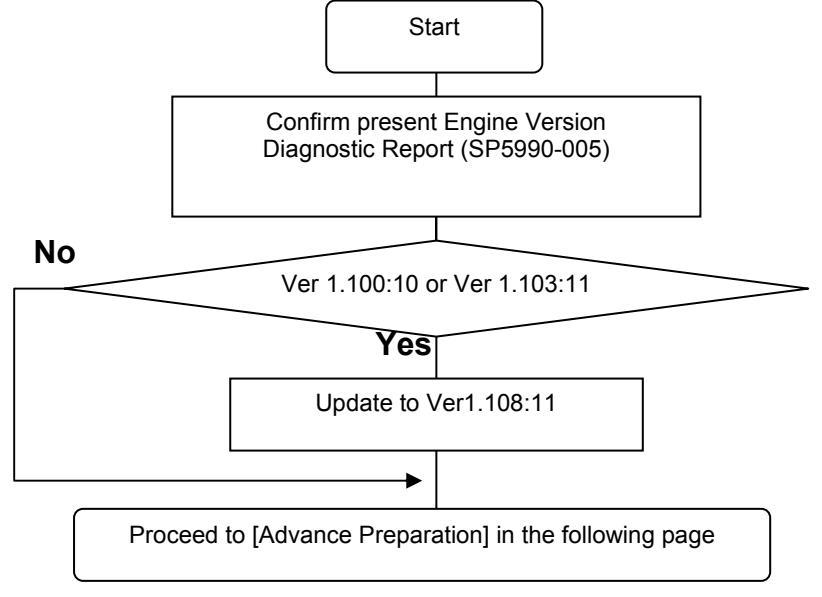
1.103:11, WatchDogTimeOut ERROR(\*1) could occur resulting in a non-functioning of the operation panel, and the machine will stop. As replacement of the BCU board will be required to resolve this error, please ensure to follow this correct procedure.

NOTE: This problem will not occur with the Aegis-C1.

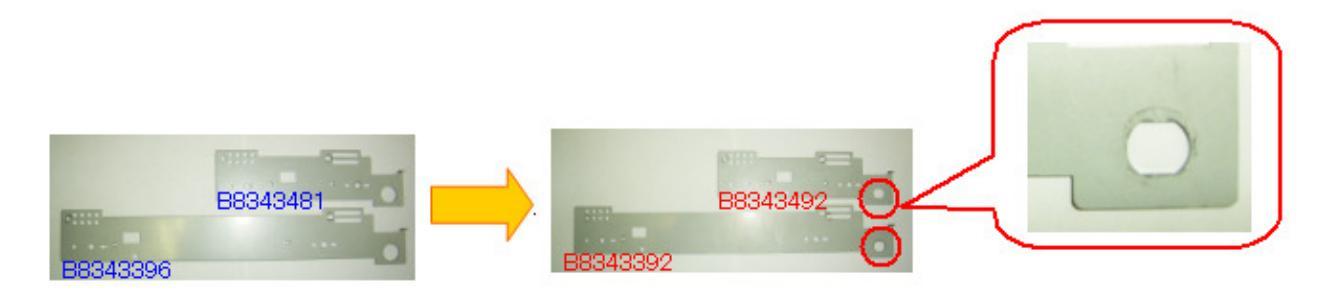
2, The size of the holes on the plates were reduced to correspond with the modified bearings.

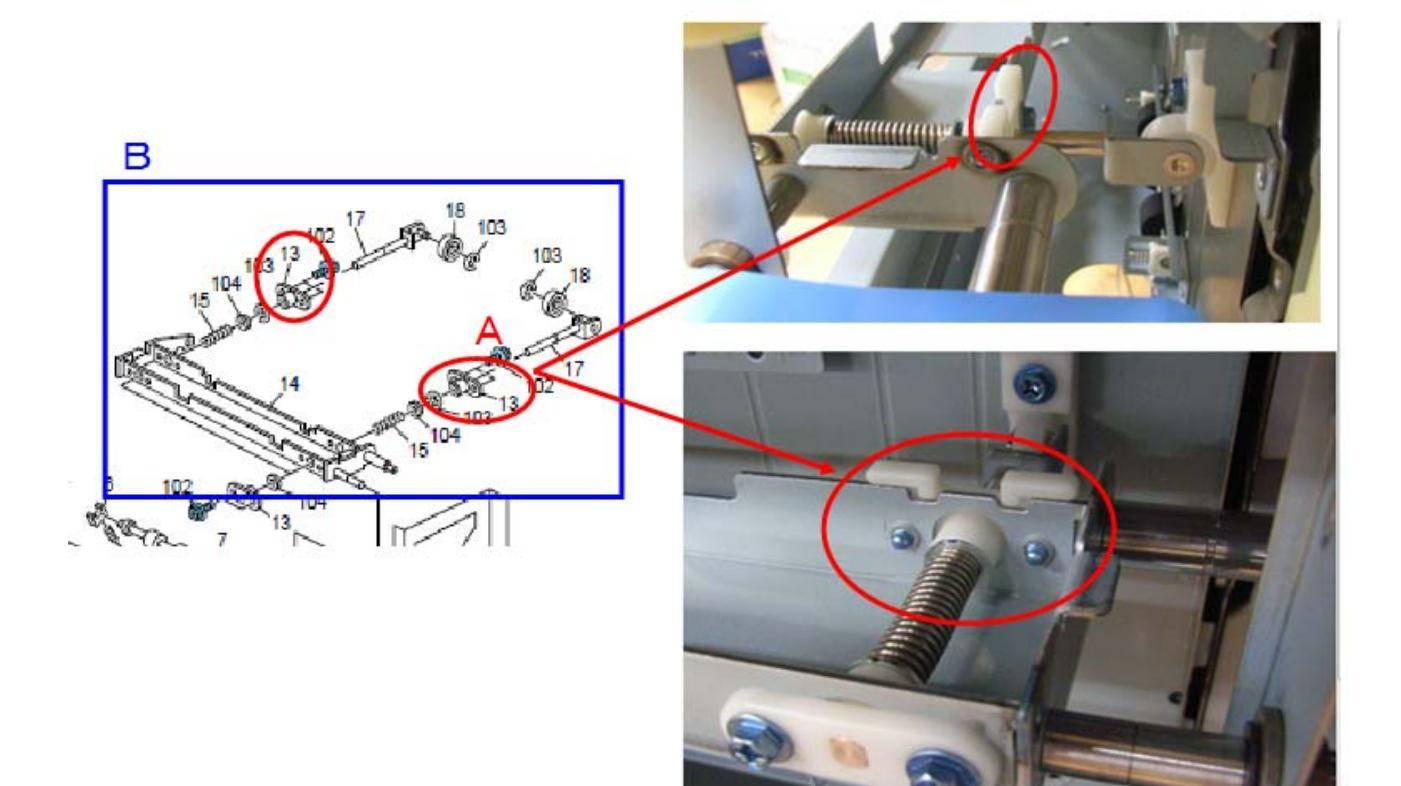
Handle was also modified in accordance with the shape change of the Shoe. (Shape of the plate was also modified.)
