# Technical Bulletin

No.: RM291001b

Model: Rev-MF1			Date: 23-Mar-18		No.: RM291004
Subject: FSM correction – The replacement procedure for scanner unit -					l by: A. Shigeta
From: Tech. Support Sec., Product Marketing Dept.					
Classification:	<ul> <li>Troubleshooting</li> <li>Mechanical</li> <li>Paper path</li> <li>Product Safety</li> </ul>	<ul> <li>Part inf</li> <li>Electric</li> <li>Transn</li> <li>Other (</li> </ul>	ormation cal nit/receive New model)	Action     Action     Servi     Retro     Tier 2	n required ce manual revision fit information 2

The procedure for replacing to a new scanner unit was revised. Before replacement, you have to obtain the PC software "48L3\_ABC\_Maintain" with the link below to conduct the CIS calibration.

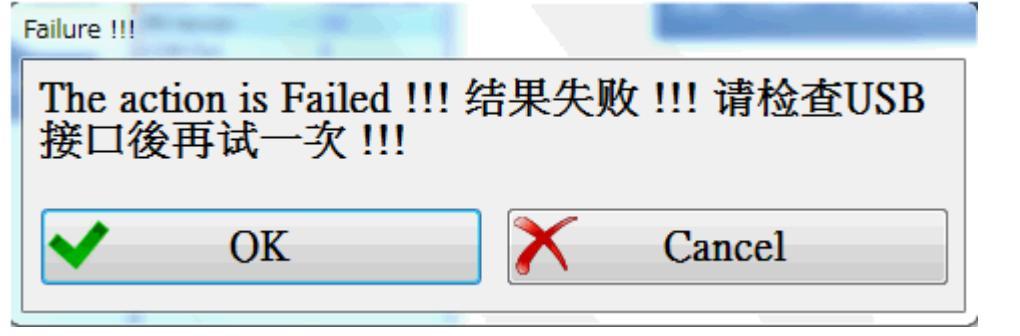
If failed to the adjustment, following message will be displayed. In that case, turn OFF the machine and go back to the adjustment step 1.
