Technical Bulletin

Model: PE-P4/PE-MF4

No.: RM200001b

Model: PE-P4/MF4(MF4 only)			Dat	e: 21-Nov	·14	No.: RM200004
Subject: PICKUP ROLLER ASS'Y (ADF No Feed)			Prepared by: Yuya Nishida			
From: 3rd Tech Service Sect., MFP/P Tech Service Dept.						
Classification:	 Troubleshooting Mechanical Paper path Product Safety 	Part info Electric Transm	ormai al it/rec	tion eive)	Action Servic Retrof	n required be manual revision fit information

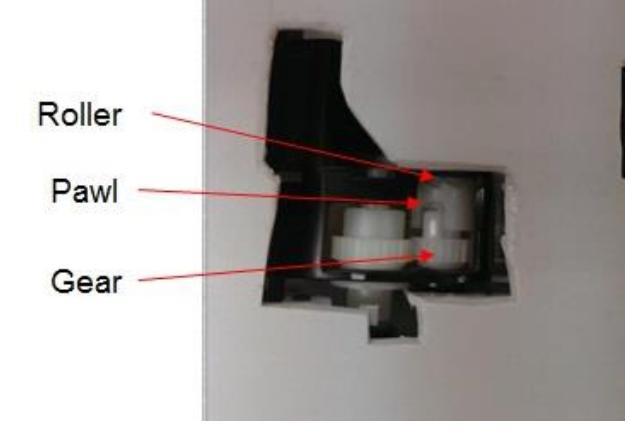
Normally, when the paper edge reaches the ADF feed roller, the pawl should move to the roller side (see first photo below) in order to drive the roller. But under LL/LH conditions, the pawl is positively charged, and slides to the gear side (see second photo below). As a result, the ADF feed roller does not rotate and the original is not fed correctly, causing the jam.

Correct position of the pawl (roller side):

- When ADF non-feed jams occur, replace the **entire Pickup Roller Assembly** (M2021643).
- For all other symptoms, replace the Gear (M2021780), Pawl (M2021781), and Discharge Brush (M2021779) together **as a set.**

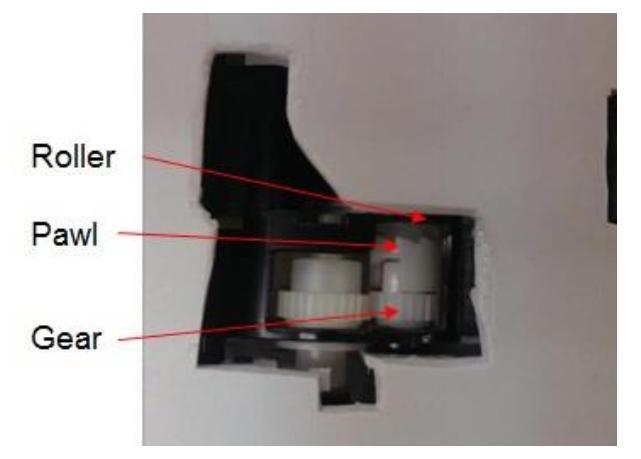
Incorrect position of the pawl (gear side):

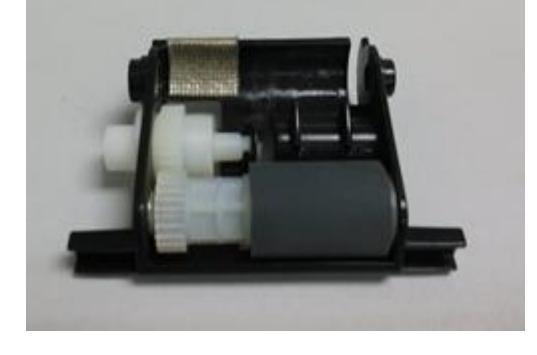
Modified Discharge Brush (M2021779)

The Discharge Brush is a strip of anti-static felt and is affixed with double-sided tape.
