RIGOH	Technical E	Bulletin	No.	BRO-001
SUBJECT: Service Manual U	pdate			<b>DATE:</b> Jan 15, 1996
PREPARED BY: Y. Okunishi CHECKED BY: M. Iwasa		FROM: Qu	ality Ass	surance Center
CLASSIFICATION:			MODE	L:
Action Required     Traublachapting	Revision of servi	ice manual	B	RO, BR1
Retrofit Information	Other

SUBJECT: Incomplete Cover Closing			<b>DATE:</b> Feb. 15, 1996
PREPARED BY: Y. Okunishi CHECKED BY: M. Iwasa	FRO	M: Quality As	ssurance Center
CLASSIFICATION:	·	MOD	EL:
Action Required Rev Troubleshooting Info	sion of service ma mation only er	anual E	BRO/BR1

SUBJECT: Printer Cover Catch	<b>DATE:</b> Feb. 15, 1996
PREPARED BY: Y. Okunishi CHECKED BY: M. Iwasa	FROM: Quality Assurance Center
CLASSIFICATION:	MODEL:
Action Required Revision of Troubleshooting Information Other	of service manual BRO/BR1 on only

SUBJECT: Document Senso		<b>DATE:</b> Mar. 15, 1996		
PREPARED BY: Y. Okunisl CHECKED BY: M. Iwasa	hi	FROM: Qu	ality Ass	surance Center
CLASSIFICATION:			MODE	L:
Action Required	Revision of servi	ice manual	Bł	RO, BR1
Troubleshooting	Information only			
Retrofit Information	Other

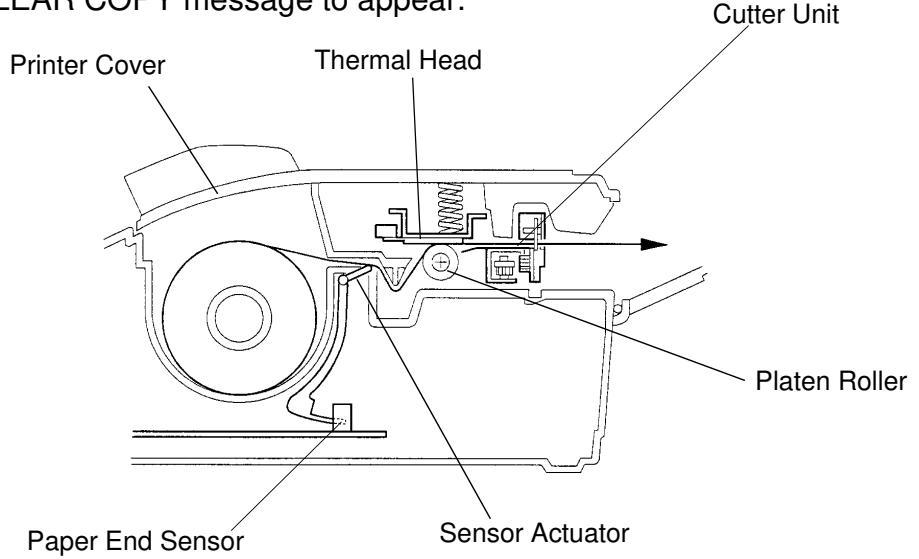
The printer cover is closed incompletely and the cover open / paper end sensor detects no paper after the paper is cut.

After the paper is cut, the paper leading edge is fed back to the print position. At the time, the paper is away from the sensor actuator because the printer cover is closed incompletely and the cover does not push the paper to the sensor actuator enough.

This causes a CLEAR COPY message to appear.

When the sensor detects no paper, the cutter is stopped before returning back to the home position (left side). (The cutter stops for about 200 ms at the right side after cutting the paper, then it returns back to the home position in the normal condition.)

- 1) A decal is attached on the printer cover. It instructs the user to close the cover completely. (February production)
- 2) A decal is attached on the cutter. It indicates the direction to the home position. (February production)
- 3) An errata sheet including the additional information for the cutter position is attached in the operator's manual.

- 4) The software (ROM) is changed. (May production)
  - To keep the cutter moving for about 1.5 s after the sensor detects no paper. (In most cases, the cutter can return to the home position during this time.)
  - To display CHECK CUTTER POSITION when the cutter does not return to the home position.

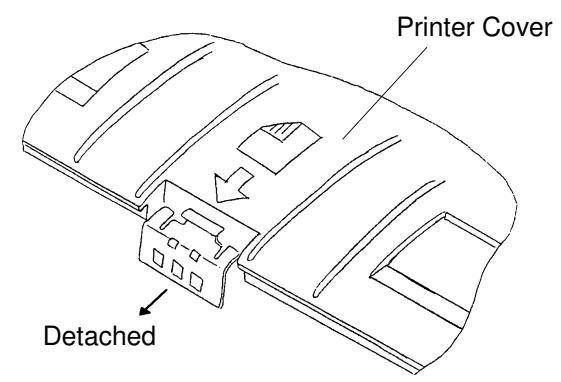
The printer cover catch (Stopper - Printer Cover) becomes detached from the printer cover.

The user confuses the direction for unlocking the printer cover catch and pushes the cover catch in the opposite direction (towards the front). This is because there is a decal with an arrow for setting the documents just behind the cover catch.

Once the cover catch becomes detached, it is not easy enough for the user to set the cover catch back on the printer cover without any instructions.

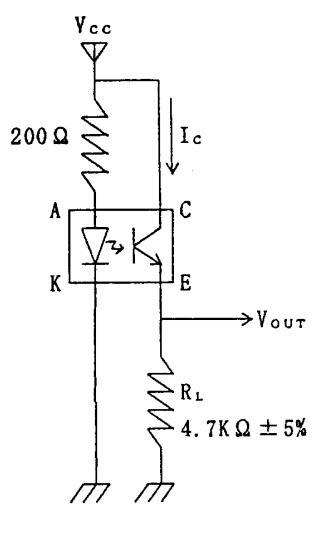
The circuit on the right is for both sensors.

The light from the photodiode A-K activates the photo transistor.

When a document is set, the actuator of the sensor cuts off the light and the voltage at Vout goes below the 3.6 V threshold (it should go below 1.0V normally) so that the machine detects the document. (Vout is over 4.0V normally when a document is not set.)

The power of the light from the photo diode becomes weak with time (Max.25% down in 5 years) and this makes Vout go down. When Vout becomes below 3.6V, the above problem occurs.

- Replace RL with the 18kΩ resistor for both the document sensor and the scan line sensor.
   H0685411 → H0685601 Operation Panel Ass'y-BRO-CHN H0685414 → H0685606 Operation Panel Ass'y-BRO-CHN2 H0685412 → H0685602 Operation Panel Ass'y-BRO-Asia H0685413 → H0685603 Operation panel Ass'y-BRO-USA H0685416 → H0685604 Operation panel Ass'y-BRO-TWN H0685415 → H0685605 Operation panel Ass'y-BRO-Ges H0695412 → H0695601 Operation panel Ass'y-BRI-CHN H0695413 → H0695606 Operation panel Ass'y-BRI-CHN2 H0695411 → H0695602 Operation panel Ass'y-BRI-CHN2 H0695611 → H0695604 Operation panel Ass'y-BRI-Asia H0695614 → H0695604 Operation panel Ass'y-BRI-TWN
- A Higher impetance resistor  $18 \text{K}\Omega$  at RL keeps Vout over 3.6v in a no document condition over 10 years. This resistor value does not affect detecting the document.
