Software problem

Model(s): FAX3000L

RIGOH	Technic	al Bulletin CSO-003	lssued	d on February 1	5, 1992
Subject: AFO/A	F2/CSO Softwa	re problem			
Model(s): AFO/AF2/C	SO				
Classification		FAX T.S. Se Assistant Ge <u>H. Motojima</u> Control No.	ction T.S. D neral Mana for Each Ar	epartment ger ea	
		R.C.		Asia	002
Betrofit Information		SAVIN		LAM	002
Revision of Service N	Manual	Europe	002	AT&T	
☐ Information Only	handa	HCS	002		
Others

## AFO/AF2/CSO Software problem

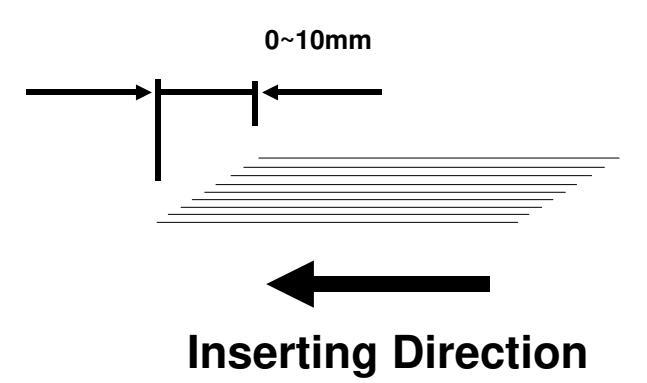
The document may not feed at all if the customer places 50 sheets in the ADF.

- 1. Static electricity. (In low humidity environment)
- 2. Some types of paper, such as rough or thick types.

Normally documents should be set with the edges even, because the CSO has a shutter. However, if the customer faces this problem, instruct the customer to do the following.

- 1. Shuffle the stack
- 2. Place the document in the feeder as follows

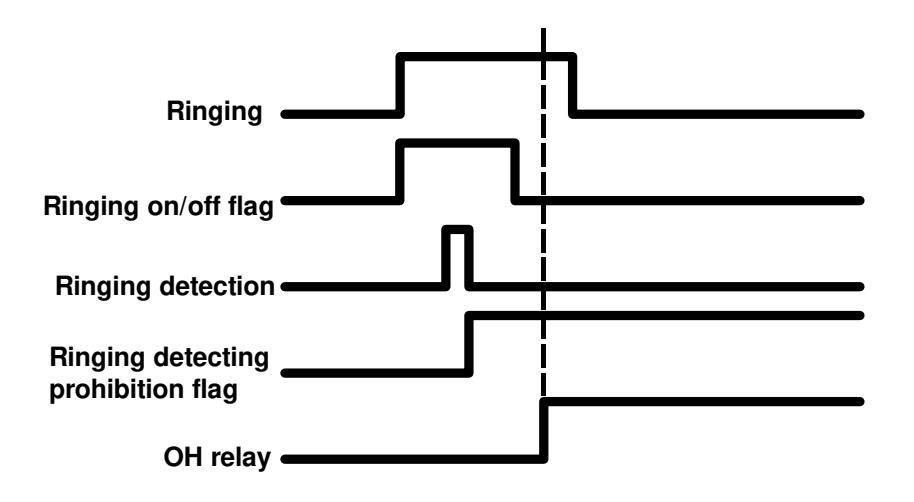
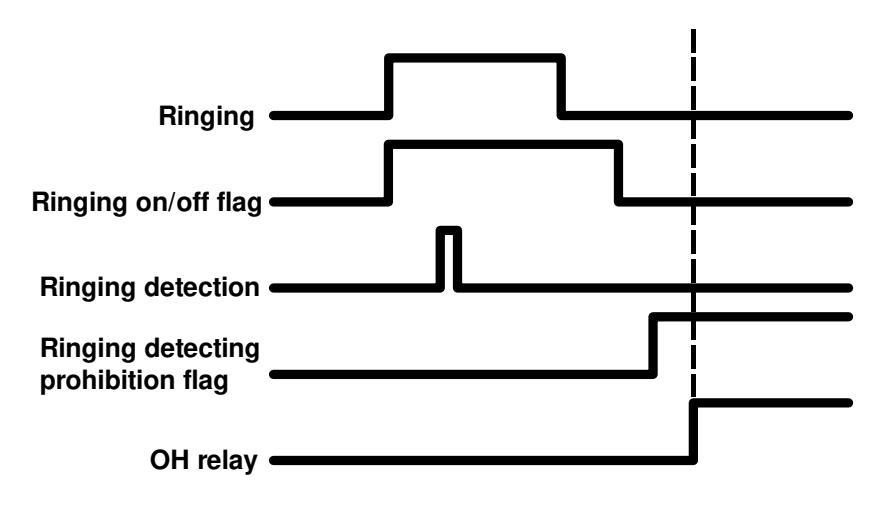
1. By a software fault, the DC loop over the OH relay is closed during an incoming call to result in putting the ringing voltage (energy) through the DC loop.

The current faulty program allows the ringing off signal be enabled during a ringing sequence, so the OH relay is to be switched on.

- 1. The program is corrected. So, exchange the ROM on the MBU to the new one.
- 2. The program is corrected.

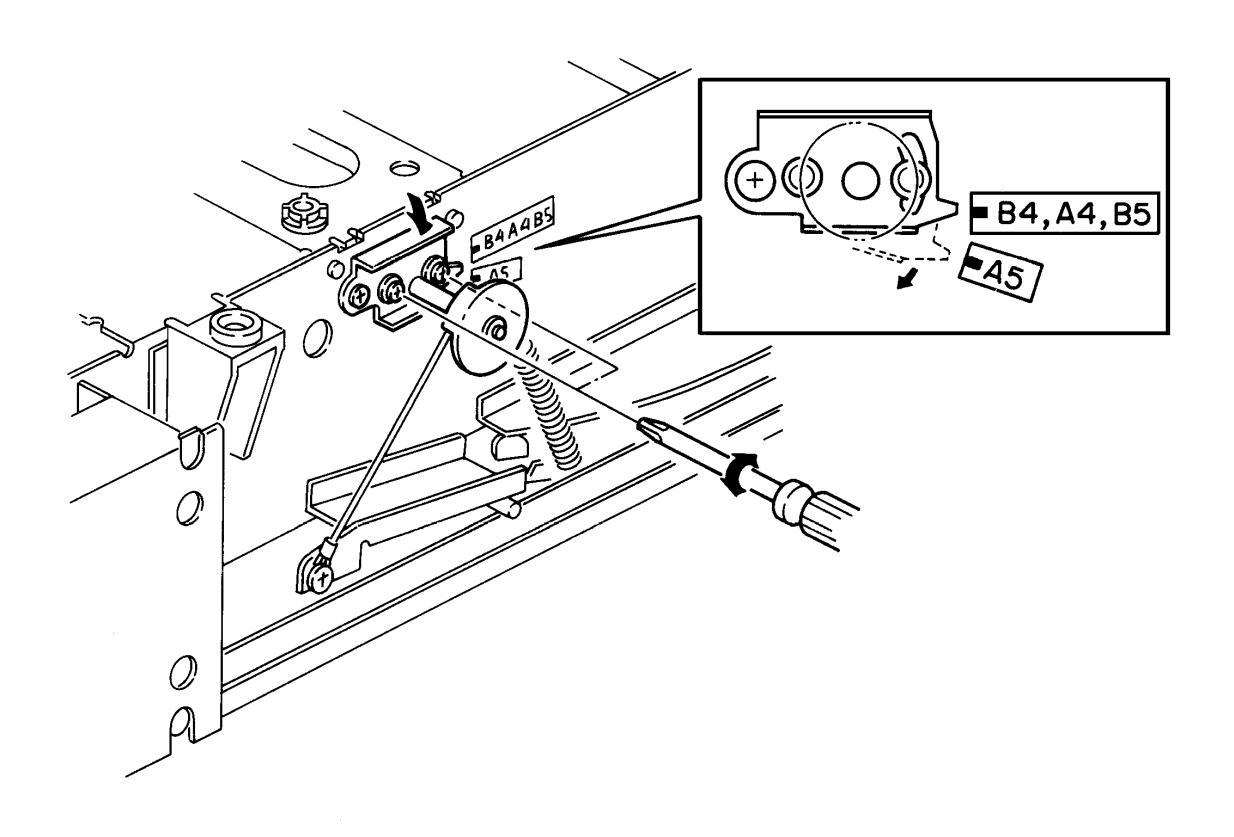
If the customer require A5 size paper in the paper feed unit, adjust the spring pressure as follows in order to prevent double feeding.

- 1. Remove the right cover.
- 2. Adjust the spring pressure by the adjustment bracket as shown below. (by loosening 2 screws)
- 3. Put the cover back.

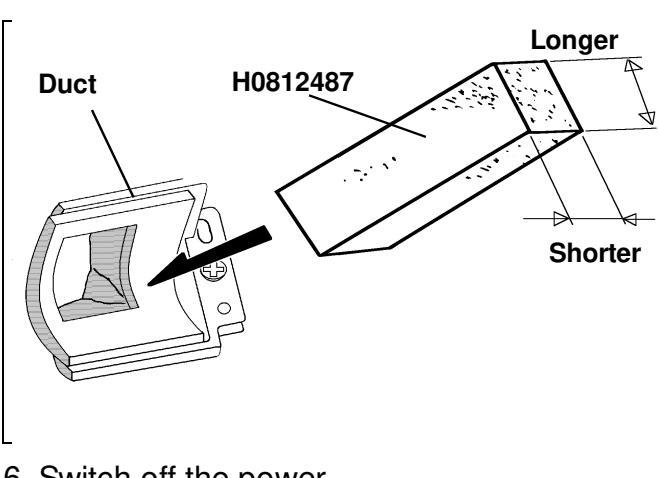
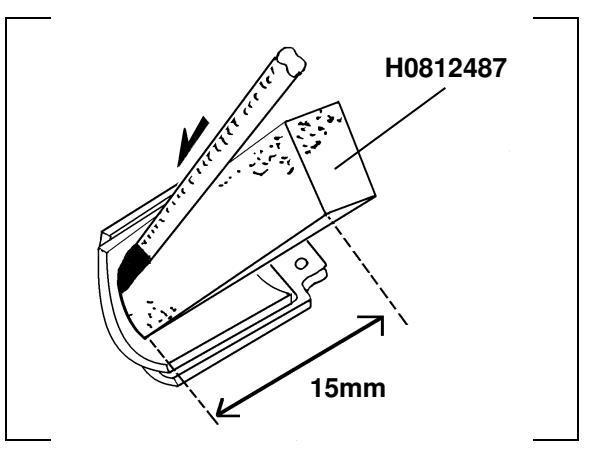
Once the machine is installed (with the Toner Cassette installed in the machine), the toner will be transferred to the developing unit. As a result, when the Toner Cassette is removed from the machine, some residual toner may spill out from the developing unit when the machine is moved.

- 1. Switch off the power, and remove the toner cassette.
- 2. Remove the remaining toner at the duct entrance by tapping the duct.
- 3. Close the front cover without putting back the toner cassette.
- 4. Using the test mode, rotate the toner supplier as follows.
  - (1) Enter test mode: Function 5 1 9 9 1
  - (2) 9 7 Yes
  - (3) 8

- (4) After the noise from the toner supply mechanism stops, press Stop
- 5. Push the duct cover (H0812487) into the development unit with a screwdriver.

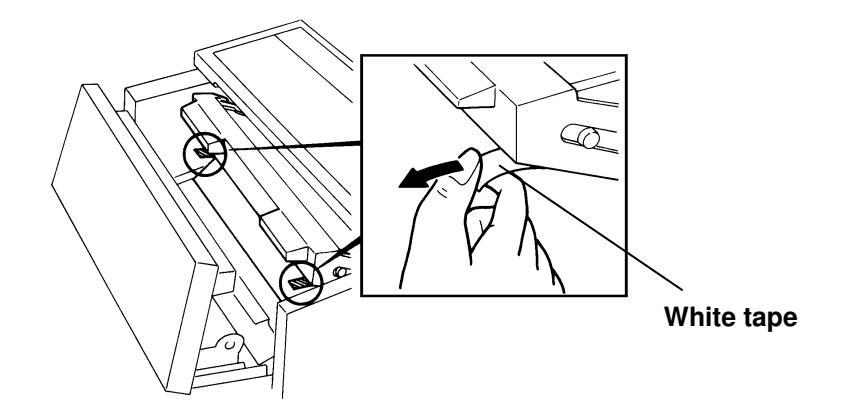
Defective OPC. (The OPC might fall down during installation, resetting or replacement of the OPC.)

Remove the two white tapes on the OPC holder after installing the OPC in the machine.

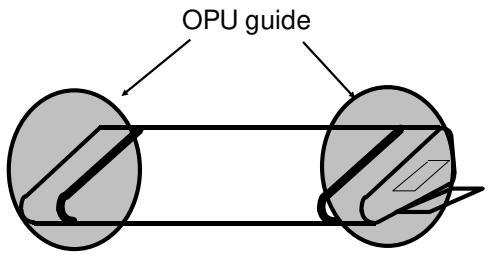
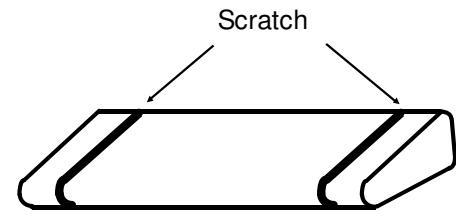
The OPU may be damaged when using the machine, as shown below. However, there is no problem on the printed image.

1. Both sides of the development roller may touch the metal blade on the development roller. By this, the shaved corpuscles may get in the space between the OPU belt and the development roller, the both sides of the OPU belt may be damaged.

- 1. If the above problem occurs, do not replace the OPU, because, there will be no problem on the printed image, in the lifetime of the OPU.
- 2. Do not adjust and change the position of the OPU guide.

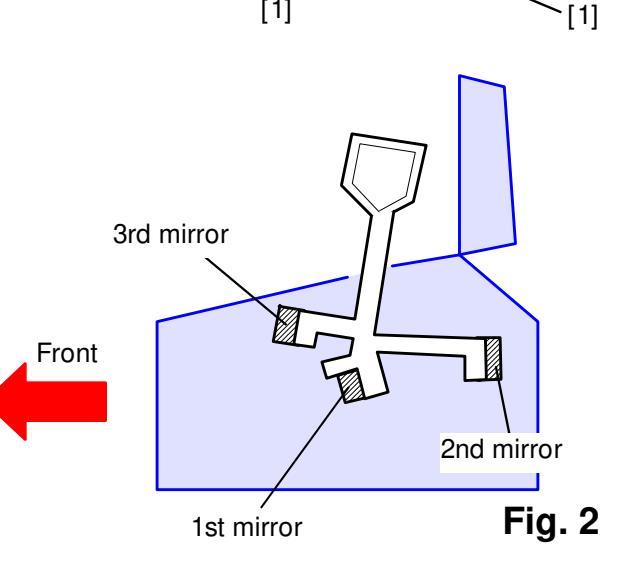
Fig. 1

In the field, the scanner mirrors may become dusty (poor scanning quality). In this case, we recommend that you do procedures 1 and 2.

- (1) Remove the exposure glass.
- (2) Insert the cleaning tool into the scanner. (Fig. 2)
- (3) Clean the mirrors by sliding the tool. (3~ 4 times for each mirror)

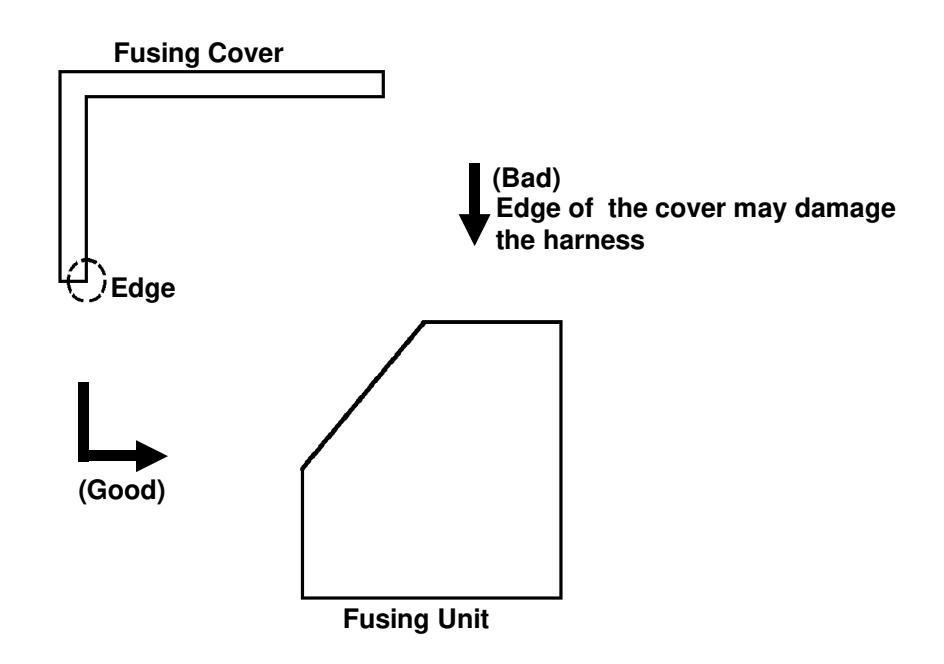
If the metal wire of the harness contacts the thermistor bracket, a no power condition may occur. Please check the thermistor harness if this occurs.

(A): Please refer to the following instructions and fix the cover to the fusing unit and check that the harness is not pinched before installing the fusing unit in the machine.
