SUBJECT: Points to note at installation

June 30, 1994

PREPARED BY: H.Yokoyama CHECKED BY: S.Hamano	FROM: 2nd	d T.S. Section
CLASSIFICATION: Action Required Revision of serv Troubleshooting Information only Retrofit Information Other	ice manual	MODEL: LHO (USA only)

### Technical Bulletin No. LHO-002

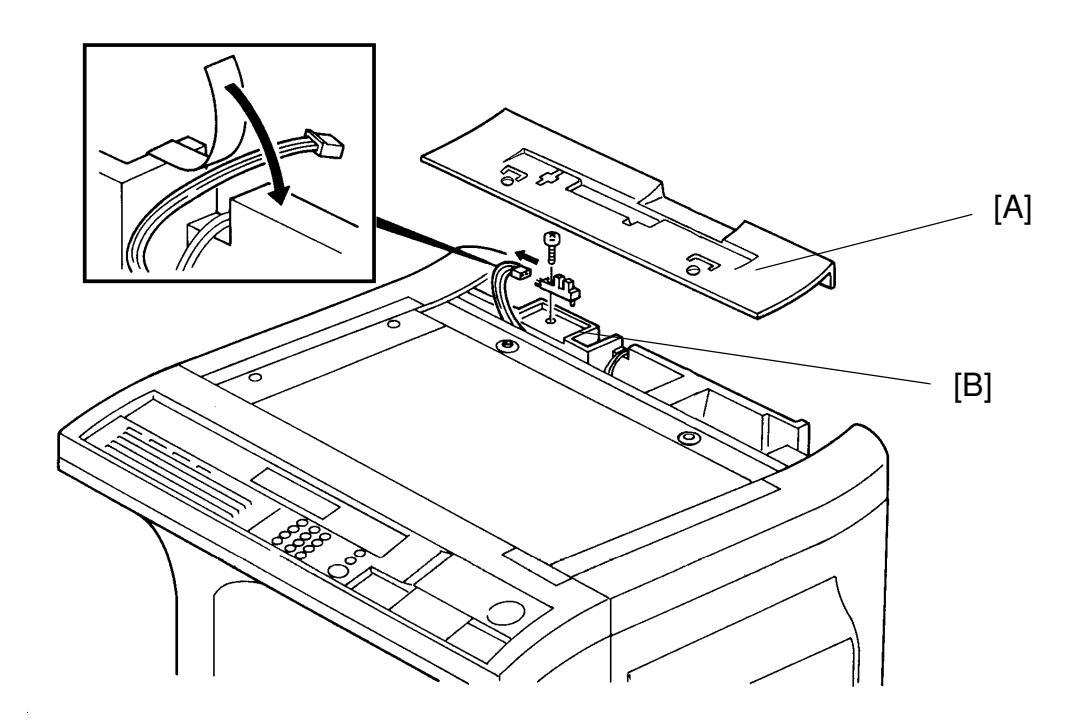
#### 3. Platen Cover Sensor

<Problem>

The machine will make a blank copy without feeding a document into the ADF original table. Note: This problem will happen only for the first copy after the main switch at the back of the machine is turned on/off.

<Cause>

Software problem.

Remove the platen cover sensor when installing the optional ADF. The procedure is as shown below.

(1) Remove the Rear Upper Cover [A]

(2) Remove the Platen Cover Sensor [B] (1 screw, 1 connector)

(3) Fix the Sensor Harness with tape

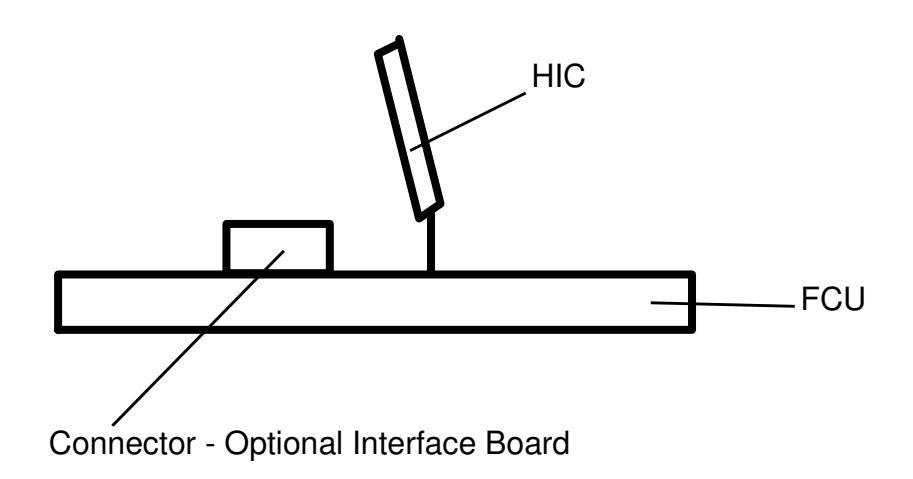
#### 5. Optional Interface Board

The HIC on the FCU has been installed and this prevents the Optional Interface Board from installing smoothly.

Reform the HIC to the correct position slowly when installing the board. Caution: Be careful not to break the legs of the HIC.

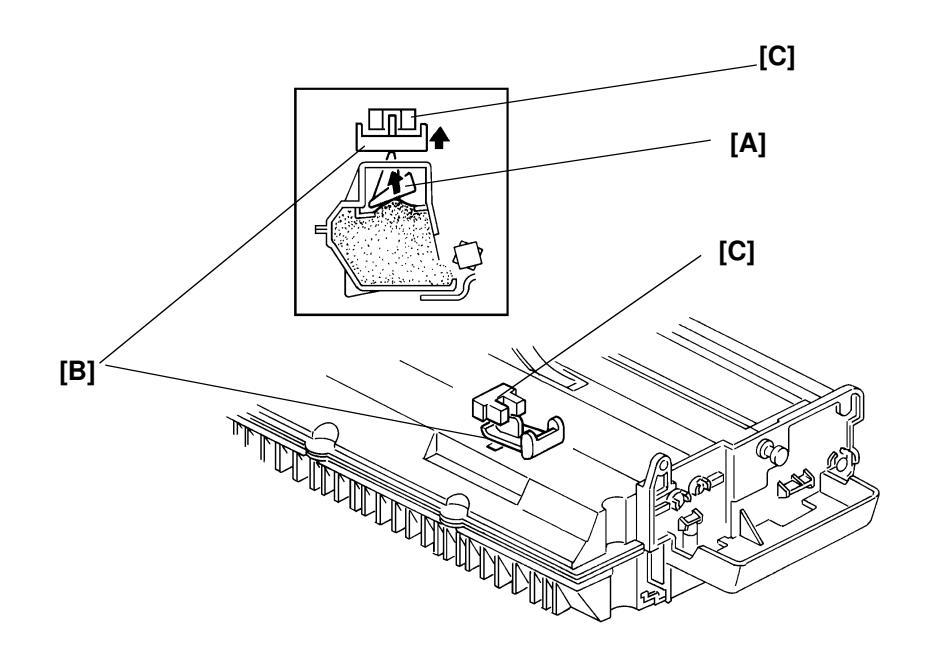
#### 2.3.2.Used Toner Overflow Detection

When the used toner piles up, the pressure of the used toner pushes up the movable plate [B]. Up to 100 prints can be made after the actuator moves into the used toner overflow sensor [C]. At this time, printing is disabled, and the display on the operation panel instructs the operator to replace the master unit.

This condition can be cleared by replacing the master unit.

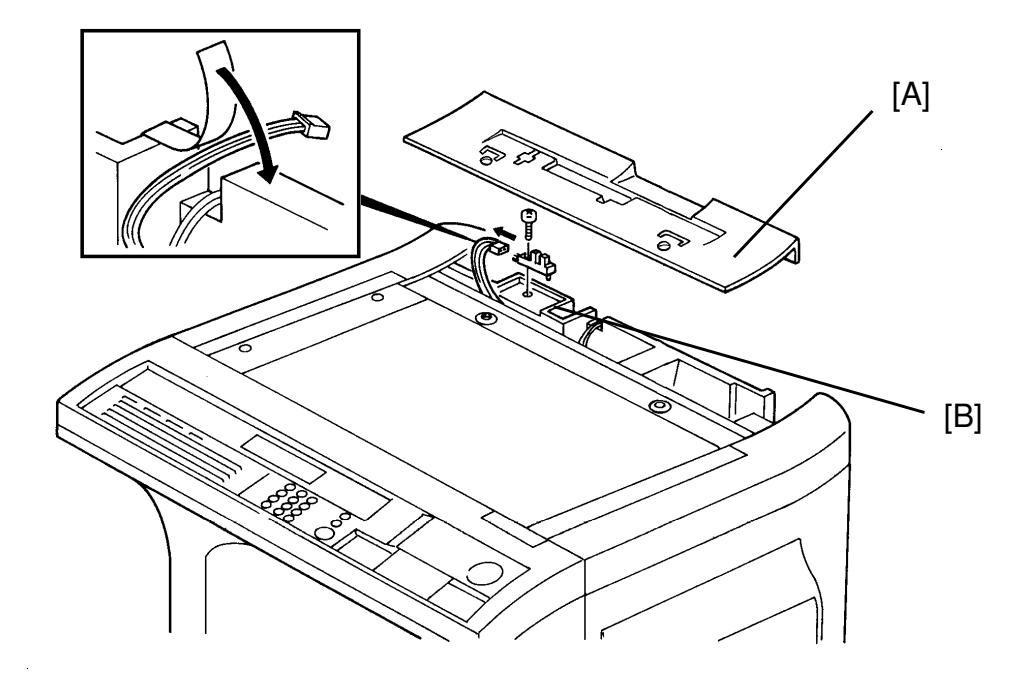
#### <Cause>

The machine contains a platen cover sensor and this will cause the problem.

#### This will be solved with the following software modification.

$H5207206B \rightarrow C (PROM \text{ for MBU-F})$  $H5207207B \rightarrow C$  (PROM for MBU-F)  $H5207209B \rightarrow C$  (PROM for MBU-S)

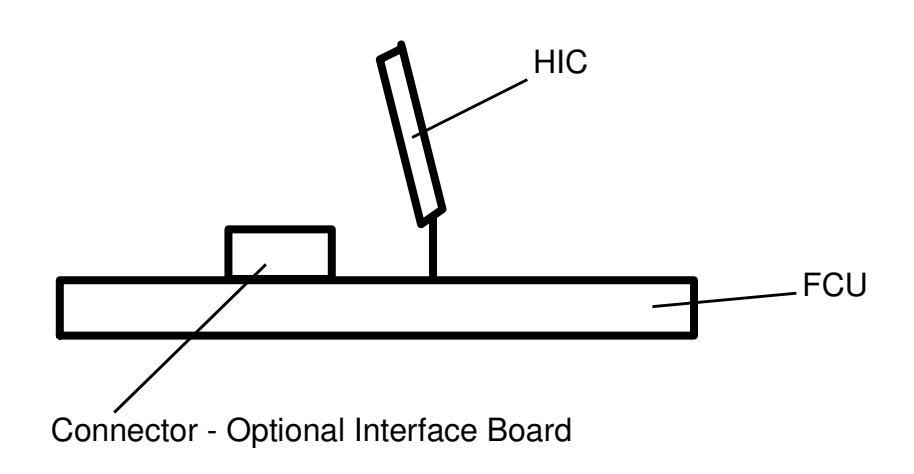
The HIC on the FCU has been bent and this prevents the Optional Interface Board from installing smoothly.

Bend the HIC to the correct position slowly when installing the board. Please be careful not to break the legsof the HIC.

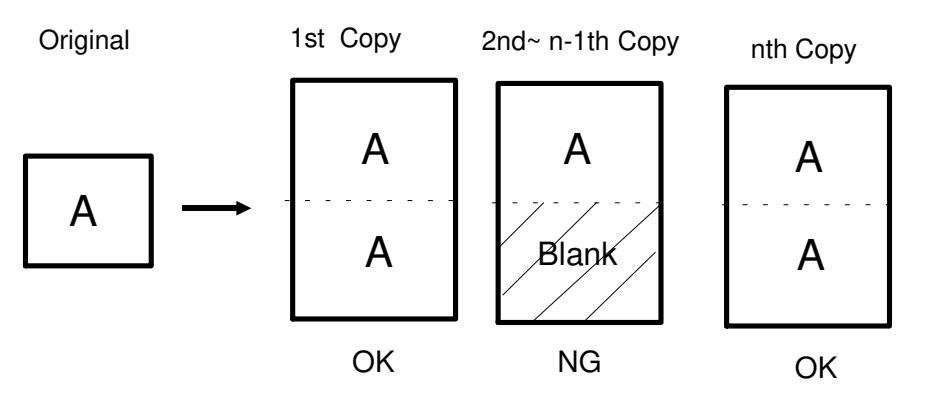
The double copy function will not work correctly when more than 3 copies are made

<Cause> Software problem

<Modification> The ROM on the PCB-MBU-S has been modified

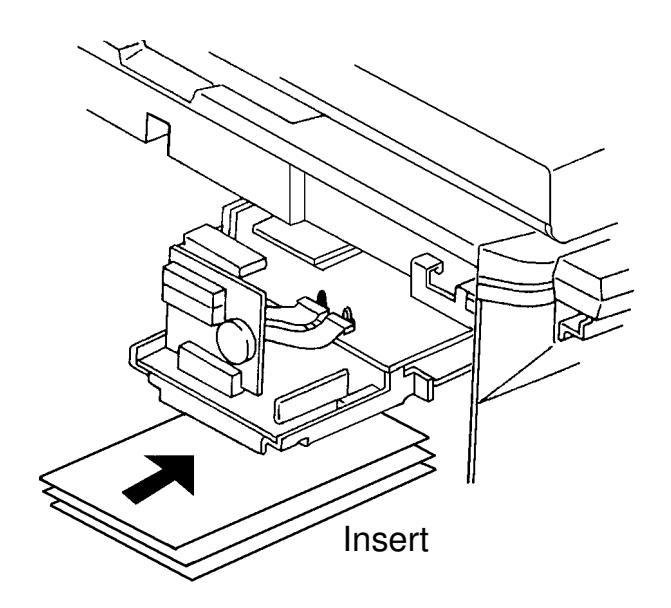
When checking the FCU and SPU boards of the machine, please note the following. Otherwise, the boards may be broken by a short circuit by contact with the main frame of the machine.

- 1. Turn off the main switch (at the rear side of the machine) when removing the boards.
- 2. Insert paper (at least 3 sheets) between the FCU and the main frame of the machine when checking a TP or adjusting a VR on the board.

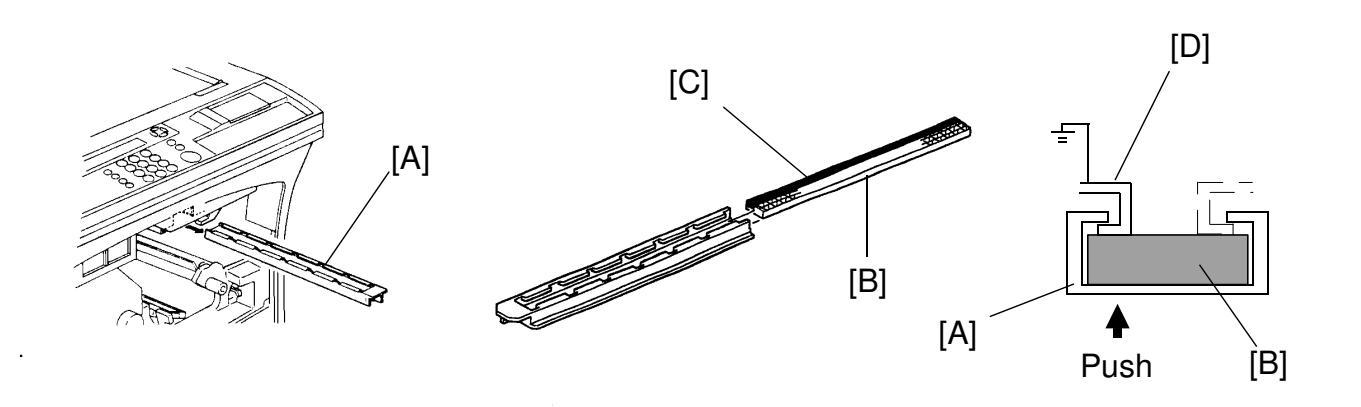
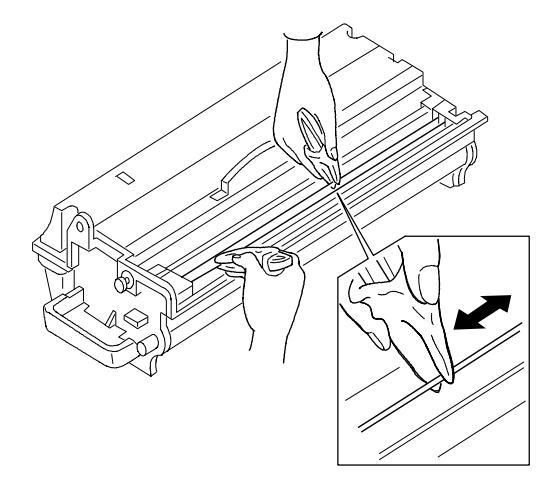
SUBJECT: Vertical black bands / lines (Zebra stripes)

The corona discharge becomes uneven because of dust adhered onto the charge corona wires under low humidity environment.

It has been confirmed that the condition of corona discharge becomes stabler if the ozone filter is grounded because it is electrically conductive. This will lengthen the interval of occurrence of this problem.

- 1. Open the front cover.
- 2. Remove the development unit.
- 3. Remove the master unit.
- 4. Remove the ozone filter case [A].
- 5. Remove the ozone filter [B] from the ozone filter case.
- 6. Remove the insulating tape [C] from the ozone filter.
- 7. Install the ozone filter to the ozone filter case.
- 8. Install the ozone filter case and then push up the ozone filter so that the upper surface of the ozone filter touches the guide rail [D].
- 9. Clean the charge corona wire with dry cloth carefully as shown below.

- 10. Reinstall the master unit on the development unit.
- 11. Close the front cover.
- 12. Check the copy quality.
- **Note**: Clean the charge corona wire at every EM call to minimize the incidence of this problem.

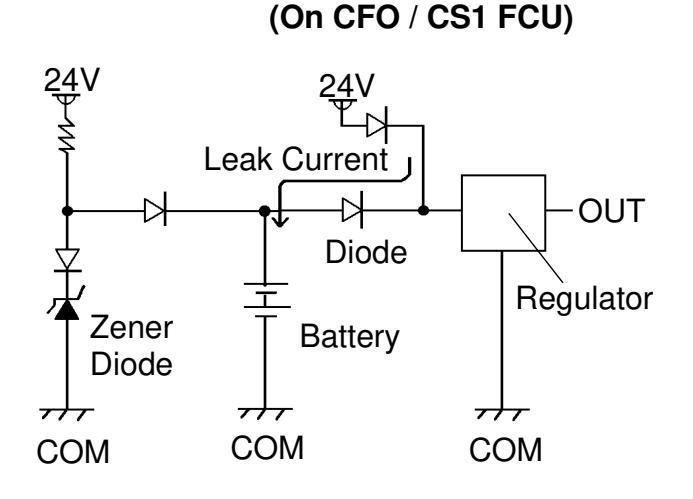
SUBJECT: Memory Back-up Battery
 DATE: Jan. 19, 1995

Stored documents in the memory might be erased when the main power goes down. A power failure report is printed with the following information.

Power loss from the memory back-up battery on FCU caused by excessive charge current, for the following reasons.

- Leak current from Diode The battery is charged after it is already fully charged. This type of battery is damaged if this occurs.
- (2) Excessive charge voltage (CFO, CS1,LHO) The target charge voltage was 6.2V against 6.4V or under which is recommended by the battery maker. This margin was too small for this battery.

See MB C Series-048A.

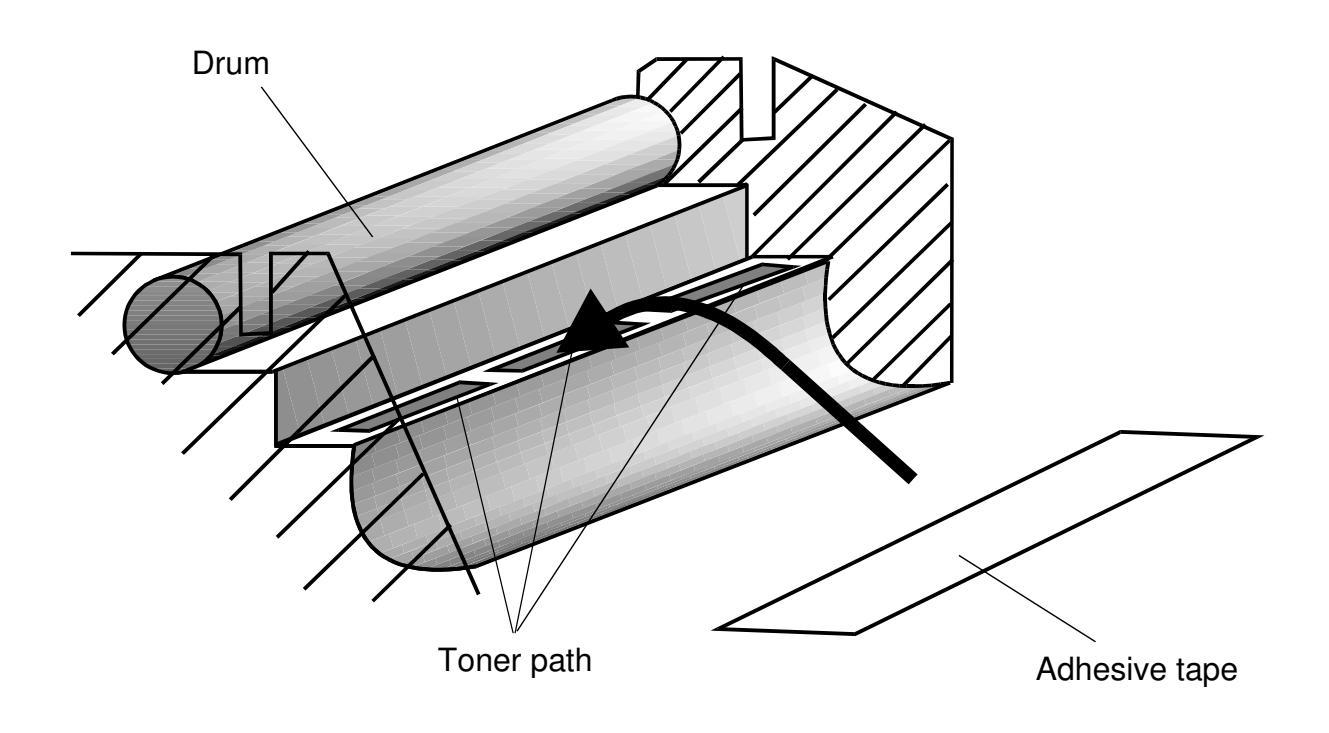
#### Inside of FX6 and LSO

Cause: Toner leaked from the development unit, the toner cartridge, or somewhere in the toner path during transportation.

Note: Adhesion of the tape should not be strong. Otherwise, it may not be taken off cleanly from the machine, or the toner path may be damaged when it is taken off.
