Model: Russian-C1		Date: 15-Feb-00	No.: RA265002
Subject: Service Manual Correction		Prepared by: S. Tomoe	
From: Technical Services Dept., GTS Division			
Classification:	<input type="checkbox"/> Troubleshooting <input type="checkbox"/> Part information <input type="checkbox"/> Action required <input type="checkbox"/> Mechanical <input type="checkbox"/> Electrical <input type="checkbox"/> Service manual revision <input type="checkbox"/> Paper path <input type="checkbox"/> Transmit/receive <input type="checkbox"/> Retrofit information <input checked="" type="checkbox"/> Other (      )

Model: Russian-C1		Date: 08-Mar-00	No.: RA265004
Subject: Printer Firmware History		Prepared by: S. Tomoe	
From: Technical Services Dept., GTS Division			
Classification:	<input type="checkbox"/> Troubleshooting	<input type="checkbox"/> Part information	<input type="checkbox"/> Action required
	<input type="checkbox"/> Mechanical	<input type="checkbox"/> Electrical	<input type="checkbox"/> Service manual revision
	<input type="checkbox"/> Paper path	<input type="checkbox"/> Transmit/receive	<input type="checkbox"/> Retrofit information
	<input checked="" type="checkbox"/> Other (       )

Model: Russ

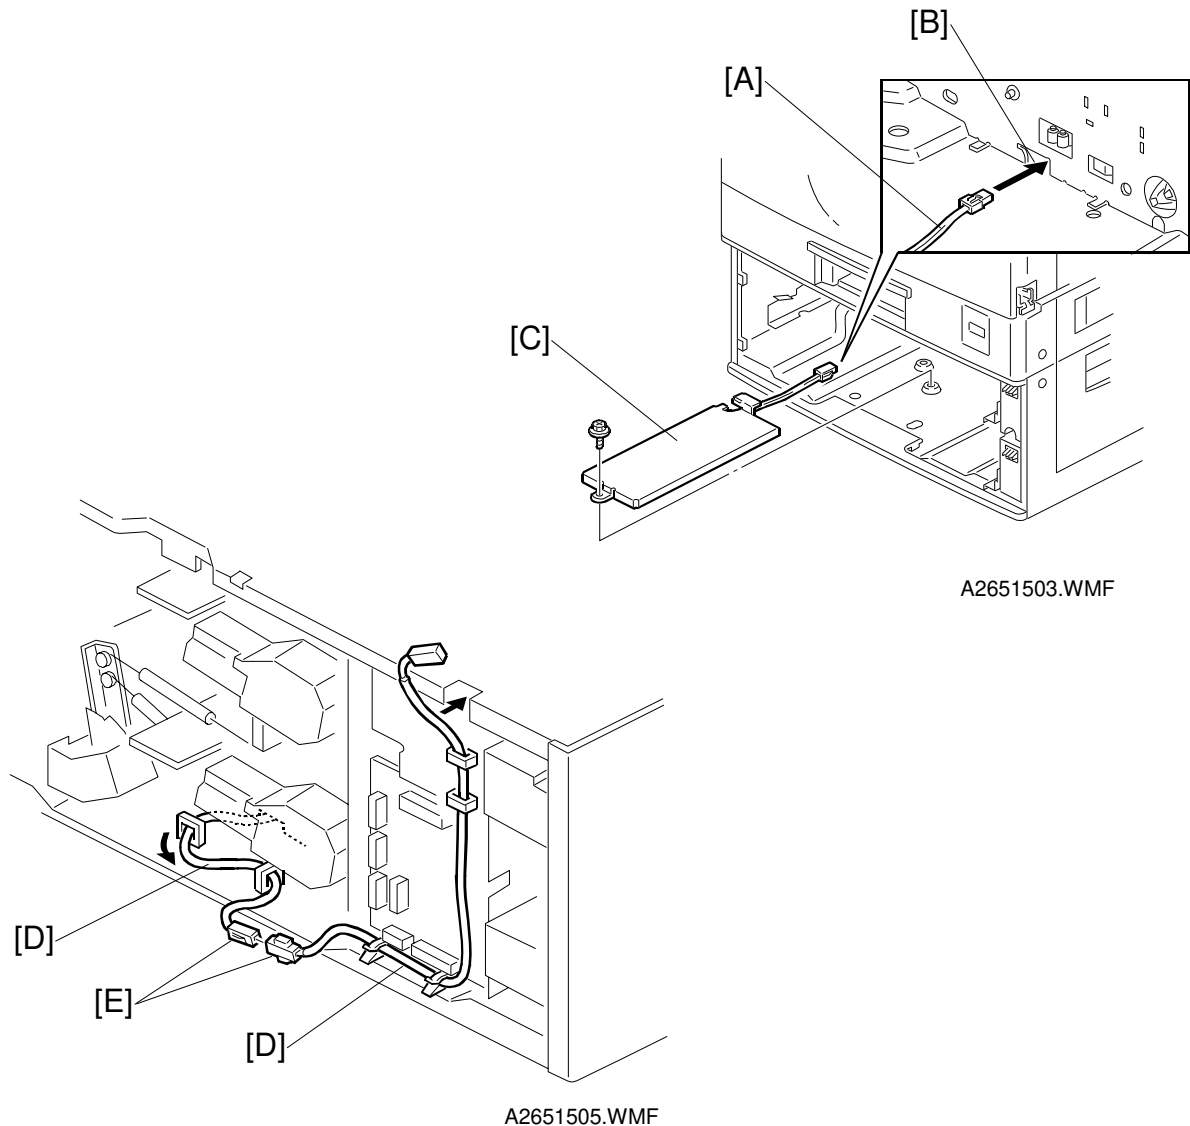
3. The call-outs and installation steps for the optional tray heater should be corrected as follows (P 3-46).

5. Slide out the two paper trays from the optional paper tray unit.
6. Pass the connector [A] through the opening [B].
7. Install the tray heater assembly [C] (1 screw).
8. Clamp the cables [D], as shown.
9. Join the connectors [E].
10. Reinstall the cable guide.
