Technical Bulletin

Model: Finisher SR3140/SR3150

Subject: How to adjust paper skew in stapled sets			Prepared by: E.Hinata		
From: 1st Tech Service Sect., MFP/P Tech Service Dept.					
Classification:	Iroubleshooting	Part informat	tion	Action required	
	Mechanical	Electrical		Service manual revision	
	Paper path	Transmit/rec	eive	Retrofit information	
	Product Safety	Other ()	Tier 2

Model: Model Met-C1			Date: 29-Jul-14		No.: RD686004	
Subject: Finisher SR3140/SR3150 staple misalignment (3mm or more)			Prepared	by: M.K	umagai	
From: 1st Tech Service Sect., MFP/P Tech Service Dept.						
Classification:	 ☑ Troubleshooting ☐ Mechanical ☑ Paper path ☑ Product Safety 	Part info Electric Transm	ormat al it/rec	tion [cive [) [2	Action Center Ce	required e manual revision it information

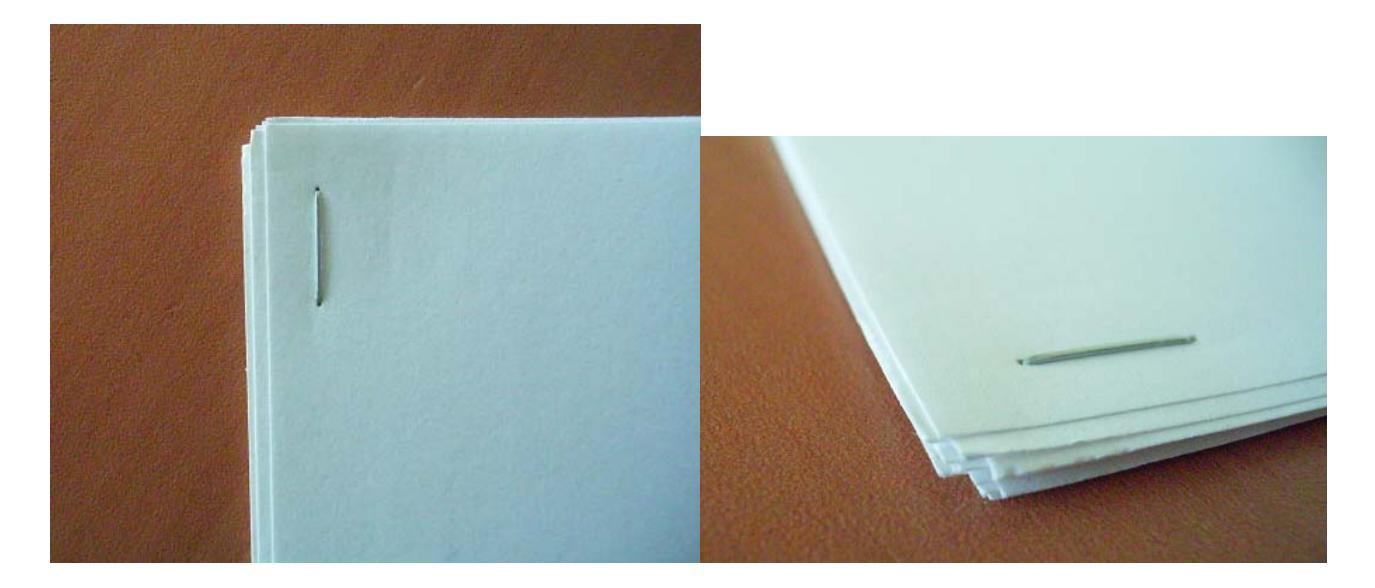
Stapled sets are skewed when using the SR3150 Booklet Finisher/SR3140 Finisher.

- 1. The pick-up roller does not pick up the paper correctly.
- 2. The paper falls far from the target position.
- 3. The leading edge of the paper is curled, and the resistance of the curled edge moves the paper out of alignment.
- 4. The jogger fence standby position is wider or narrower than the width of the paper.
- 5. The reverse roller may not move the paper all the way to the stopper on the staple tray.
- 6. The reverse roller may move the paper too much, causing the paper to buckle when it contacts the stopper.

Causes #1-3: Update the firmware to Ver. 01.130:04 or newer.

Causes #4: Do the Jogger Fence Adjustment Procedure below.

Cause #5, 6: Do the Reverse Roller Adjustment Procedure below.

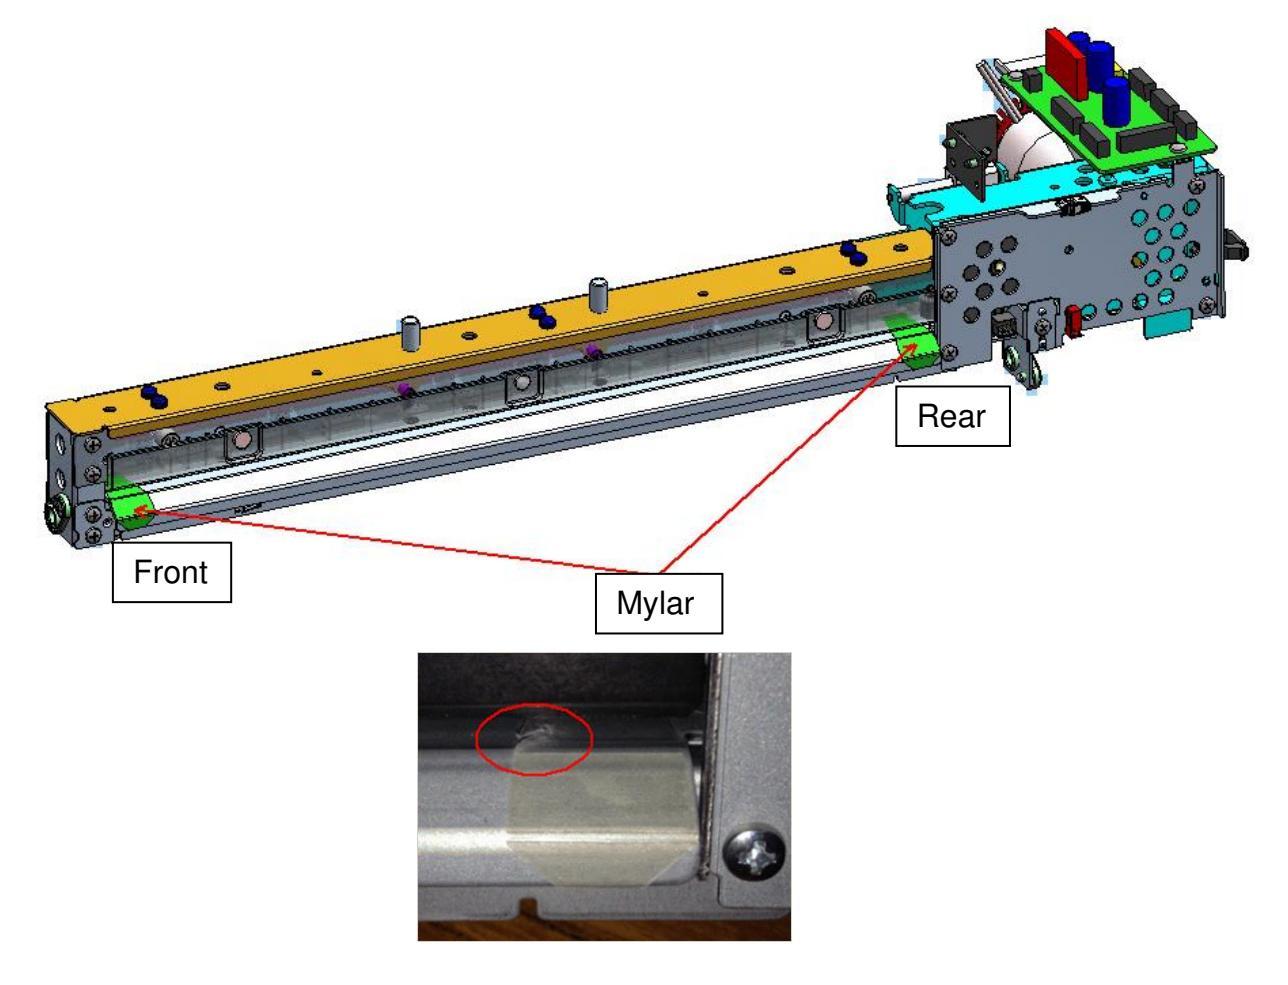
Jam 152

The paper may catch on the Mylar along the paper path inside the punch unit.

The Mylar has been deleted.

- Remove the punch unit from the machine
- Remove the two Mylars inside the punch unit (two different locations)

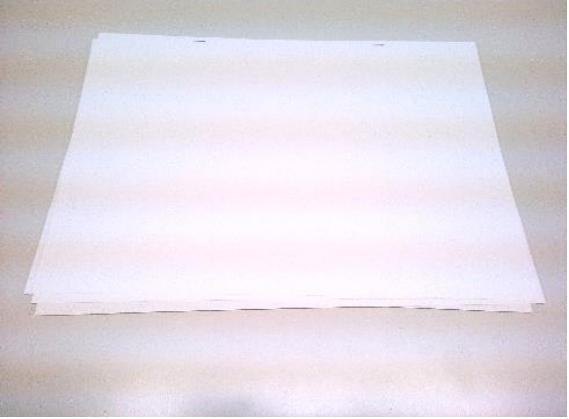
Sample:

Staple misalignment (3mm or more) occurs.

The side to side registration is not aligned when the paper is being transported to the finisher.

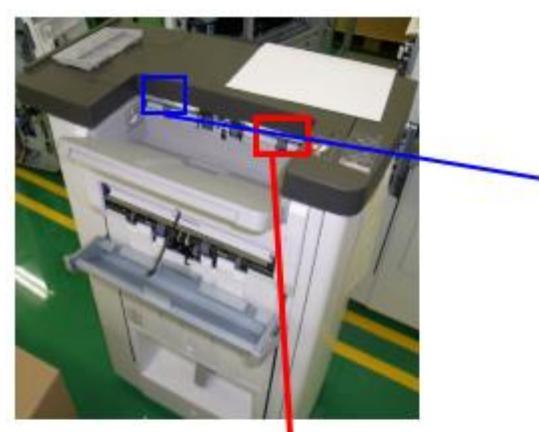
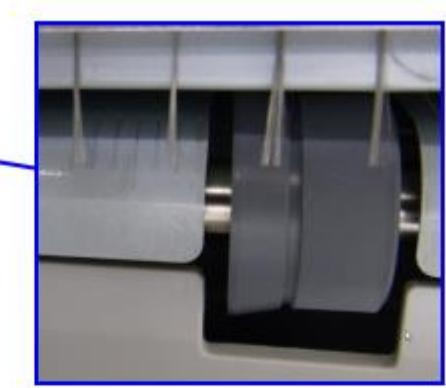
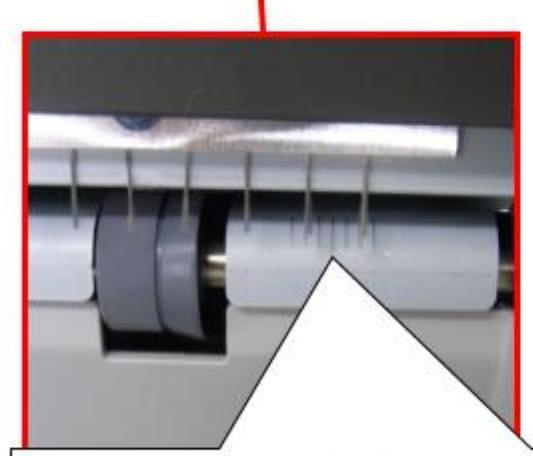
Make sure to use the markings on the FRONT exit rollers. The roller markings at the rear side are for DLT sized paper only, and do not apply to this

Each marking represents 2mm.+/

- 1. If the paper edge is lined up with the center marking, this means the paper is aligned correctly.
- 2. If the paper edge is lined up with any marking to the right of center, this means the paper is shifted toward the front.4
- 3. If the paper edge is lined up with any marking to the left of center, this means the paper is shifted toward the rear.4

- 4. If the machine has an additional marking (Gridline):
 - Using the markings on the front-most exit roller (see the photo below), check to see where the paper edge is located when the paper is fed out. For purposes of accuracy, print out about 5 sets.

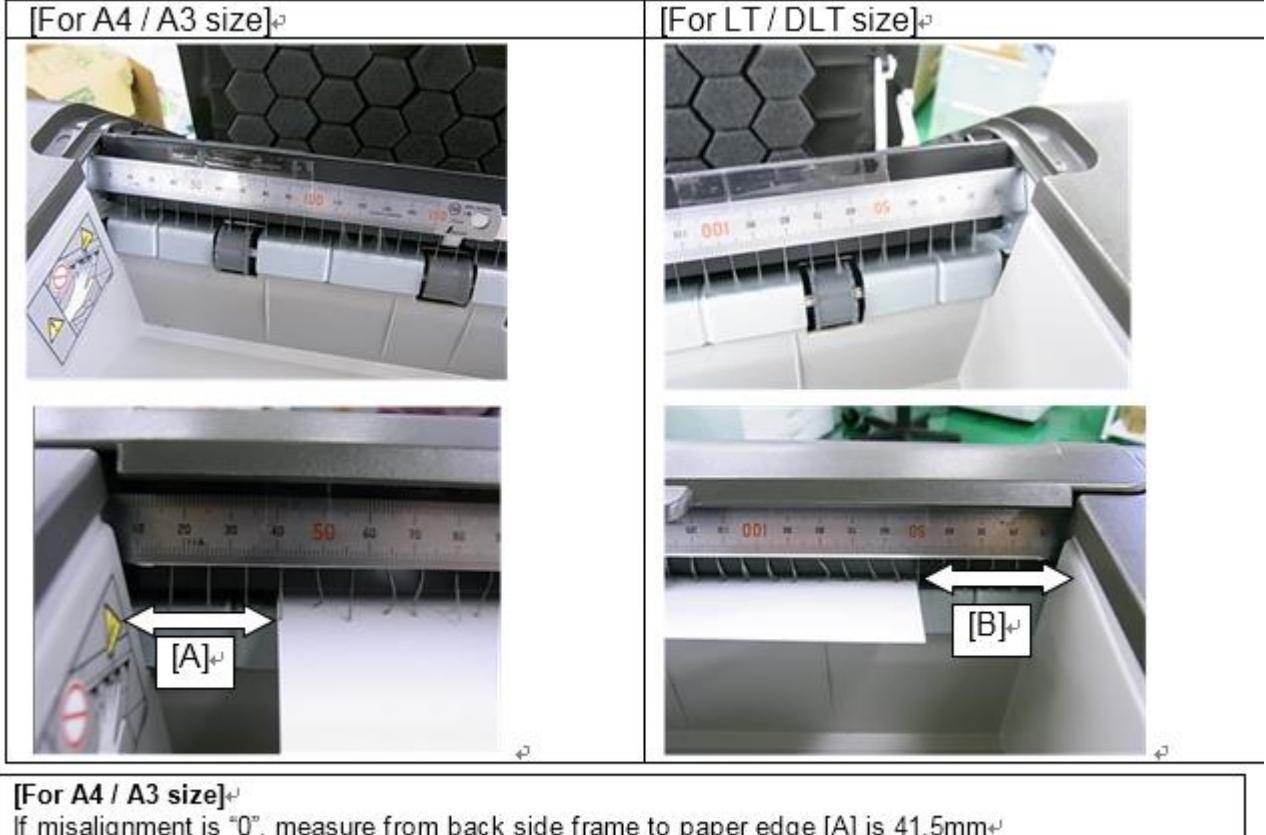
- If misalignment is "0", measure from back side frame to paper edge [B] is 50.3mm+
- 6. If the paper shifts forward (toward the operator side), slide the docking bracket by the same amount in the same direction. (This is to move the Finisher toward the operator side).
 - **Note:** If the machine already has the additional marking (Gridline), each scale marking represents 2mm.

5. If the machine does **NOT** have the additional marking: Using the scale (see the photo below), check to see where the paper edge is located when the paper is fed out. For purposes of accuracy, print out about 5 sets.

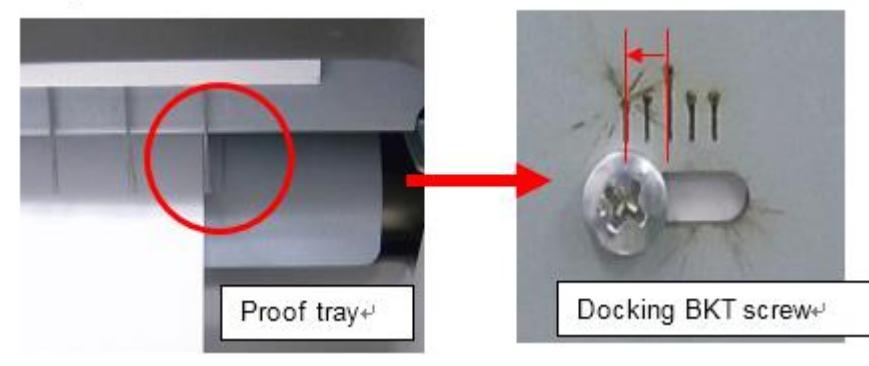
Ex: Paper is shifted 4mm from center toward the front +

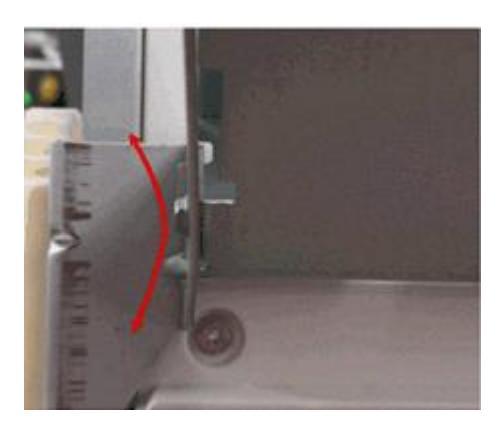
SC721 (Tray Lift Motor Error) occurs on the SR3140/SR3150 finisher.

There is a difference in level on the frame of the side plate tray. If the screw is tightened too tightly, the side plate may deform.
