Technical Bulletin

Model: Shepherd-P1

No.: RJ093003

Subject: Changed the installation procedure for installing the proximity sensors.			Prepared by: Y.Kurohashi		
From: 1st System Business Promotion Section, System Business Department					
Classification:	 Troubleshooting Mechanical Paper path Product Safety 	Part informat Electrical Transmit/rec Other (tion eive)	 Action required Service manual revision Retrofit information Tier 2

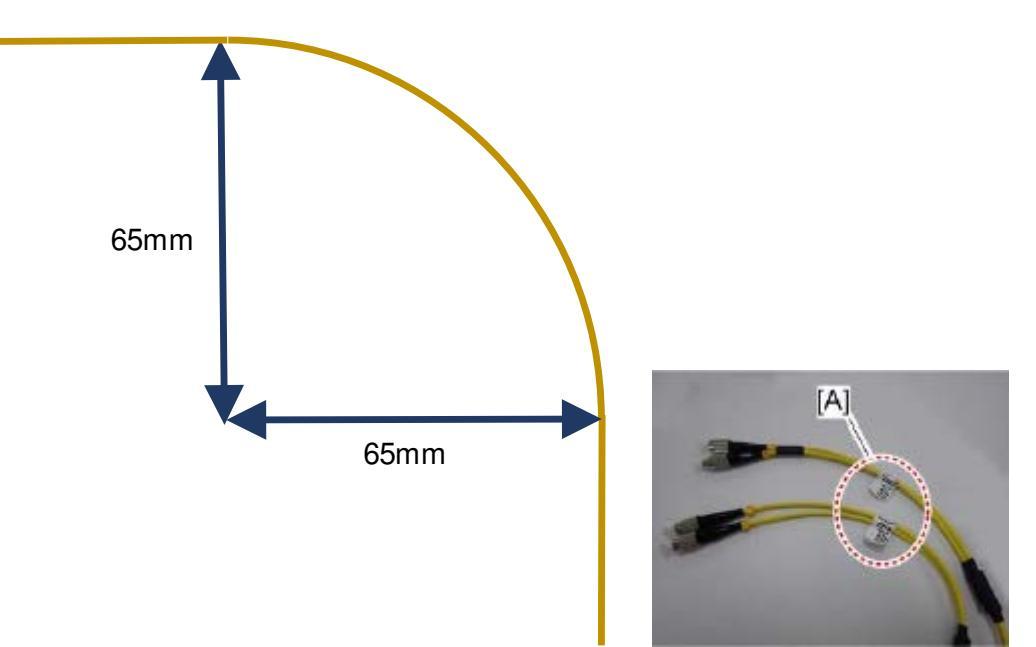
Make sure not to curve the optical fiber cable sharply shown below. If you do it, the fiber cable will be broken.

DO NOT curve the optical fiber cable within 65mm radius.

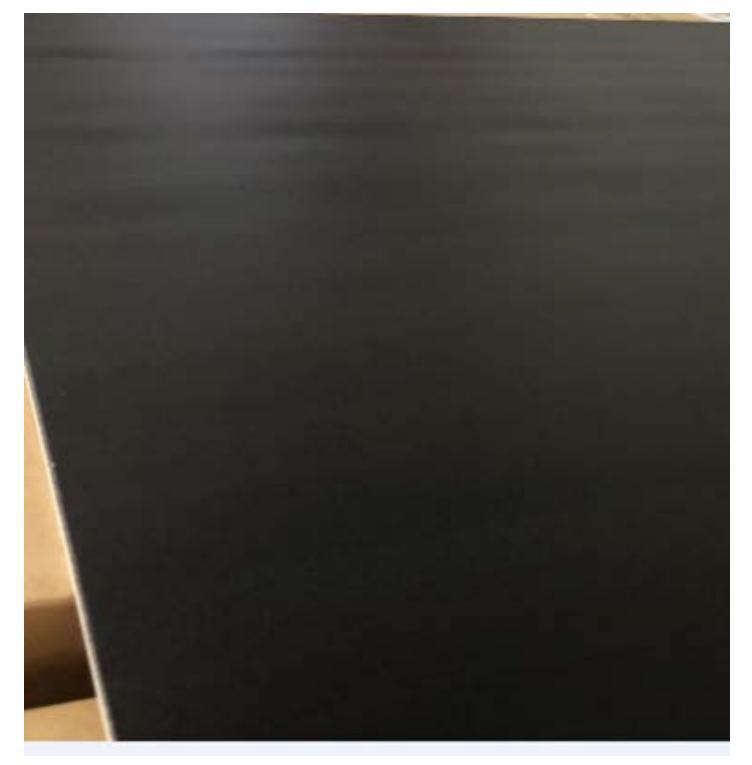
These modes are useful to reduce banding image like below photo.

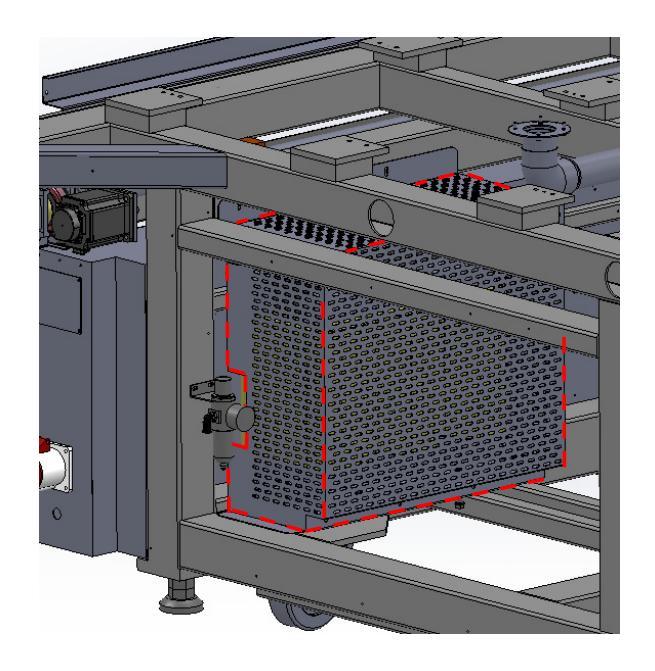
There is a transformer unit at following position. The transformer converts the voltage from 220V to 380V. Though transformer unit is covered with metal gauze illustrated in red frame below, please observe following precautions when working near there.

• <u>Make sure to turn off main power switch and disconnect the power supply</u> <u>cable from the machine</u> before starting work.

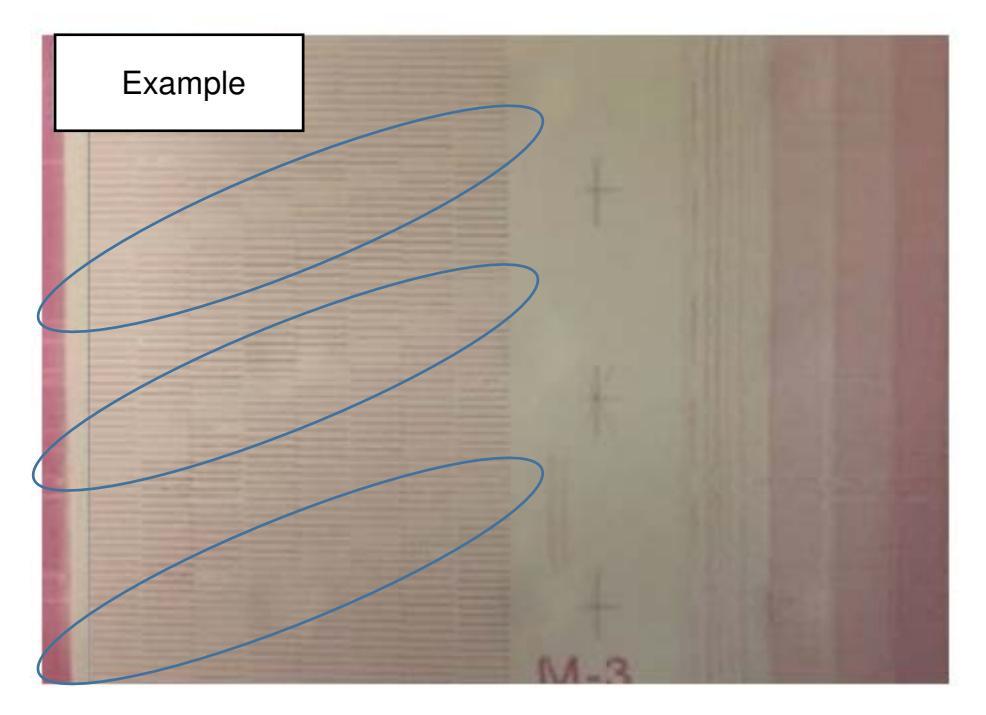
Ink ejection from print head is available but printing result is not stable. When printing 'Print status' pattern, unstable image is printed like following photo.

Conduction failure between carriage board to print head. The conduction failure may have caused less communication at printing data.

- 1. Disconnect and reconnect the cables and connectors on print head, head amplifier board and carriage board.
- 2. Replace the head amplifier boards with new one.
- 3. Replace the carriage boards with new one.

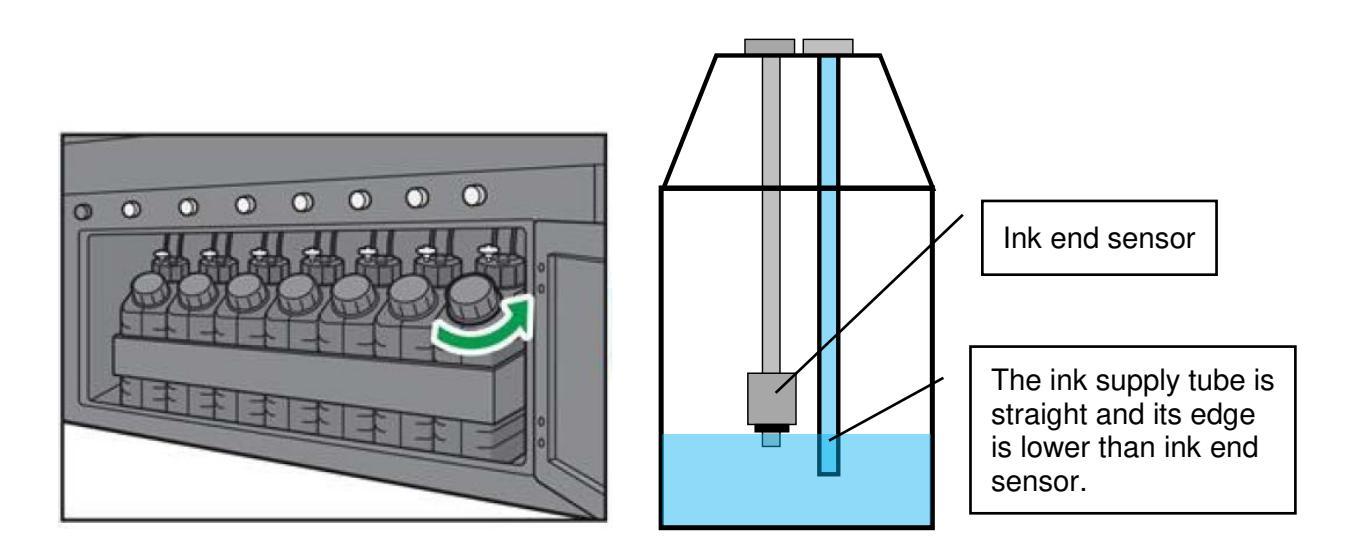
- 1. Whether the edge of the tube is placed lower position than ink end sensor.
- 2. Whether the ink supply tube is straight.

- 1. Check the points from ink filling port after removing caps.
- 2. Straighten out the kink of tube, or cut it to the correct length, or replace it with correct length one.

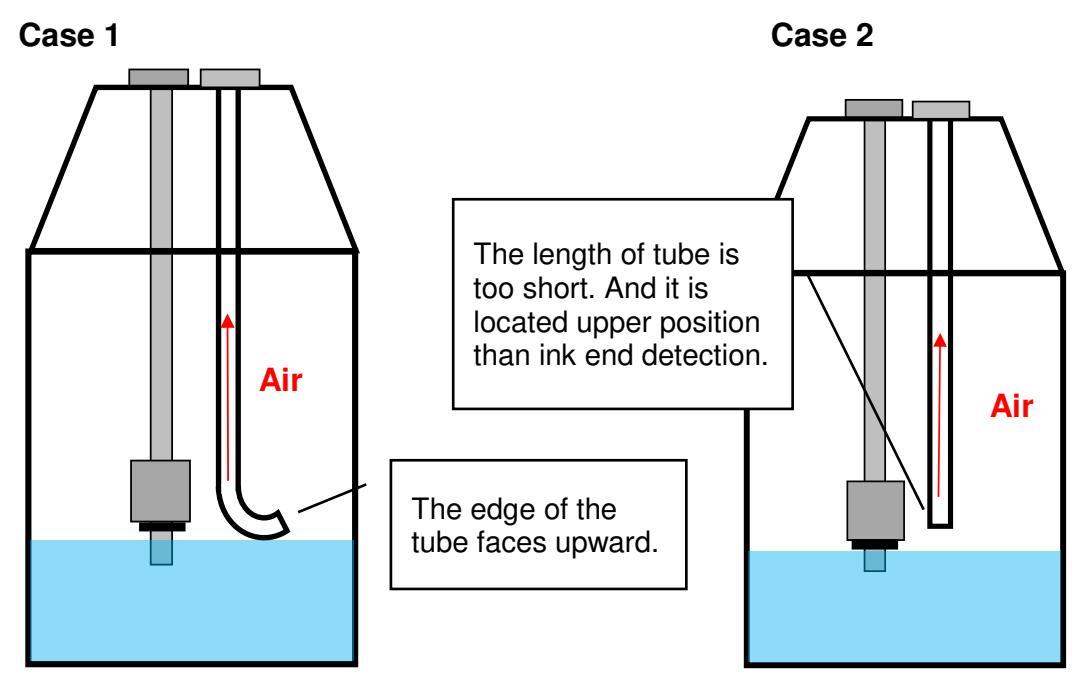
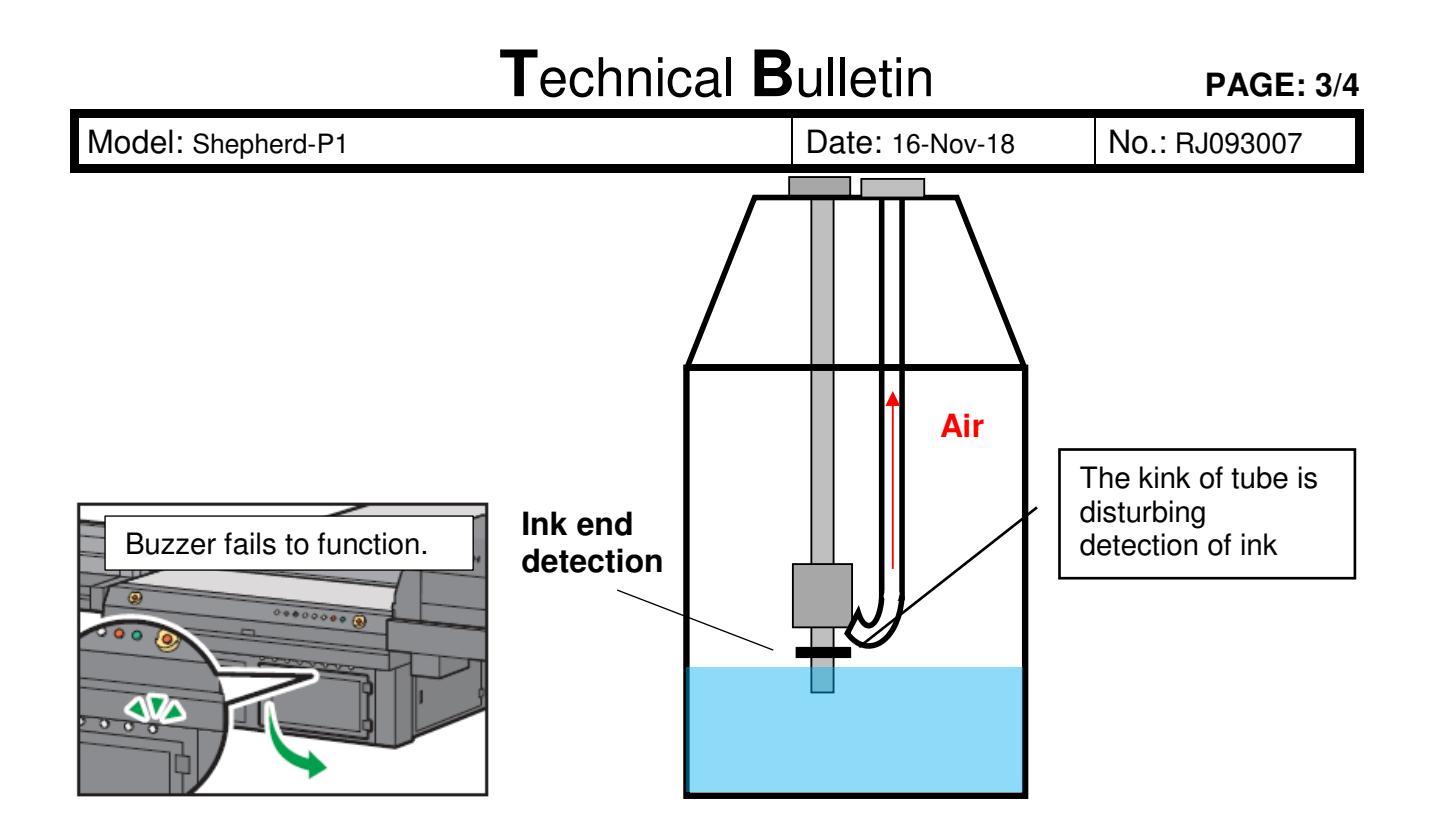
No good cases

If ink tube is not correct position, the air will be supplied instead of ink or ink is not supplied correctly. The air will be supplied instead of ink when ink surface is below the end of ink supplying tube. When air is in the ink supplying tube, the air may cause nozzle clogged or flowing inks into the air tube by negative pressure broken. The following cases are not good.

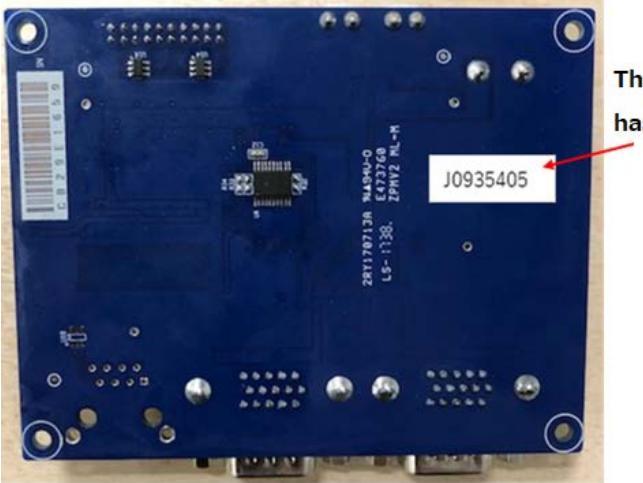
The improved Interface Board has a seal numbered "J0935405".

So please replace the current Inter Board(J0935404) with J0935405.

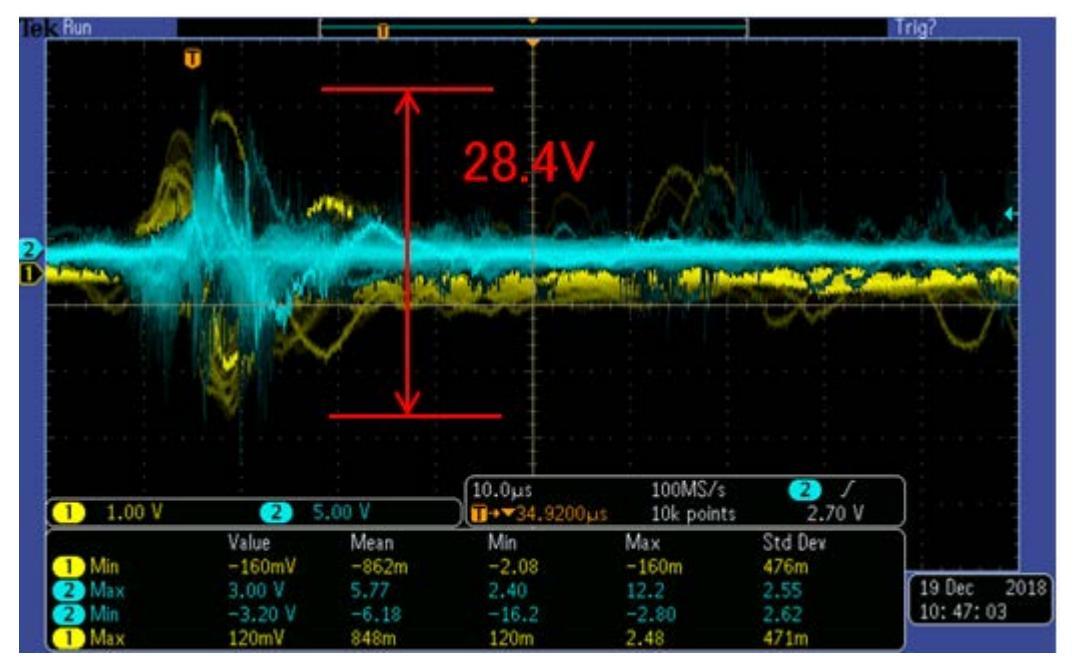
So this issue may occur in the environment where the earth potential is not stable.

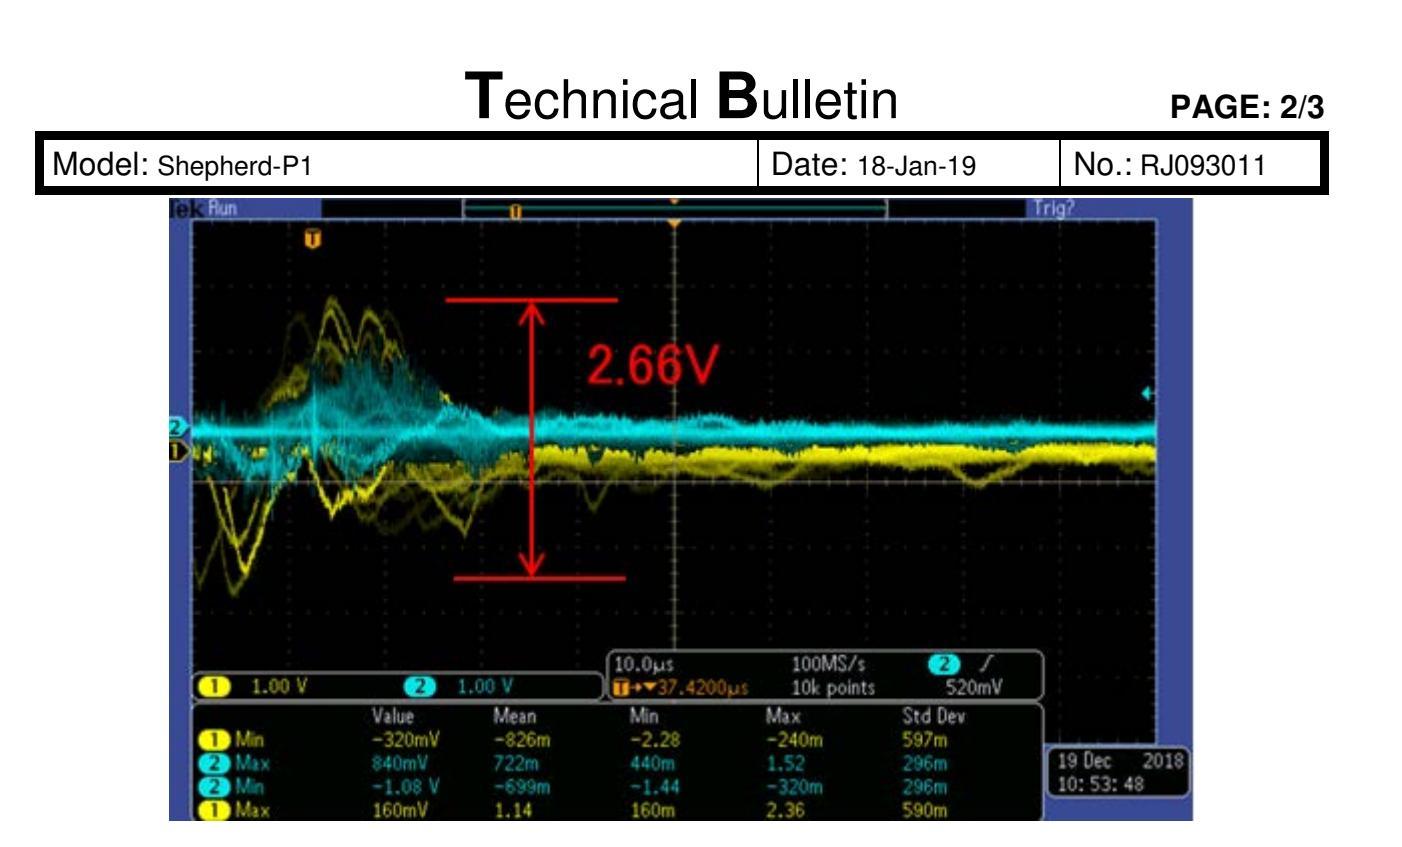
Connecting the PC's GND and T7210's GND directly with a wire cable lowered the difference to 2.66[V] in RPL, which resolved the USB error issue.

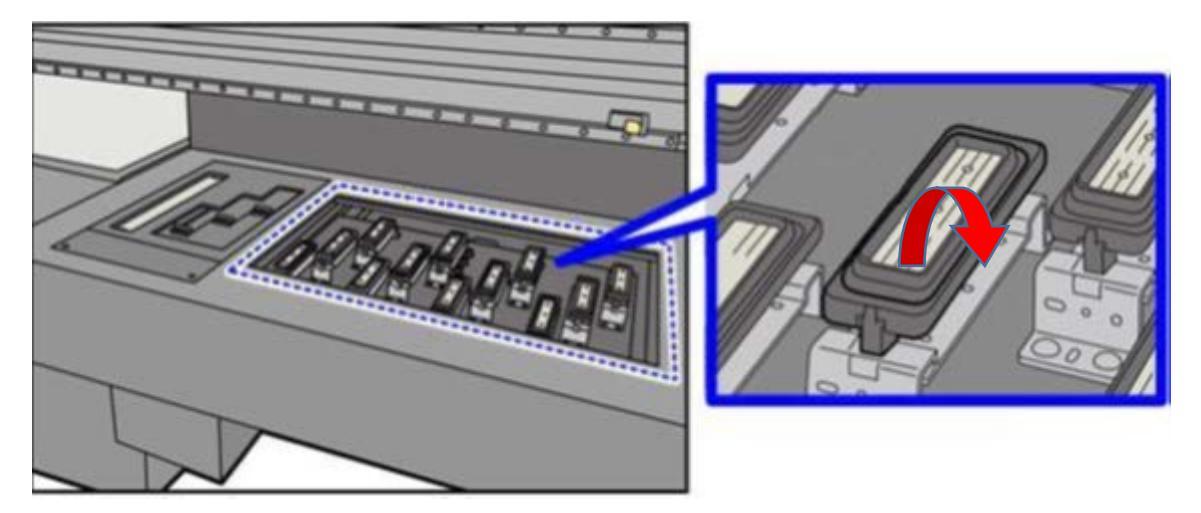
Caps may be out from capping unit.

If the capping operation is performed with the cap is out from capping unit, the print head may be damaged.

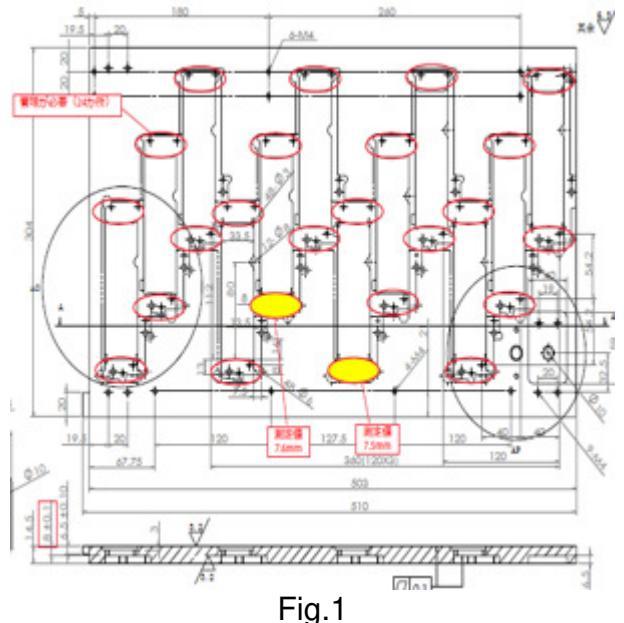
Phenomenon that the nozzle surface of the print head rubs against the media and causes nozzle clogging.

Excessive excavation of the head installation surface of the head plate makes it easier for the nozzle surface at the red circle in the figure below to come into contact with the media and rub it.

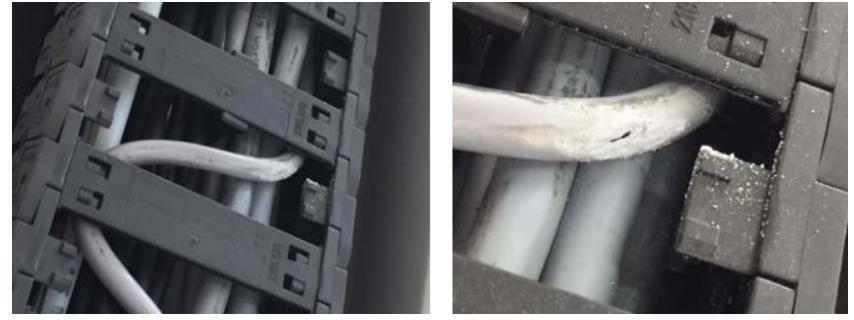
A cable in the main scanning cable bearer was damaged in one Ricoh Pro T7210 machine.

So one of the cables which length was too long was bent, and contacted the edges of parts in the cable bearer, which caused the cable to be damaged.
