# RIGOH

# Technical Bulletin

Model: EMP156		Date: 22-Nov-05		No.: RG155001	
Subject: Firmware Release History (Controller)			Prepared by: N. Sakamoto		
From: 2nd Tech. Support Sec. Service Support Dept					
Classification:	Troubleshooting	Part information Action require		n required	
	Mechanical	Electrical		Servic	ce manual revision
	Paper path	Transm	it/rec	eive 🗌 Retro	fit information
	🔀 Other ( )

This RTB contains the software release history for the Controller.

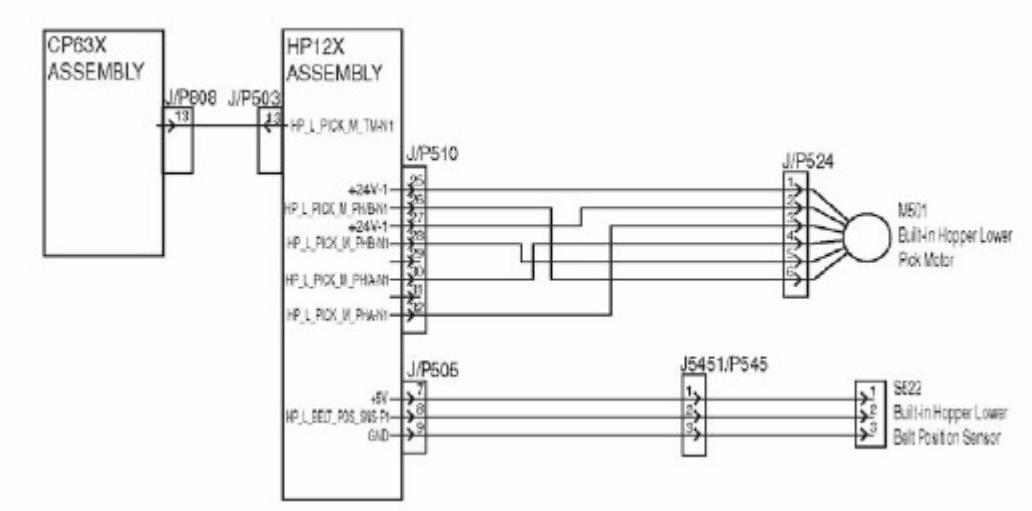
Figure 5-223. Error Code E372

7. Pick Belt is not assembled correctly. (Pick Belt slip off)	Repair: Pick Belt	7.6.1.57, 7-446				
	8. Hex Socket Set screws of Pulley Assembly are loose. *1	Check: Pulley Assembly	7.6.1.58, 7-447				
*1 Turn Pick Belt in fror	nt and back and check the wobble	of the Pulley Assembly.

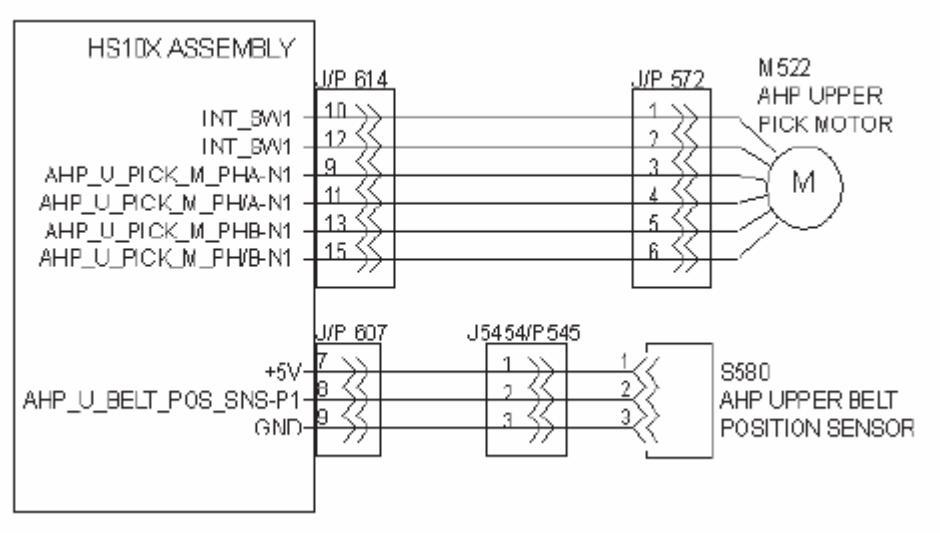
Figure 5-229. Error Code E37B

7. Pick Belt is not assembled correctly. (Pick Belt slip off)	Repair: Pick Belt	7.8.2.11, 7-604
	8. Hex Socket Set screws of Pulley Assembly are loose. *1	Check: Pulley Assembly	7.8.2.7, 7-600 7.8.2.8, 7-601
*1 Turn Pick Belt in fro	nt and back and check the wobble	of the Pulley Assembly.

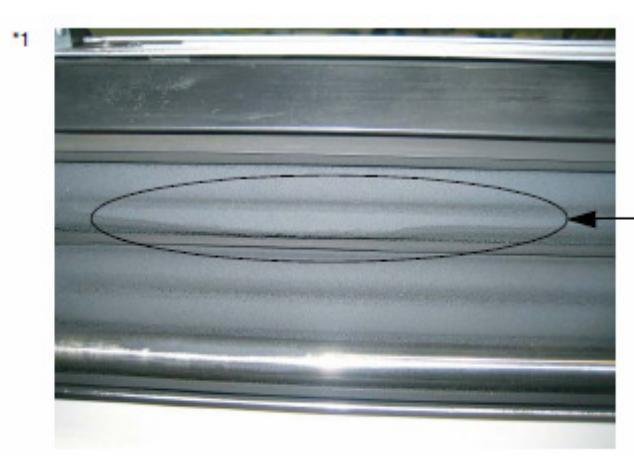
OVERFLOW OF THE DEVELOPER MIX

5. Overflow of the Developer mix. *1	Adjustment of the magnetic pole angle. Replace the Developer Unit Assembly.	5.3.123, 5-319 7.2.4.1, 7-101
6. The carrier remains in the form running part.	After the above Nos. 1 to 4 are treated, the remaining carrier is cleaned. (Regist Roller exit, the neighborhood of the Transfer Unit, Pressure Roller and Feed Roller, etc.)	4.4.2.3, 4-38, etc.,
