Technical Bulletin

Model: R-G1

No.: RJ018001g

Subject: Firmware Release Note: Engine/Controller			Prepared by: Y. Murata
From: 3rd Tech Service Sect., MFP/Printer Tech Service Dept.			
Classification:	Troubleshooting	Part information	Action required
	🗌 Mechanical	Electrical	Service manual revision
	Paper path	Transmit/receive	Retrofit information
	Product Safety	Other (Firmware)	🖾 Tier 2

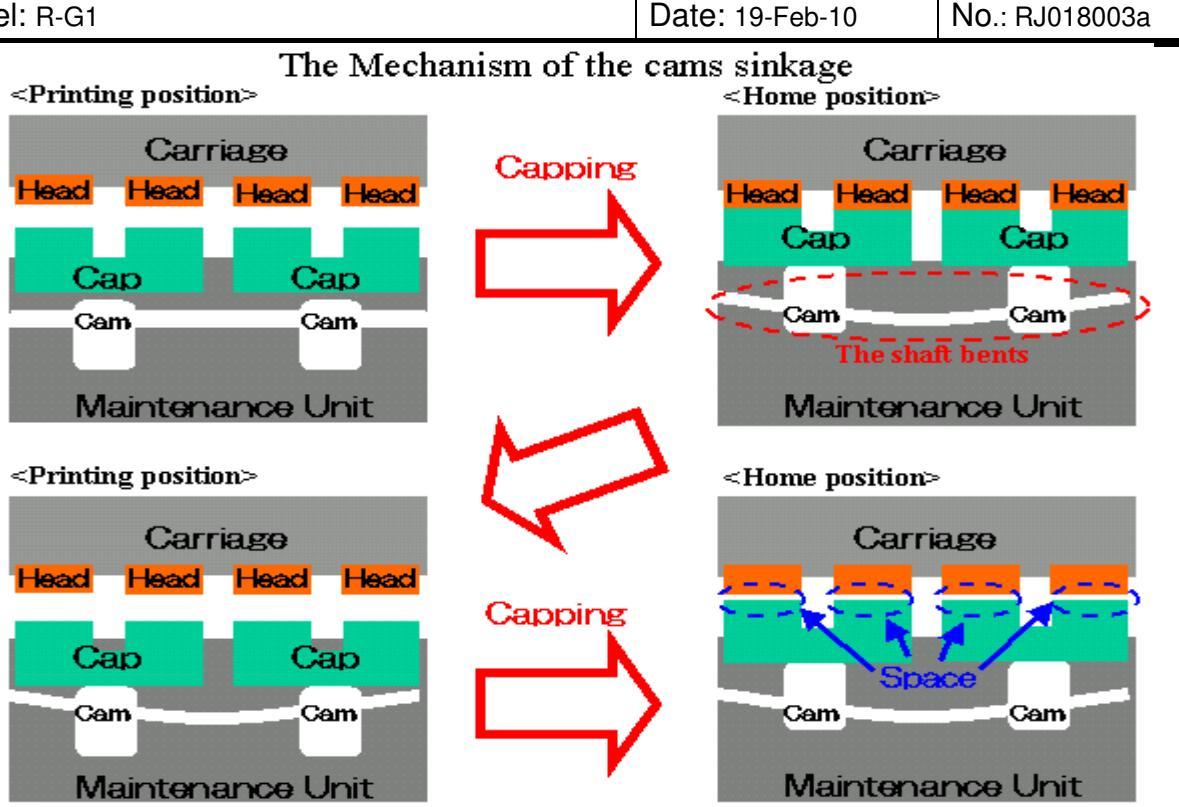
1. The cams in the maintenance unit sinks

As the capping process for the carriage heads is repeated over time, the camshaft on the maintenance unit bends slightly. If the carriage position lever is left in the envelope position when the machine performs the maintenance tasks mentioned above, a gap develops between the carriage heads and caps on the maintenance unit. Please see the diagram below for the mechanism:

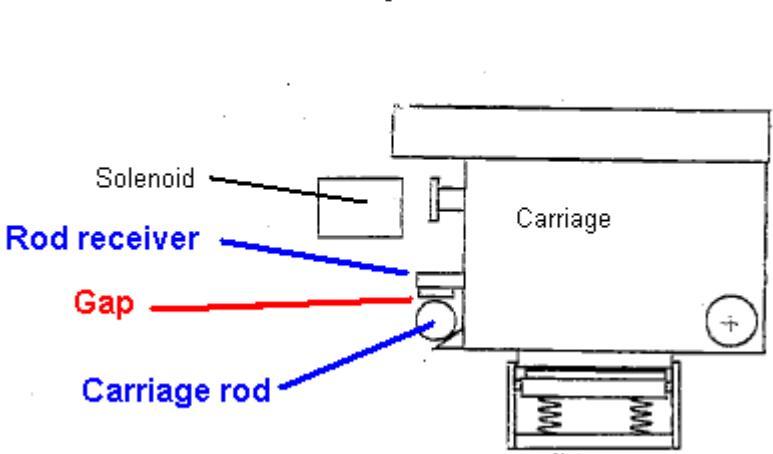
Home position

2. The carriage unit rattles

As shown in the diagram below, when the carriage unit is in the home position, a gap develops between the rod receiver on the carriage unit and the carriage rod. This makes it easy for the carriage unit to rattle, which can cause a gap to develop between the carriage heads and caps on the maintenance unit.

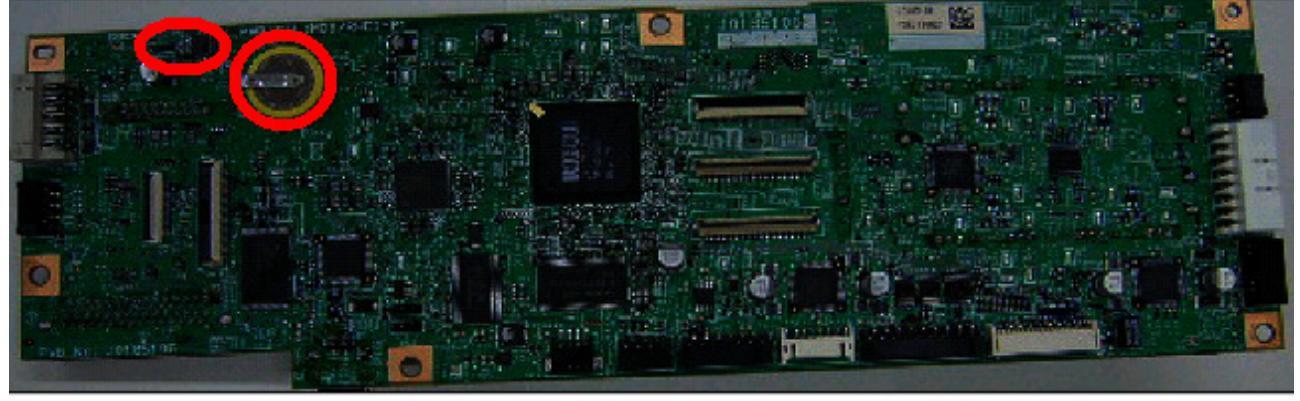
Parts side

• When you replace the controller board, **DO NOT touch the areas circled in red below directly or with anything metallic.** If you do, *SC974* (RTC* malfunction) may occur.

• If SC974 occurs, turn the main power OFF/ON. If this does not clear the error, replace the controller board.

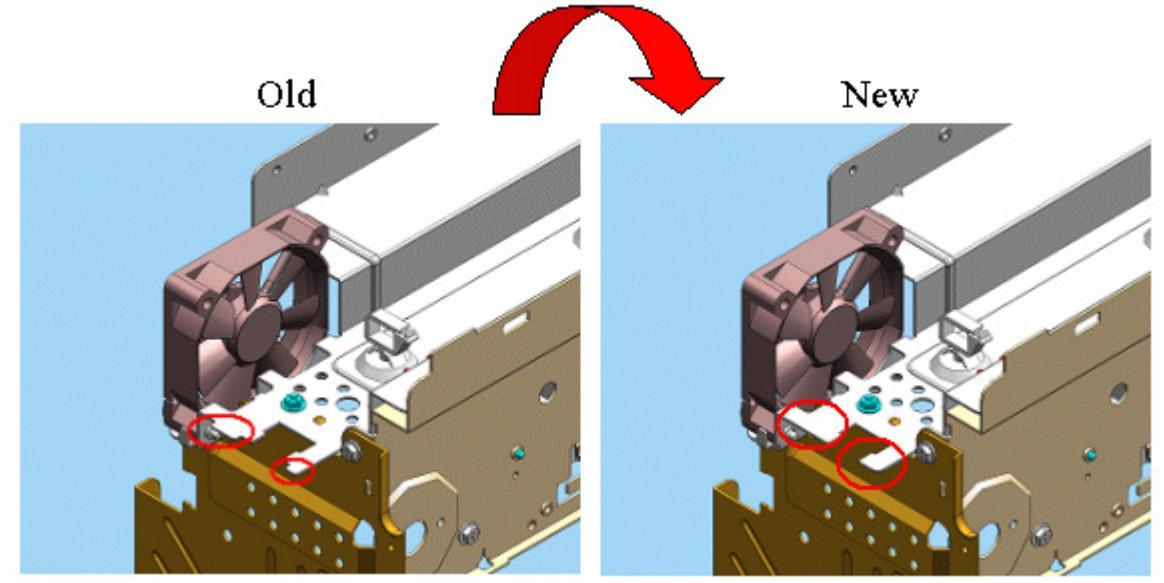
BRACKET: PCB: CONTROL

The small tabs on the tip of the bracket were removed.

- 1) The shape of the left cover was changed.
- 2) The bracket for the PCB was added as a service part. **Note:** The shape of the bracket was changed as shown in the illustration.
- **Reason:** To provide further protection against shock and vibration during product shipping.
- **Important:** If you need to replace the cover on a machine produced before the cut-in serial numbers (see below), install the new cover and PCB together as a set.

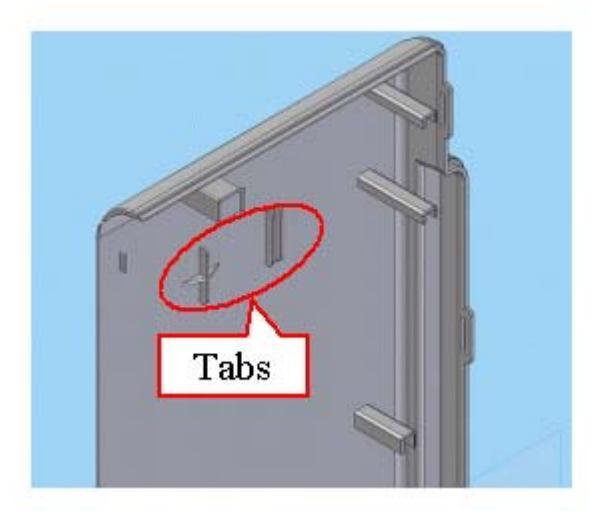
COVER: LEFT: MOS-P1: EU Tabs were added.

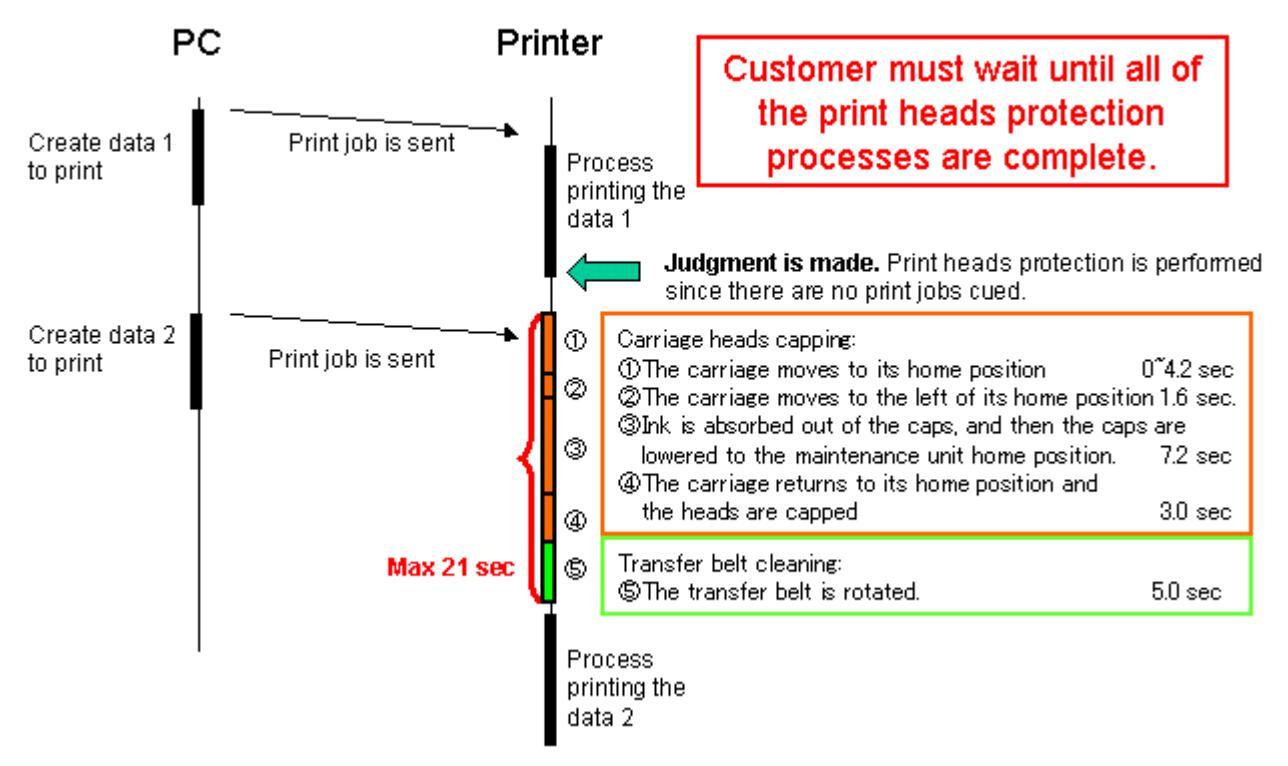
The waiting time between jobs increases (maximum 21 seconds) if the machine receives a new print job just after finishing the current job.

The machine performs "Print-heads protection maintenance" after completing a print job. This involves performing several operations (please see the diagram below for each operation). Therefore, the customer must wait until all the operations are complete.

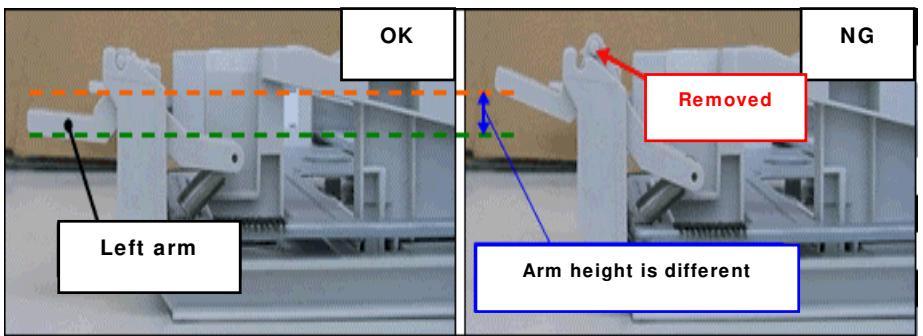
The trailing edge sensor is broken, which triggers a paper feed jam.

This sensor can be damaged if the cassette tray is loaded with the left arm unseated. When the tray is dropped, the base plate hits the arm, which then the arm becomes unseated).

- Replace the trailing edge sensor.
- Make sure that the left arm on the cassette tray is correctly attached before inserting the tray.
- Replace the cassette tray and the left side fence to the modified ones mentioned above.

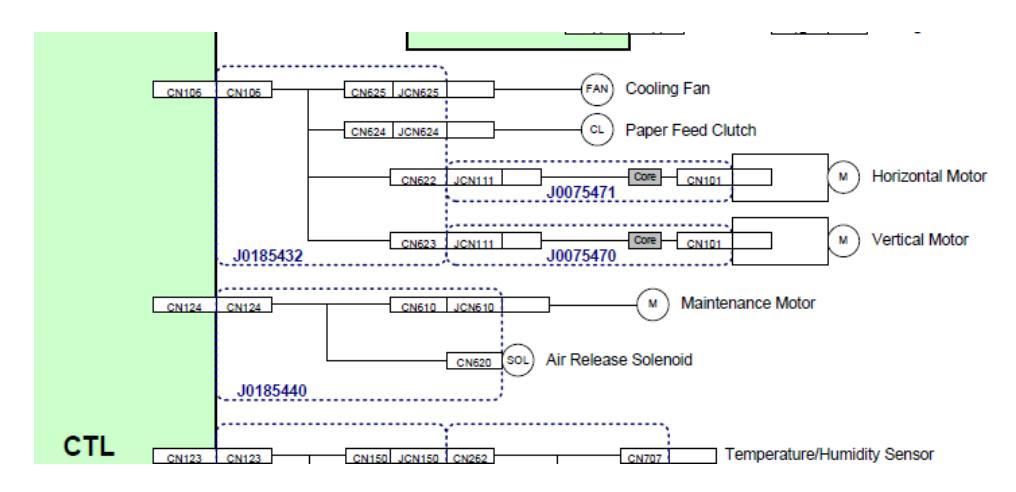
The harness for the main motor (P/N J0075471) touches the fan.

- The J0075471 harness was deleted.
- The length of the J0185432 harness was changed and a binder has been added around the core of the harness.

Make sure to replace the harness with modified one (J0185433).

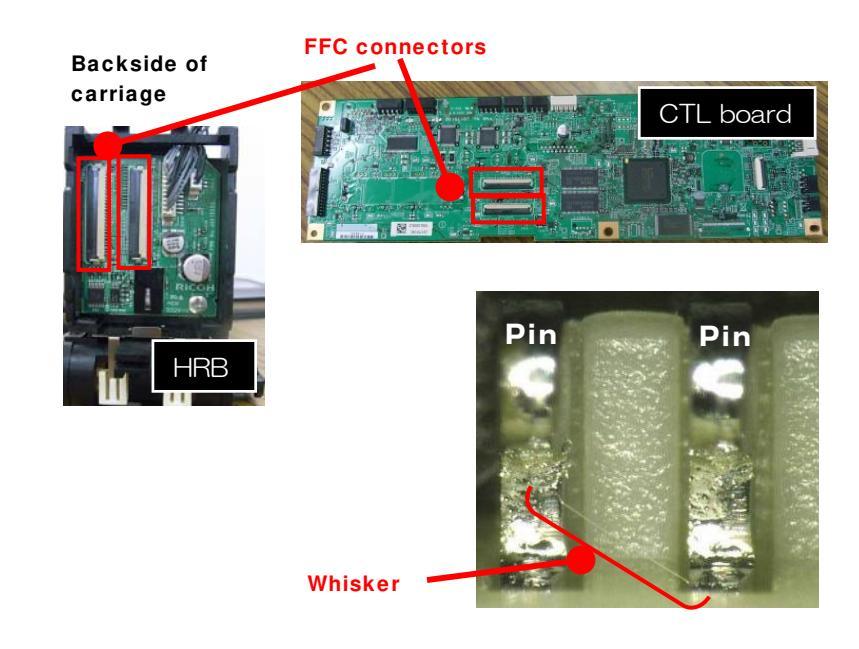
The FFC connector pins are short-circuited, causing a paper misfeed or abnormal temperature condition to be mis-detected.

The short circuit occurs when a metallic fiber (whisker) attaches itself so that it connects the pins at the FFC connectors, which are located on the controller board and the rear side of the carriage unit.

Remove the FFC from the two main PCB connectors, and then reconnect them. If the symptom still occurs, do the same for the carriage PCB connectors. *Otherwise, please replace the modified parts mentioned above.*
