Technical Bulletin

Model: Andromeda-P2		Date: 6	Jun-18	No.: RM0B1001
Subject: SP modification to change special characteristic v of the TIM-RED/MAG unit shading plates		ristic values	Prepared b	9 y : Hiroaki H Matsui
From: PP Tech Se	rvice Dept., 1st PP Tech Service S	ect.		
Classification:	□ Troubleshooting □ □ Mechanical □ □ Paper path □ □ Product Safety □	Part informa Electrical Transmit/rec Other (tion ceive) X	Action required Service manual revision Retrofit information Tier 2

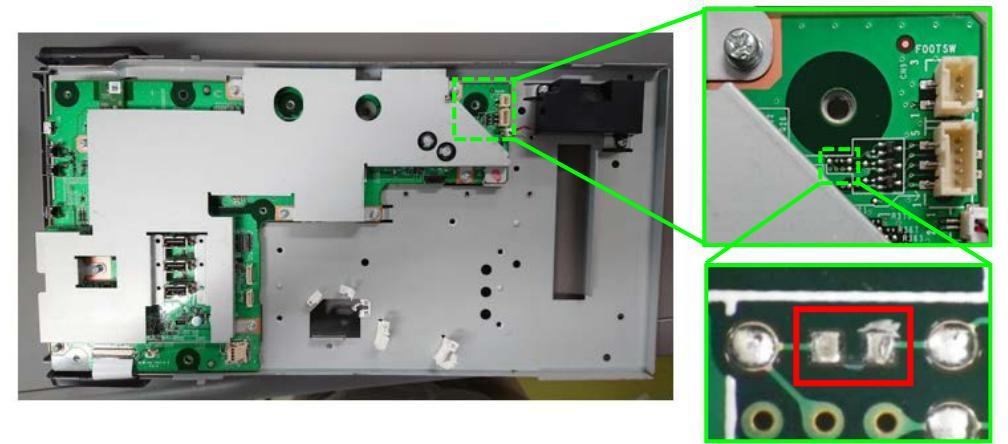
When attaching the rear cover of the operation panel the projection on the cover presses and breaks the resistor (squared in red below) for the blue LED.

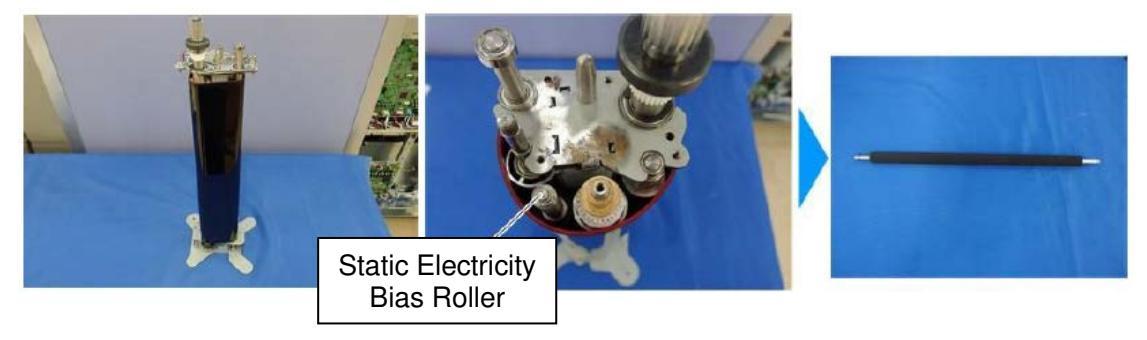
The surface of the Static Electricity Bias Roller (p/n: M0B16344), which is made of sponge, is adhered with sponge residues, because the process to remove the residues after smoothening the surface of the roller was falsely left out in the production line.

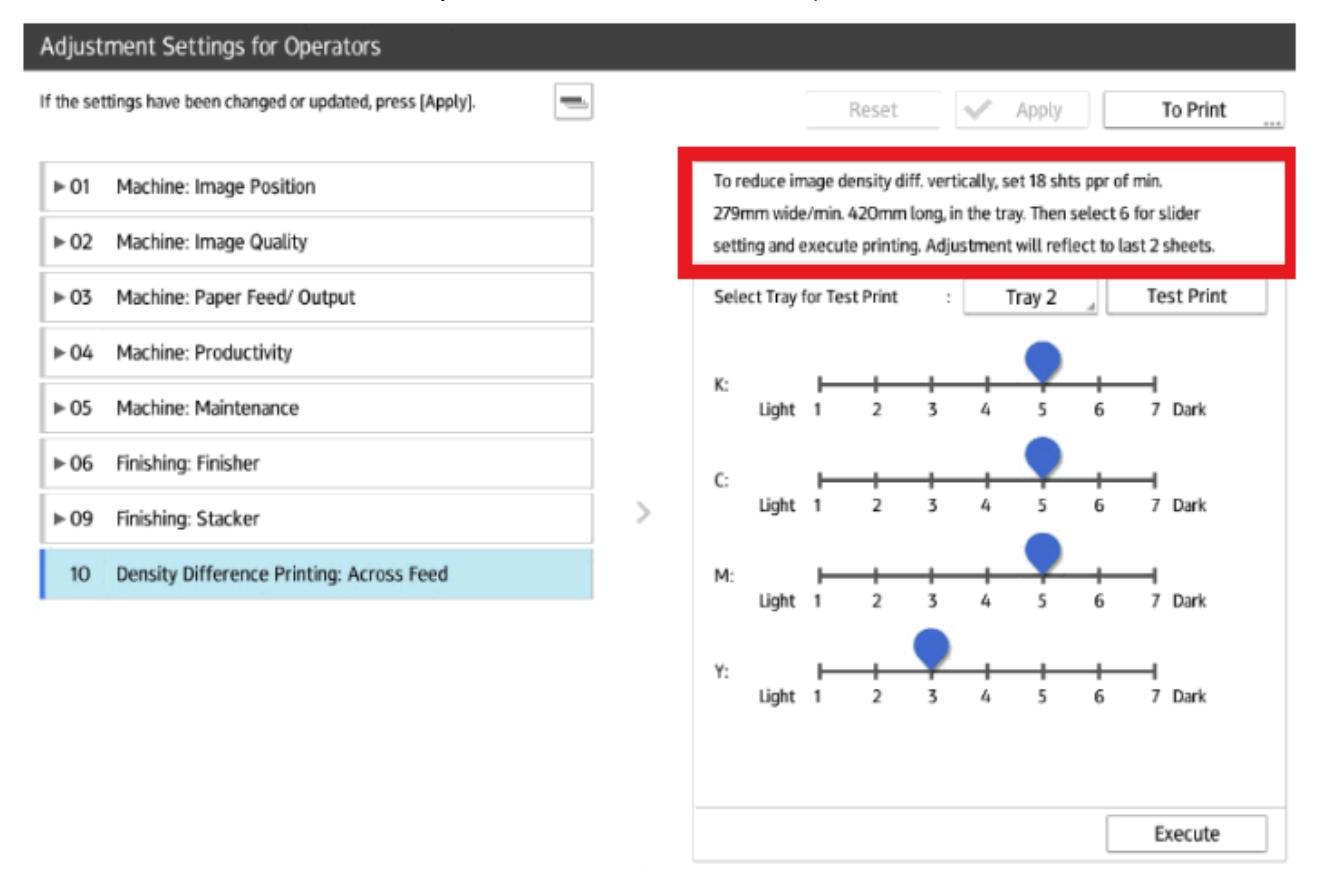
The explanation about the **[Density Difference Printing: Across Feed]** function that appears on the operation panel shows incorrect recommended values. (The explanation is of Leo-C2/P2 which is also implemented of this function.)

The recommended value for K/C/M/Y is described as '6' (while the illustration of the slider bar shows 5 and 3).

The recommended values are as follows: '5' for K/C/M, '3' for Y, which are also default values.

- 1. The incorrect description will be deleted from the explanation in the updated firmware, which is <u>scheduled for release in Oct, 2018</u>.
- 2. The explanation provided in the 'Notes for Users' document is described of the correct recommended values, as follows:

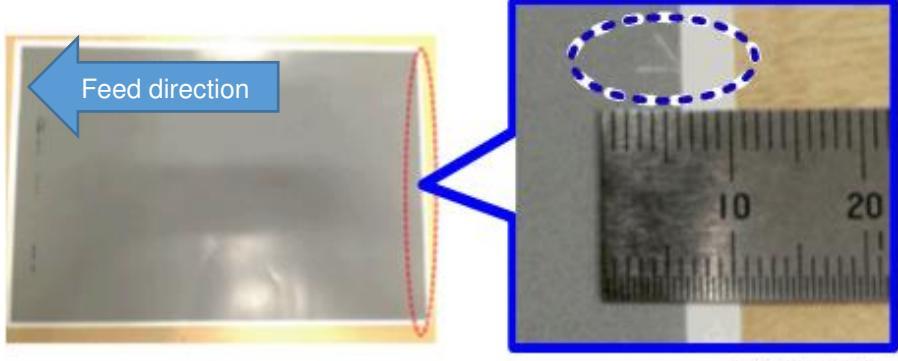
m0b2d6971

In duplex jobs, unprinted white marks in the shape of bird footprints appear within 10 mm from the trailing edge on the back side.

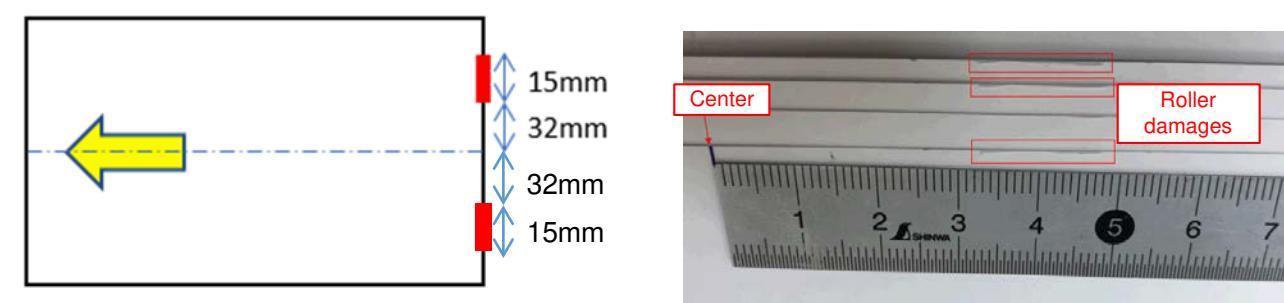
The trailing edge of banner sheets is curled and damaged by the transport rollers when printed from the Vacuum Feed Banner Sheet Tray Type S9 or Multi Bypass Banner Sheet Tray Type S9.

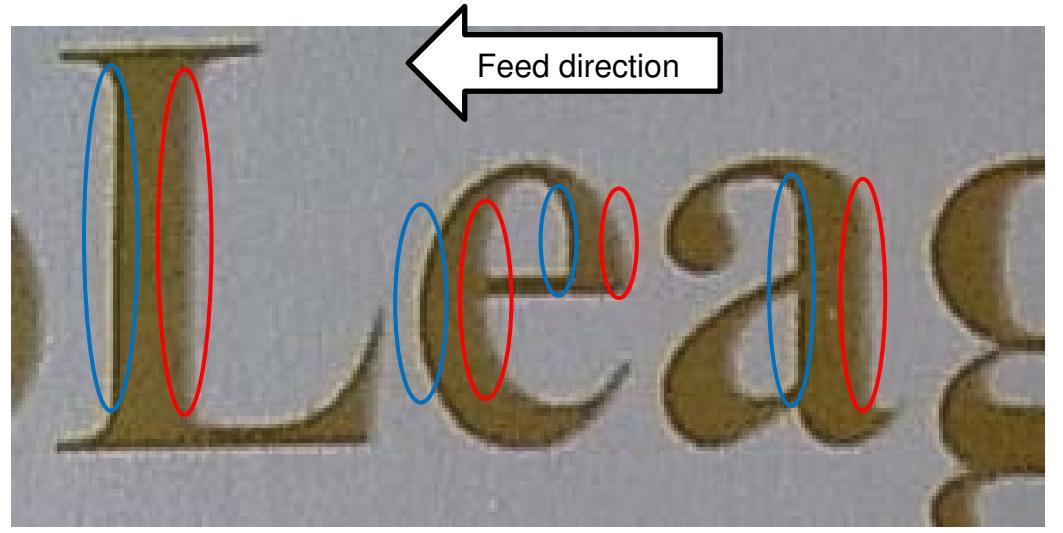
The edges toward the trailing side of halftone texts appear blurry.

The edges toward the trailing side (affected) are circled in red and leading side (unaffected) in blue.

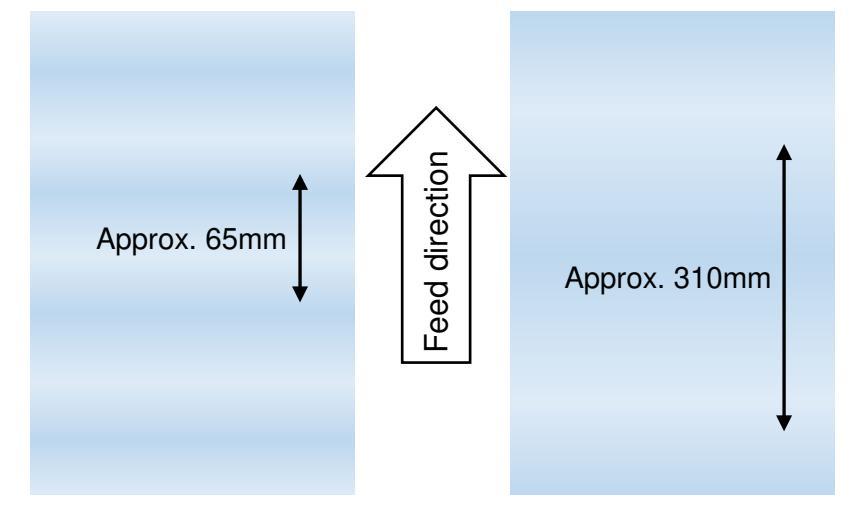
Bands across the feed direction appear in 65mm or 310mm pitch, which correspond to the circumference of the development roller and drum.

NOTE: The symptom tends to occur in low-temperature/humidity environment.

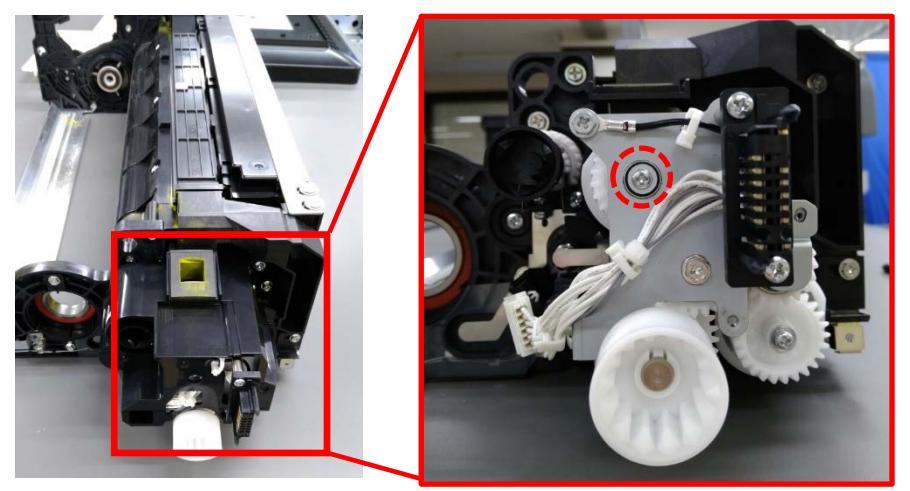
DEMS/DSC may be malfunctioning due to noise generated from the development drive sensor. To eliminate this possibility, grease the screw circled in red below at the rear side of the PCDU, which fixes the auger screw.

- For the procedure on how to access this screw, see the following section of the FSM: Replacement and Adjustment > Around the Drum > Developer Replacement > Development Drive Sensor
- Make sure to use the following grease and apply it along the <u>entire periphery of the</u> <u>screw</u>.

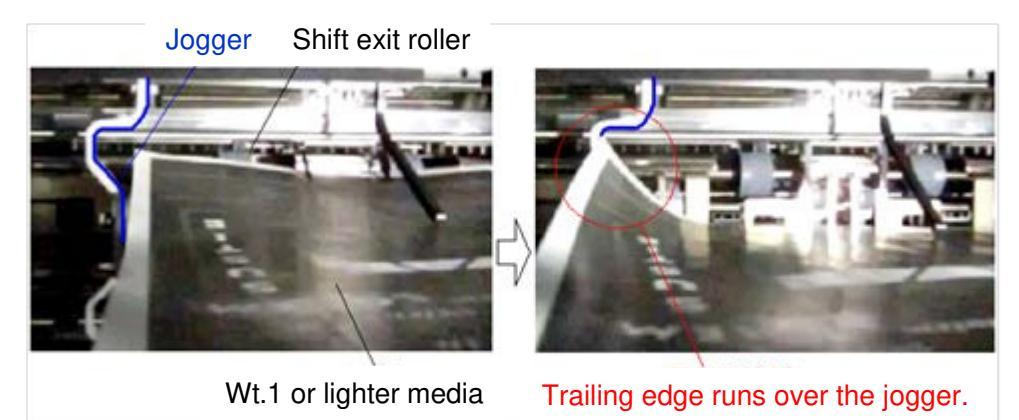
The trailing edge of the printouts run over the jogger and results in poor stacking when printed Wt.1 or lighter media to the High Capacity Stacker SK5040.

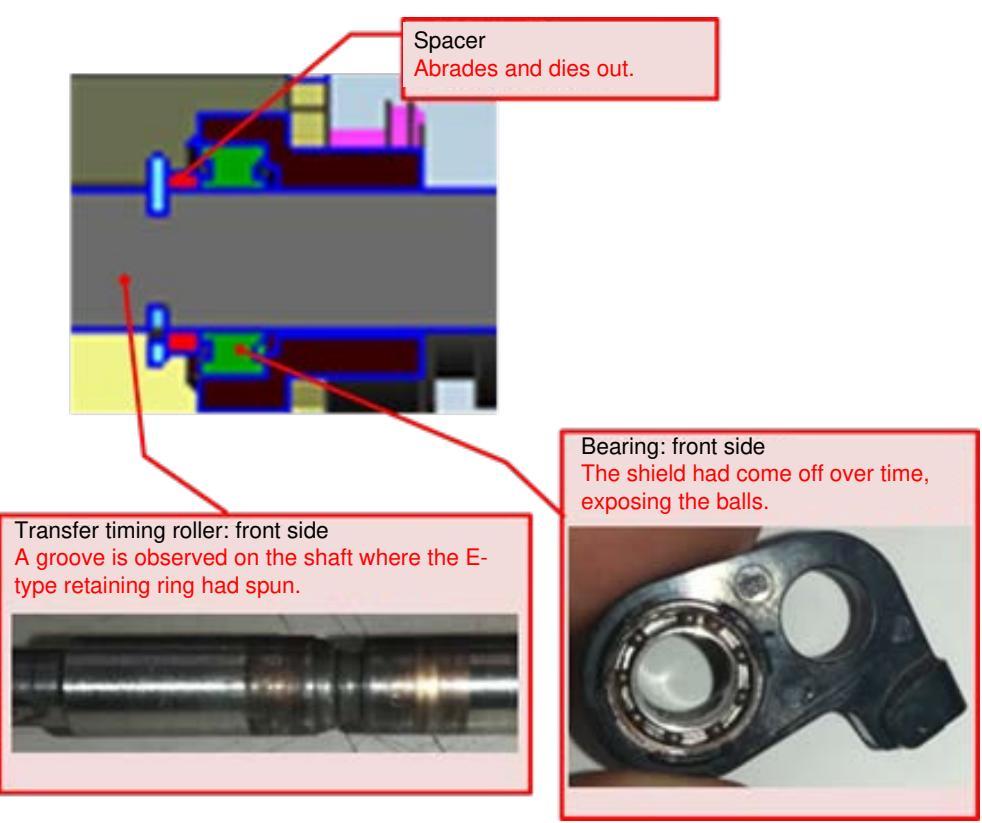
The transfer timing roller shifts toward the encoder and eventually breaks the encoder. This happens due to the thrust motion, which abrades and breaks the spacer and E-type retaining ring over time.

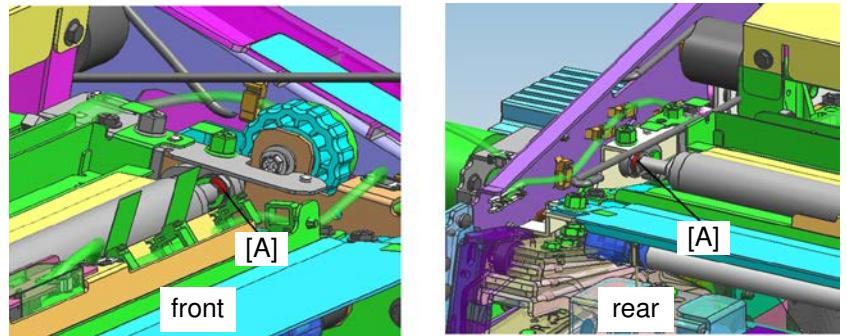
This spacer is supposed to be 1.6mm thick. If it is 0.5mm or thinner, replace with a new set of spacers [B].

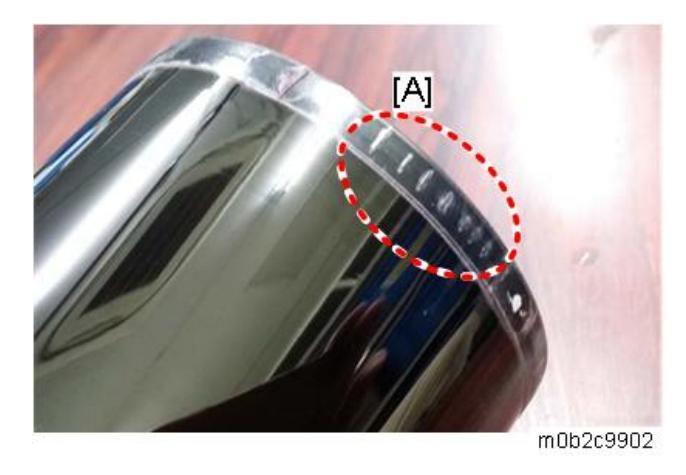
Look at the reinforcement tape attached to the edge of the belt. Cracks and/or bubbles [A] indicate that the belt has run over the edge. They may not be observed, if the belt was positioned improperly only for a short time.

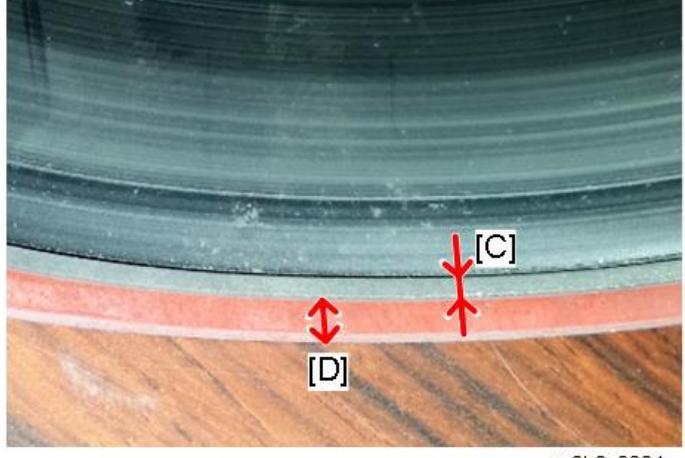
m0b2c9904

• When the belt runs off the edge, abrasion causes the belt guide to change its color from red to gray. Area [C] shows the affected area and [D] the unaffected area.

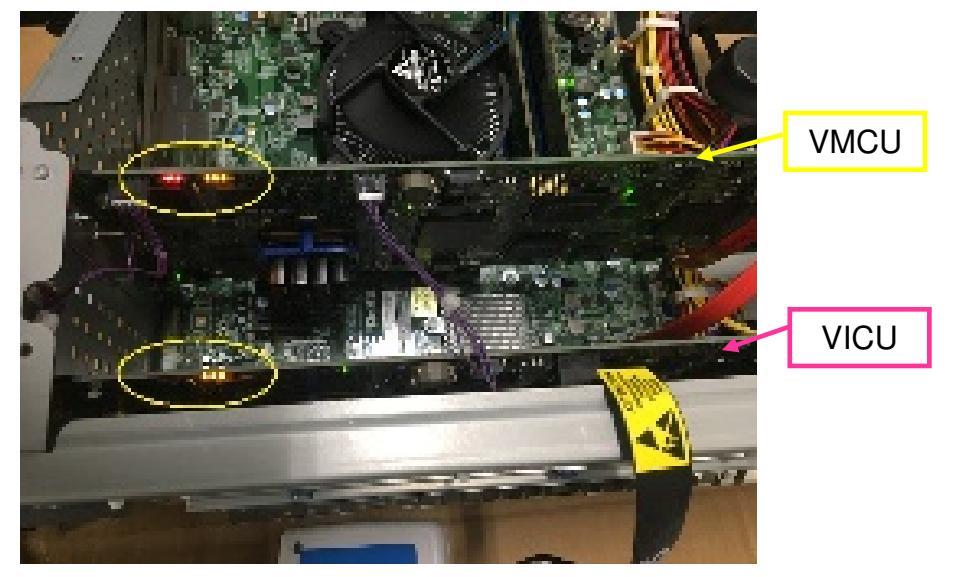
Photo above shows an affected VMCU board.
