RIGOH	Technical	Bulletin		No. RTB-001
SUBJECT: Ink Cartridge "O" Rir	ng and Rubber Pa	d		DATE: April.30.'91 PAGE: 1 of 2
PREPARED BY: S. Asai CHECKED BY:		FROM: Copier	Technie	cal Support Section
CLASSIFICATION: Action Required Troubleshooting Retrofit Information	<ul> <li>Revision of a</li> <li>Information</li> <li>Other</li> </ul>	service manual only	MOD VT21 VT23 Ges 5 Rex 1 NSH	EL: 00/2130/2150 00/2500 5310/5315/5320/5330 240/1241/1242/1260 CP310/CP315/CP330
[Phenomenon 1]:				
There has been a problem with comes off and remains on the or it comes off and stays in the the temperature changes radic	n the "O" ring insid nozzle of the ink e cartridge cap wh ally making the "C	de the ink cartridg pump when the in the cap is ren D" ring contract.	e nozz nk carti noved.	le. The "O" ring ridge is replaced, This occurs when
[Countermeasure 1]:				
Instruct customers on how to r	eplace the ink ca	rtridge. Have ther	n follov	v this procedure:

## **Technical Bulletin**

# No. RTB-001

SUBJECT: Ink Cartridge "O" Ring and Rubber Pad

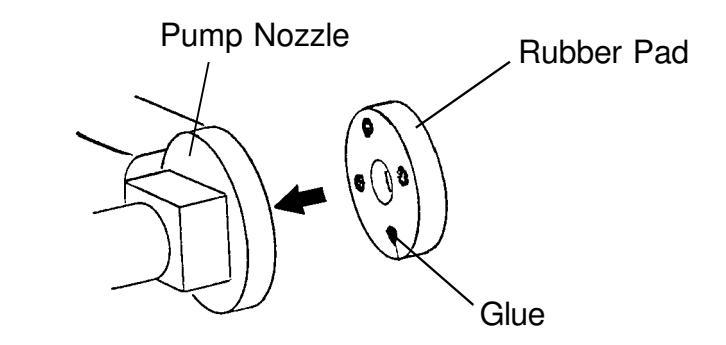
There has been a problem with the rubber pad located on the ink pump nozzle. It comes off when the ink cartridge is removed. When no rubber pad remains on the ink pump nozzle, ink inside the cartridge may not be pumped to the drum even if a new ink cartridge is installed. This problem does not happen very often.

Apply a strong adhesive ( super glue ) as follows:

- 1. Remove the rubber pad with a small screwdriver.
- 2. Clean the rubber pad and the ink pump nozzle (contacting place of the rubber pad) with cloth. If stains remain, clean them off with the thermal head cleaner.
- 3. Apply a little super glue to the 4 points on the rubber pad as shown.
- **Note:** Do not apply too much glue. This is because the rubber pad cannot be inserted correctly if there is too much glue.
- 4. Insert the rubber pad into the pump nozzle.

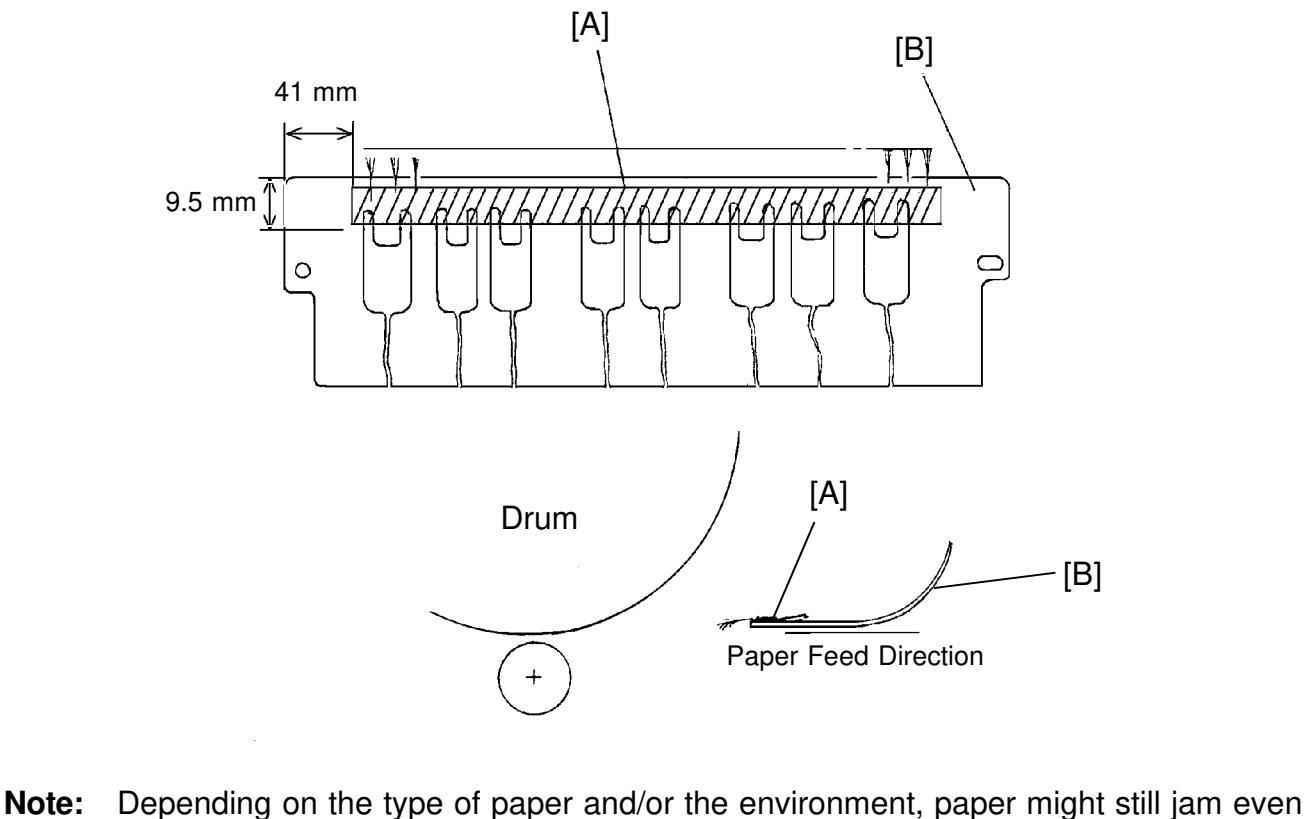
Paper jamming occurs around the drum because of static electricity when the machine is used under low humidity conditions. Heavy static charges will build up around the master during the printing run. This happens particularly when thin paper is being used at high speed rotations. This also happens if the original (and therefore the master on the drum) is changed.

though the antistatic brush was installed on the guide plate. The occurrence ratio varies according to the environment. If possible, improve the environmental conditions or move the machine to a better place.

Stick the antistatic brush (P/N: C2079010) [A] on the upper second feed roller guide plate [B] as illustrated below: (The antistatic brush has been registered as a spare part.)

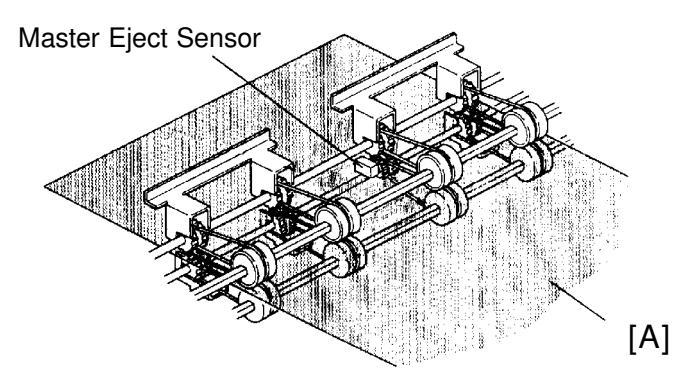
F jam indication (Master eject jam indication) lights when the main switch turns on. This is because the master eject sensor always stays on.

To ensure that the master eject sensor functions, perform the following adjustment procedure.

- 1. Clean the sensor surface with cloth dampened with alcohol.
- 2. Make a master with the blank original.a. Set the blank original and make about 20 prints.b. Stop printing and remove the master from the drum.
- 3. Insert the above master [A] between the upper and the lower eject rollers with the master film side up as shown.
- 4. Confirm that the voltage between TP104 and GND line (CN103-5) on the main PCB is  $3.5V\pm0.5V$
- 5. If it is not, adjust it by turning VR104 on the main PCB.
- Note: Adjust the voltage under the condition that the master is stretched.
- 6. Make sure that the voltage is 1.7V or less when no master is under the master eject sensor.
- **Note:** If the sensor surface stains, the voltage may go over 1.7V

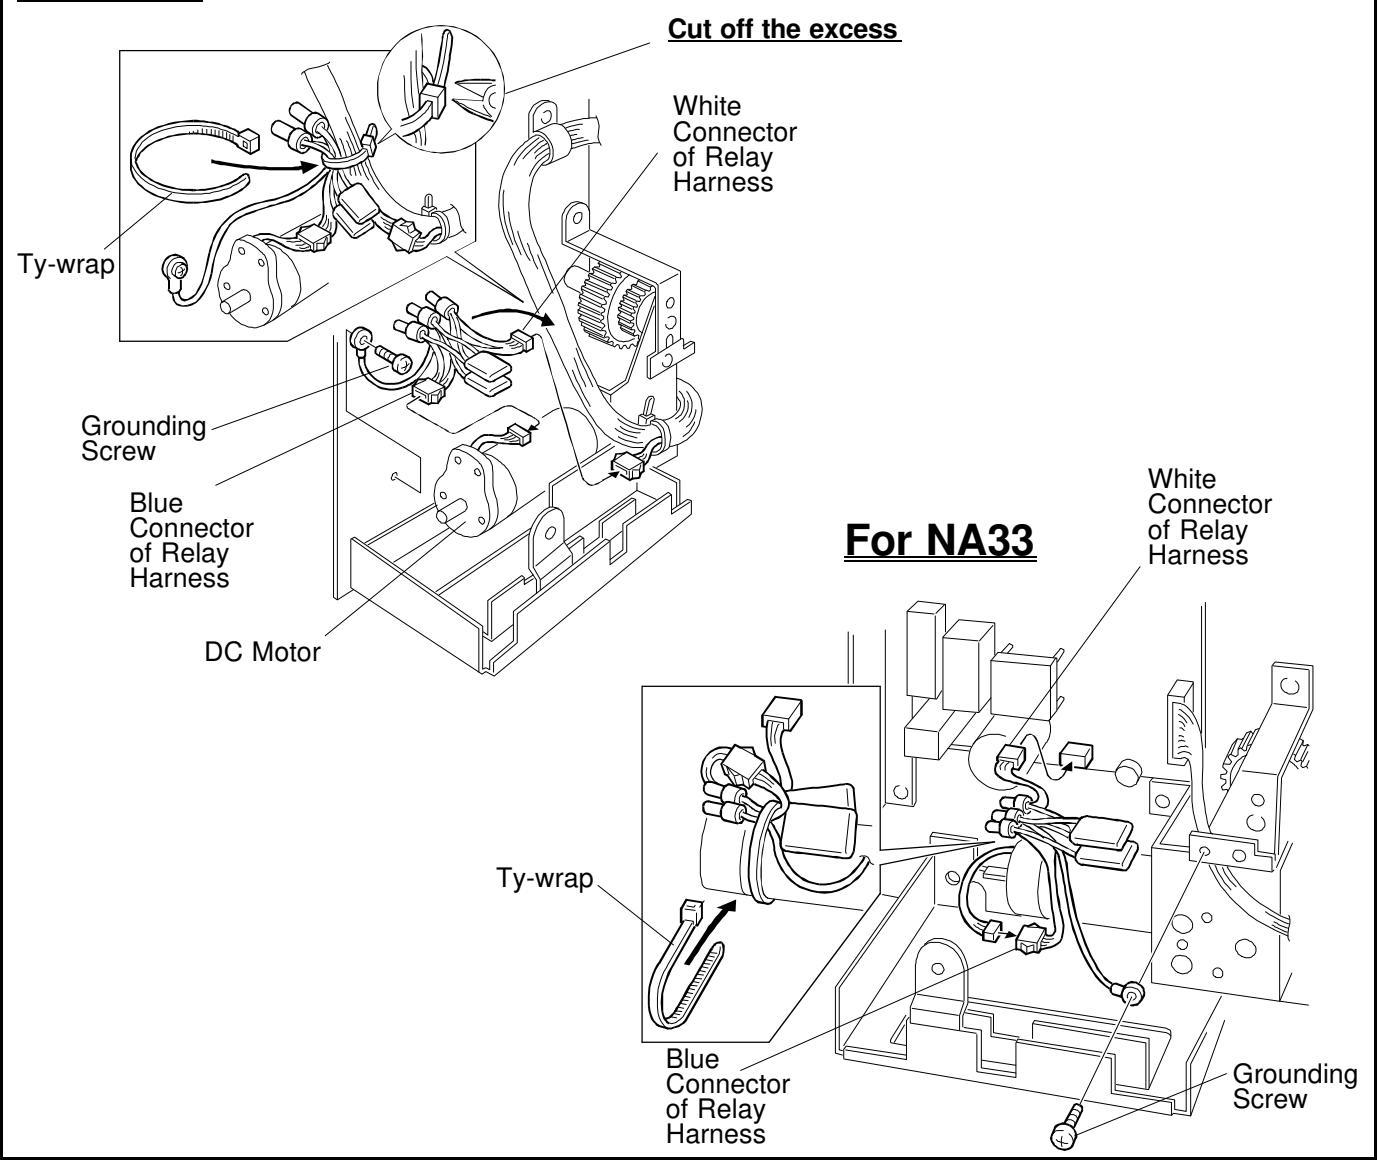
The dc motor that drives the table occasionally generates electrical noise when it starts rotating. This electrical noise is input into the ac drive board and damages IC301 on the board.

Electrical noise tends to be generated especially when the motor is still new. While the motor turns, the brushes inside are not yet worn in and this can cause electrical noise to occur.

- The layout of the dc motor is slightly different between the N850 and NA33 models as shown. To prevent the relay harness from being caught by the gears, firmly secure it with the Ty-wrap as shown in the illustrations for each model. NOTE: -
  - -Since the Ty-wrap is too long for the N850 model, cut off the excess, as shown.

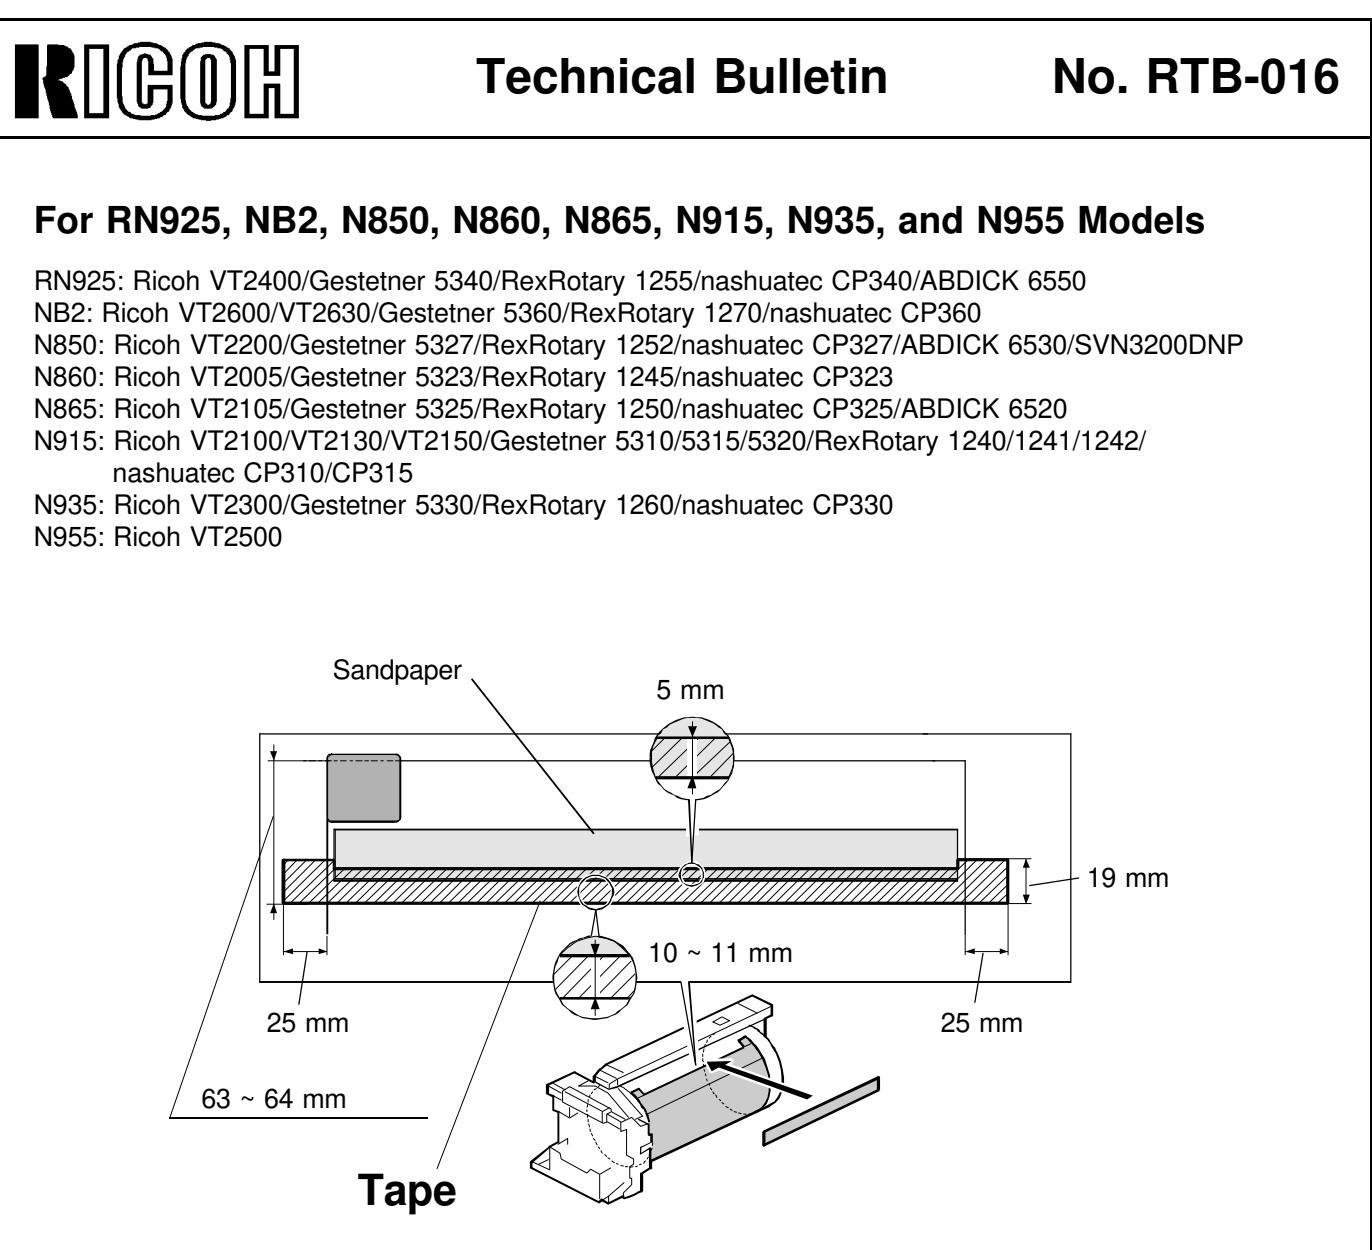
Due to the rough edges of the paper, the master wrapped around the drum becomes damaged.

Normally, even if the master is damaged, there is no ink around the area beneath the master where the paper leading edge contacts (there are no holes in the metal screen). However, after a long printing run, ink leaks onto this area and is transferred to the paper through the damaged part of the master.

3. Cover the leading edge part of the cloth screen on the drum with tape, so that ink does not leak even when the master is damaged.

- Even if the sandpaper is not used on the cloth screen (the old type cloth screen), install the tape at the same position by measuring the distance from the edge of the cloth screen. (Refer to the distance between the edge of the screen and the sand paper, which is shown in the following illustrations for each model.)

- Cut the tape where it covers the sandpaper as shown. (The indicated area must be left as shown to hold the tape on the screen firmly.) Be careful not to damage the cloth screen surface.
- Cut both edges of the tape as indicated.
- Even if the sandpaper is not used on the cloth screen (the old type cloth screen), install tape at the same position by measuring the distance from the edge of the cloth screen to the lower edge of the tape (between 63 and 64 mm).
- Since the specification of the leading edge blank margin for the N915/935/955 models is 10 mm (5 mm for the other models), it is permissible to install the tape <u>5 mm lower</u> than the position indicated above.

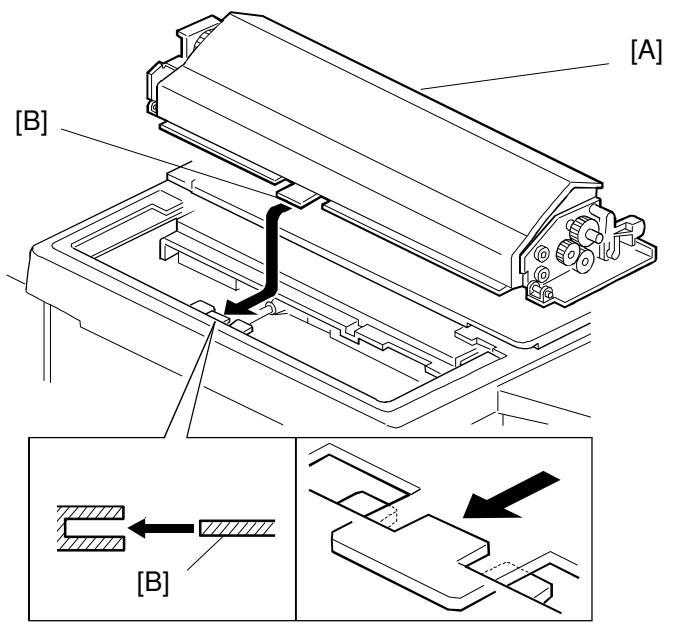
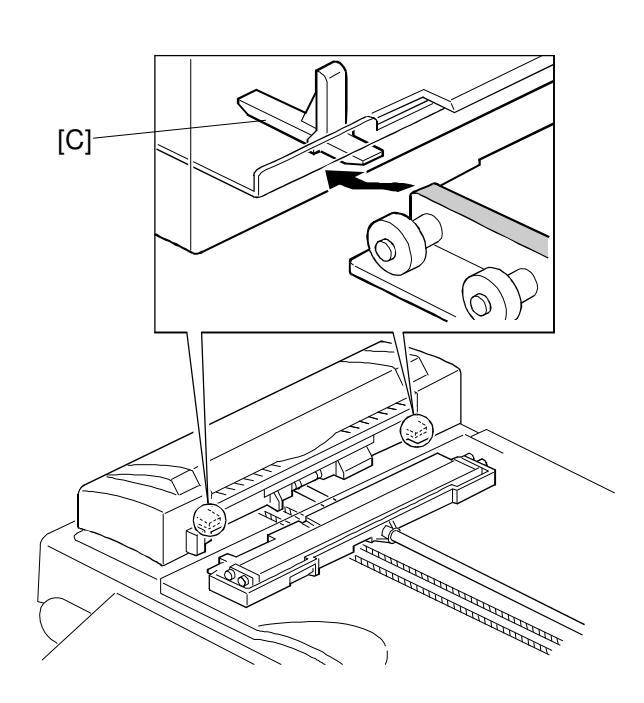
**NOTE:** If you do not follow the above instruction and the tab rides over the scanner unit frame, the ADF unit leans toward the right. There are guides [C], which are to guide both ends of the carriage, beneath the right end of the ADF (see the illustration above). Thus, these guides are just slightly lowered.

As a result, the carriage tends to be caught by the edge of the guides [C] while the carriage moves toward the original scanning position for the ADF mode. Even if the carriage is stopped on the way to the original scanning position, the master making process will happen as in the normal manner. However, as the original is not scanned properly, images will not be reproduced on the master, resulting in blank (or black) copies.

1. When you install the ADF unit [A] on the scanner unit, make sure to insert the tab [B] as shown above.

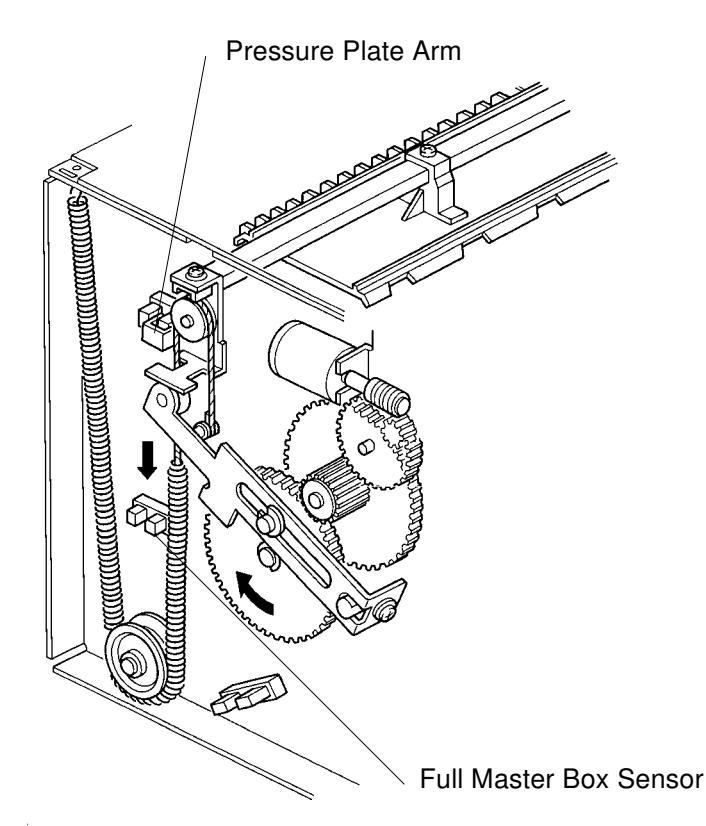
We found that the master eject belt may slip off in the following situation:

The new part has a narrower actuation plate as shown below. This means that the full master condition will be detected earlier than before.

If SOLUTION 1" is not good enough, install the new part on the operation side of the master eject unit (see below).

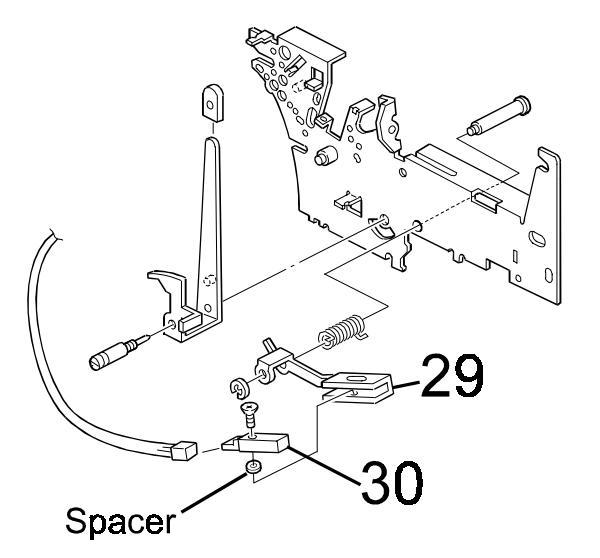
# **KIGOH Technical Bulletin SENSOR POSITION ADJUSTMENT PROCEDURE:**

The machine continues to rotate the Master Roll even after the actual end condition is reached, stripping the roll paper off the roll. The very edge of the roll paper with the adhesive then causes a jam when it sticks to the Master Feed Rollers.

Change the sensor, or adjust the sensor's position as shown on the next page. An output check for the Master End Sensor has been added from July 2001 production.

- 1. Unplug the power cord and slide the Scanner Unit to the left as seen from the operation panel side.
- 2. Lift the release lever and remove the Master Roll.
- 3. Raise the sensor position by installing a 0.2 mm-thick spacer as shown above (08072071). If this spacer has no effect, install one more 0.2 mm spacer or remove the first one and use a 0.4 mm spacer (07010030Z).
