Model: Gim-MF1d/dM	Date: 21-Nov-14	No.: RM160004b
--------------------	-----------------	----------------

Subject: Firmware Release Note: Web Uapl		Prepared by: Y. Gaman	
From: 1st Tech Service Sect., MFP/Printer Tech Service Dept.			
Classification:	<input type="checkbox"/> Troubleshooting <input type="checkbox"/> Mechanical <input type="checkbox"/> Paper path <input type="checkbox"/> Product Safety	<input type="checkbox"/> Part information <input type="checkbox"/> Electrical <input type="checkbox"/> Transmit/receive <input checked="" type="checkbox"/> Other (Firmware)	<input type="checkbox"/> Action required <input type="checkbox"/> Service manual revision <input type="checkbox"/> Retrofit information <input checked="" type="checkbox"/> Tier 2

Model: GIM-MF1d/dM		Date: 22-Jul-15	No.:RM160028
Subject: Poor fusing caused by wrong lever position		Prepared by: Y. Gaman	
From: 3rd Tech Service Sect., MFP/P Tech Service Dept.			
Classification:	<input checked="" type="checkbox"/> Troubleshooting <input type="checkbox"/> Mechanical <input type="checkbox"/> Paper path <input type="checkbox"/> Product Safety	<input type="checkbox"/> Part information <input type="checkbox"/> Electrical <

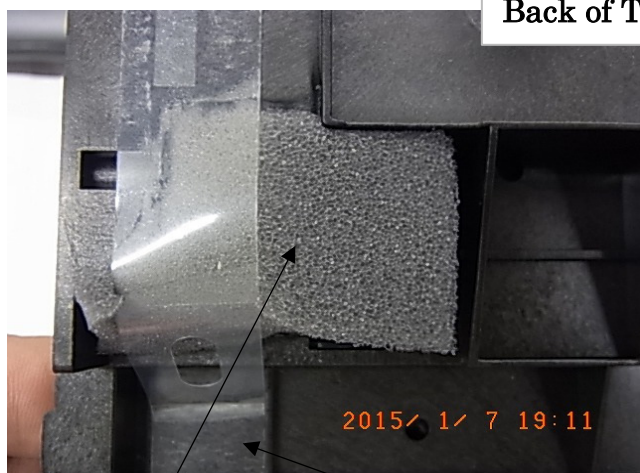
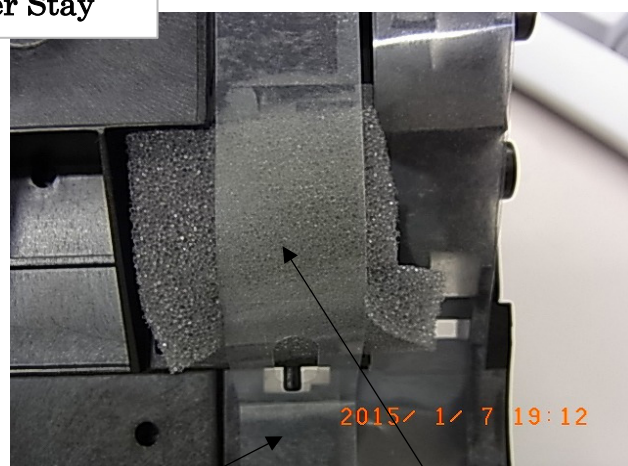
Back of Transfer Stay

#16 Sponge: Left

#18 Sheet

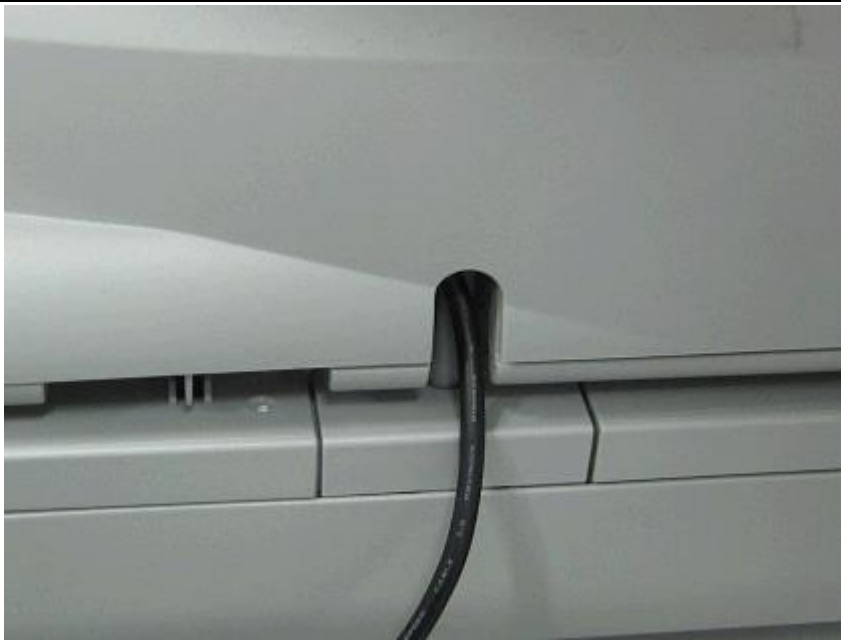
4. Route the cable [A] as shown above.

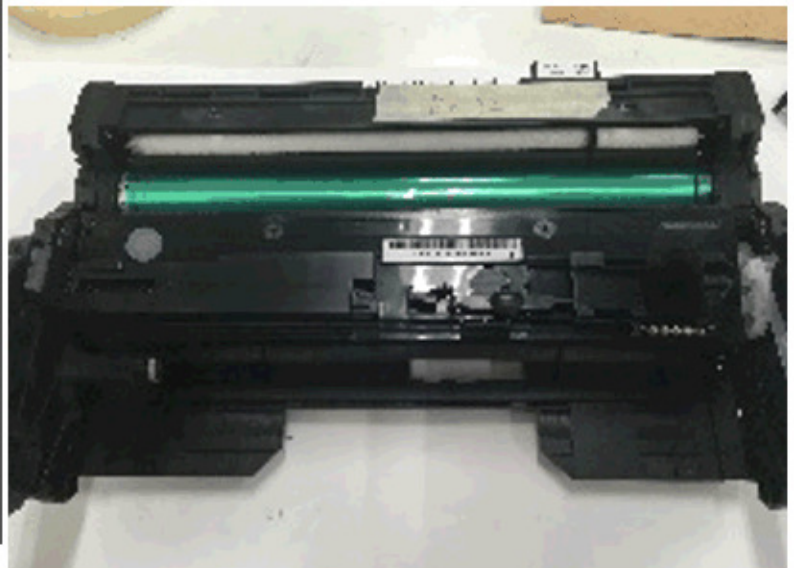
Black line or white line appears on prints in the feeding direction along with unwanted toner on the charge cleaning roller at the line position.

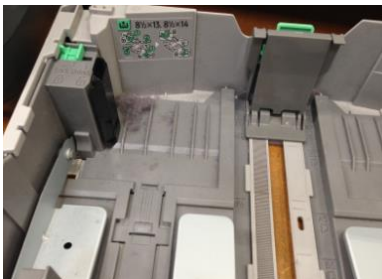
3. *A foreign substance adheres to the paper loaded in the tray and on the bypass.*

Remove any paper dust or other foreign substance from the paper path, paper loaded in the tray, and paper tray.

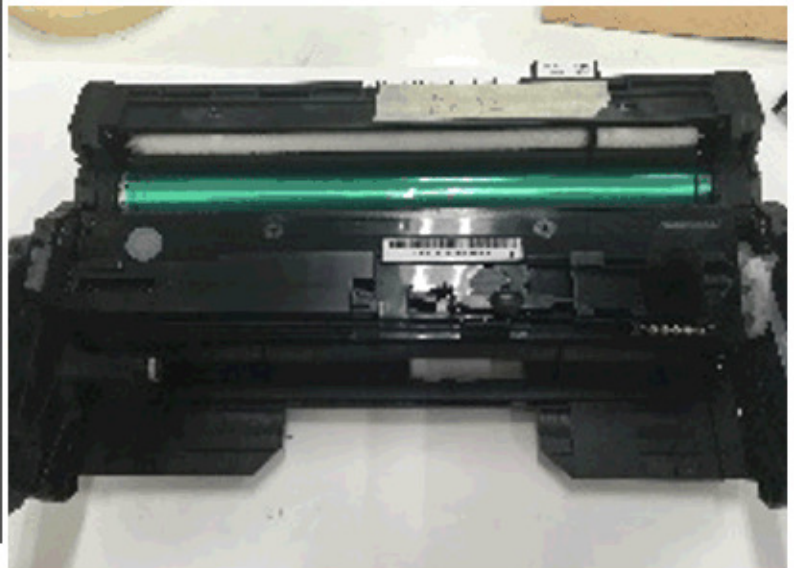
Black line or white line appears on prints in the feeding direction along with toner on the charge cleaning roller at the line position.
