Model: Model PG-C1		Date: 14-Jun-06	No.: MB229001
Modified Article: Parts catalog correction: Engine Unit		Prepared by: A. Ishiyama	
From: 1st Technical Support Sec. Service Support Dept.			
Reason for Modification:	<input checked="" type="checkbox"/> Parts catalog correction <input type="checkbox"/> To facilitate assembly <input type="checkbox"/> Part standardization	<input type="checkbox"/> Vendor change <input type="checkbox"/> To improve reliability <input type="checkbox"/> Other	<input type="checkbox"/> To meet standards ()
Modification Schedule:	From first mass production.

Model: Model PG-C1		Date: 14-Jun-06	No.: MB229002
Modified Article: Parts catalog correction: Waste Ink Tank		Prepared by: A. Ishiyama	
From: 1st Technical Support Sec. Service Support Dept.			
Reason for Modification:	<input checked="" type="checkbox"/> Parts catalog correction <input type="checkbox"/> To facilitate assembly <input type="checkbox"/> Part standardization	<input type="checkbox"/> Vendor change <input type="checkbox"/> To improve reliability <input type="checkbox"/> Other	<input type="checkbox"/> To meet standards ()
Modification Schedule:	From first mass production.

Modified Article: Power

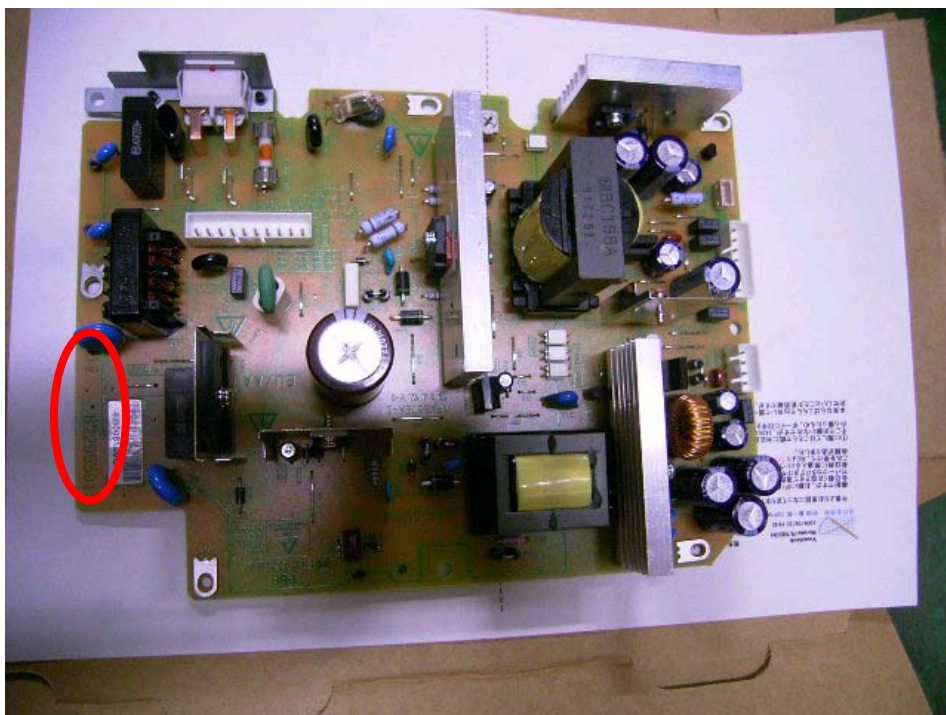
Note: To distinguish between B2295500 and B2295501, check the part number printed on the PSU board (circled below).

Change: The descriptions for the parts were changed.

Reason: To make it clear which PCB is for N.A. machines and which PCB is for E.U. machines.

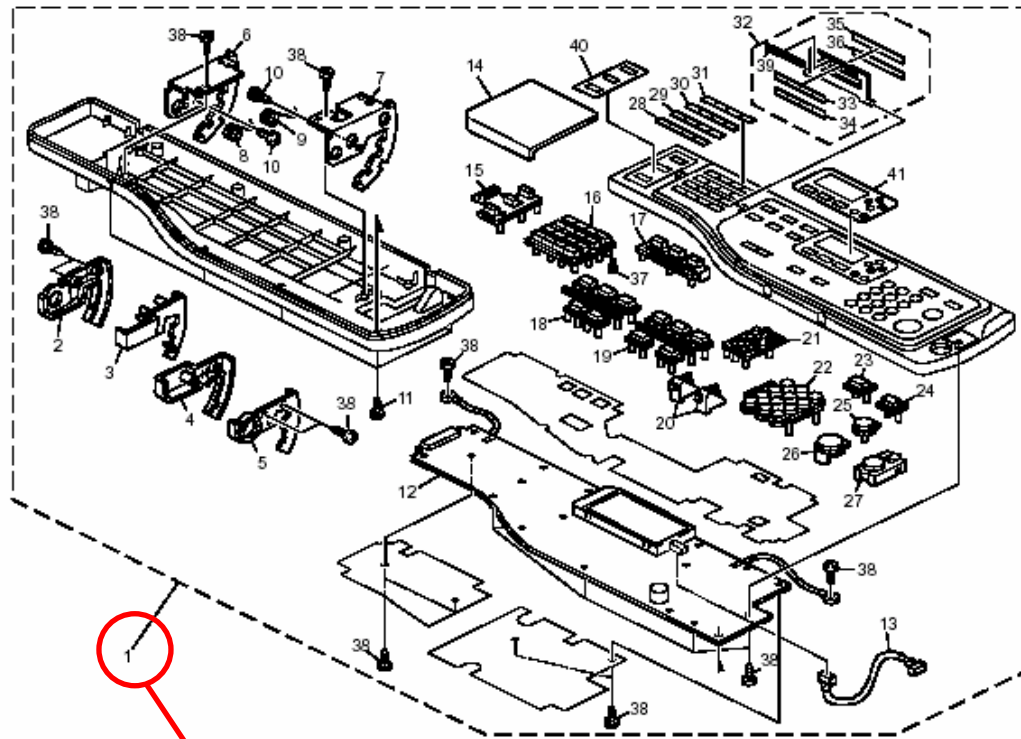
3. OPERATION PANEL (B229)

Only #1 is available

Change: The parts in the table were deleted.

Reason: As per a request from the operation panel vendor.

Important: If one of the deleted parts needs to be replaced, replace the operation panel unit (B2291433, B2291434, B2291435).

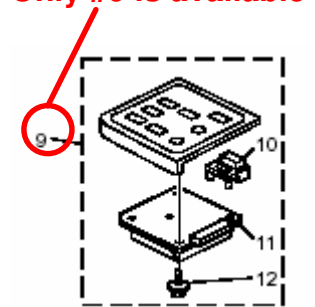
Change: A Mylar was added to the operation panel.

Only #9 is available

Change: The parts were deleted.

Reason: As per a request from the operation panel vendor.

Important: If one of the deleted parts needs to be replaced, replace the operation panel unit (B2291421, B2291422).

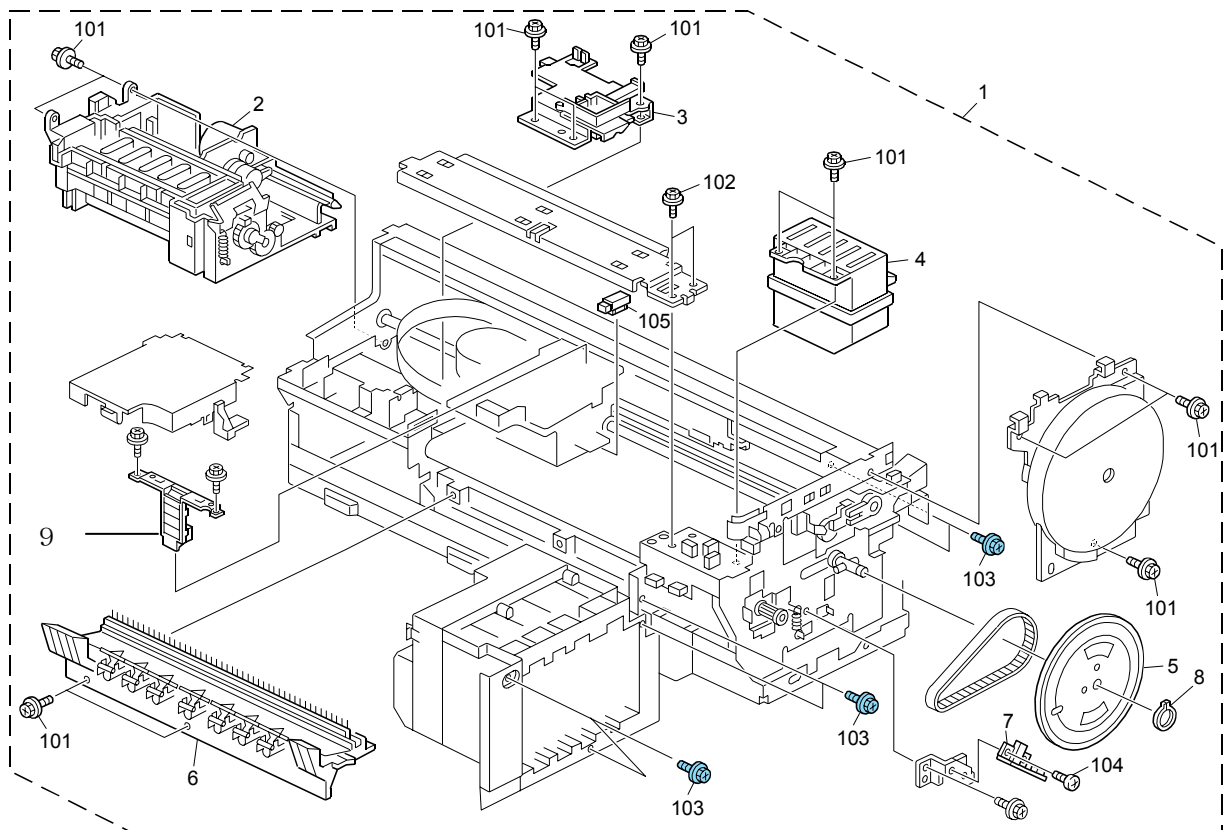
The illustration has added as shown below.

Old part number	New part number	Description	Q'ty	Int	Page	Index	Note
-	B2292426	Encoder Sensor	1		29	9

Change/Reason: Parts Catalog correction

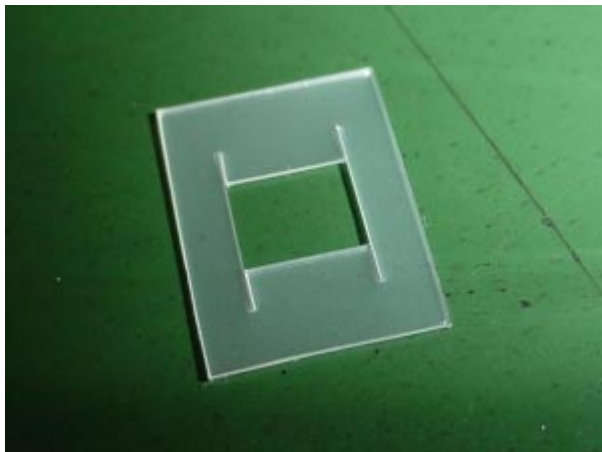
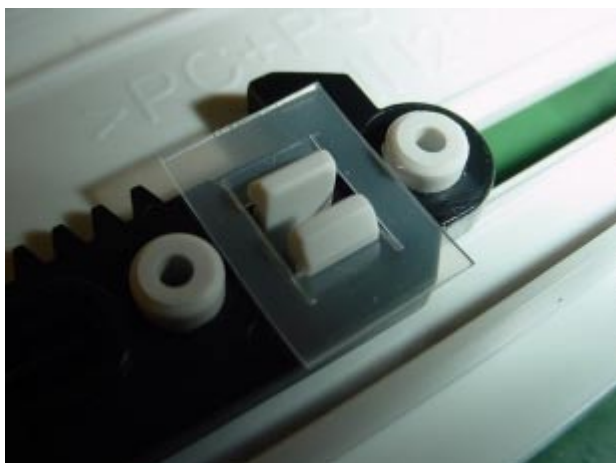
Change: Two Mylar sheets were added to the side fence racks.

Reason: To improve the mobility of the side fence.

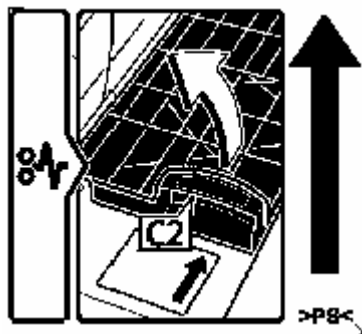
Change: The decal was added to the front inner cover.

Reason: To clarify the position of the C2 cover to the user.

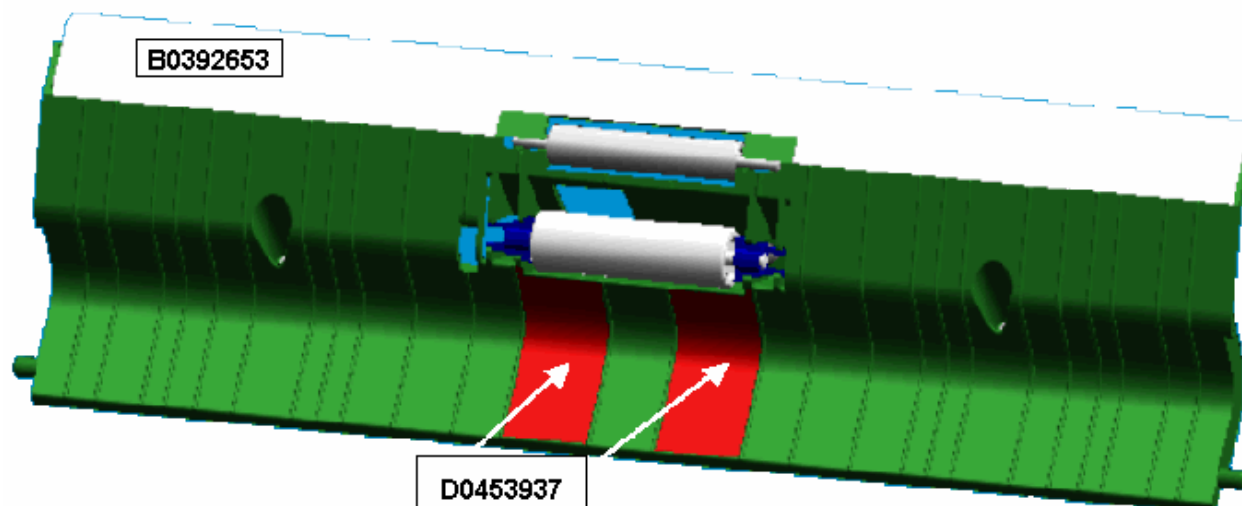
Change:

- 1) The shape of the Mylar was changed.
- 2) A new Mylar was added.

Reason: To further improve paper transport.

Important: When you replace any of these parts for the first time, make sure to install all the new parts **together as a set**.
