| Model: K-P1 Duplex Unit (G552) | | Date: 22-Jun-09 | No.: RG552001 |
| Subject: PCB/Harness | | Prepared by: Y.Murata | |

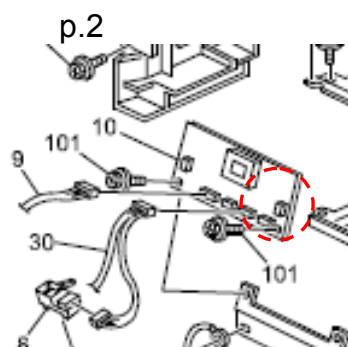
- 1) The shapes of the harness connector (PCB side, circled in red below) and the PCB connector were changed.
- 2) The PCB/harness assembly was added.

**Reason:** Harness vendor change.
