Model: Kir-C4 1Bin Tray BN2010		Date: 16-Oct-14	No.: RD697001
Subject: 1 Bin Tray BN2010 cannot be installed (no screw hole)		Prepared by: K.Yamamoto	
From: 1st Tech Service Sect., MFP/P Tech Service Dept.			
Classification:	<input checked="" type="checkbox"/> Troubleshooting <input type="checkbox"/> Mechanical <input type="checkbox"/> Paper path <input type="checkbox"/> Product Safety	<input type="checkbox"/> Part information <input type="checkbox"/> Electrical <input type="checkbox"/> Transmit/receive <input type="checkbox"/> Other ()	<input checked="" type="checkbox"/> Action required <input type="checkbox"/> Service manual revision <input type="checkbox"/> Retrofit information <input type="checkbox"/> Tier 2

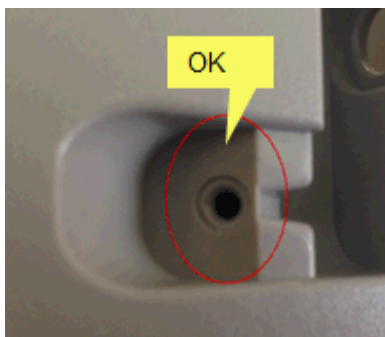
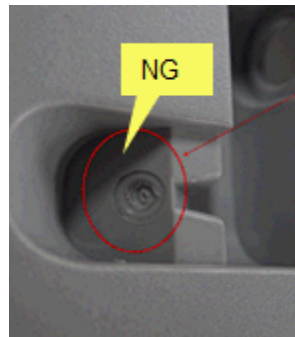
1 Bin Tray BN2010 cannot be installed.

Screw cannot be tightened up due to no screw hole.

Replace the cover D6979901 during the installation.
