Model: AT-C1 Paper feed unit		Date: 25-Apr-07	No.: RB801001
Subject: LCT JAM		Prepared by: T.Kiyohara	
From: 1st Tech. Support Sec. Service Support Dept.			
Classification:	<input checked="" type="checkbox"/> Troubleshooting <input type="checkbox"/> Mechanical <input type="checkbox"/> Paper path <input type="checkbox"/> Product Safety	<input type="checkbox"/> Part information <input type="checkbox"/> Electrical <input type="checkbox"/> Transmit/receive <input type="checkbox"/> Other ()	<input type="checkbox"/> Action required <input type="checkbox"/> Service manual revision <input type="checkbox"/> Retrofit information

SYMPTOM

A paper feed jam occurs with the LCT unit at installation.

Mylar Attachment Procedure

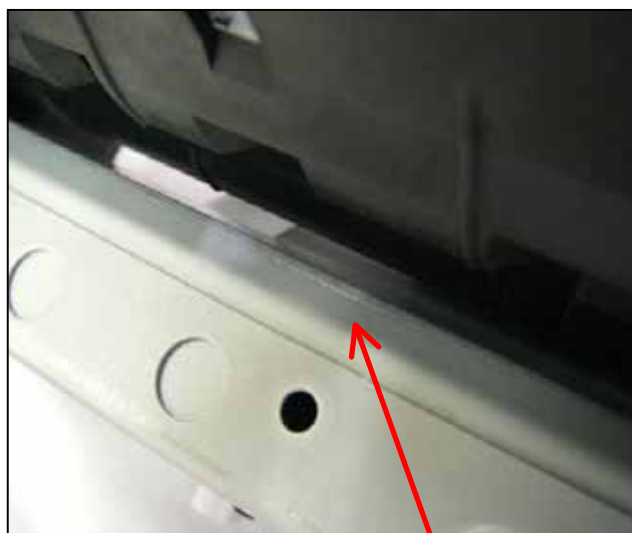
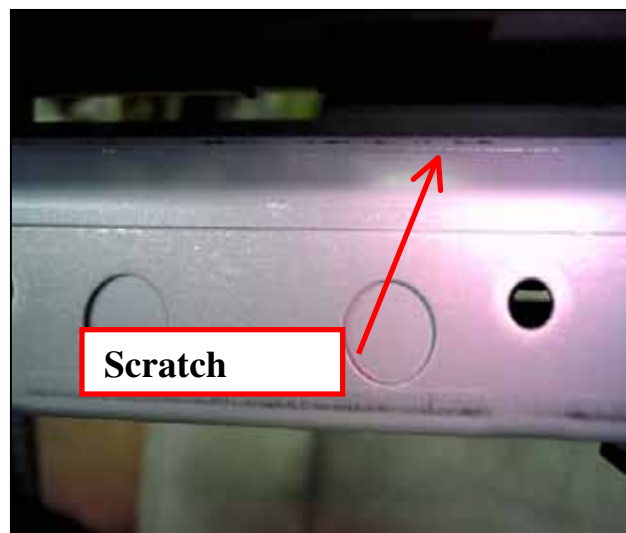
There is a small scratch in the separation guide plate of the LCT unit.

Attach two Mylars(P/N:B2249500) to the separation guide plate (**see procedure below**).

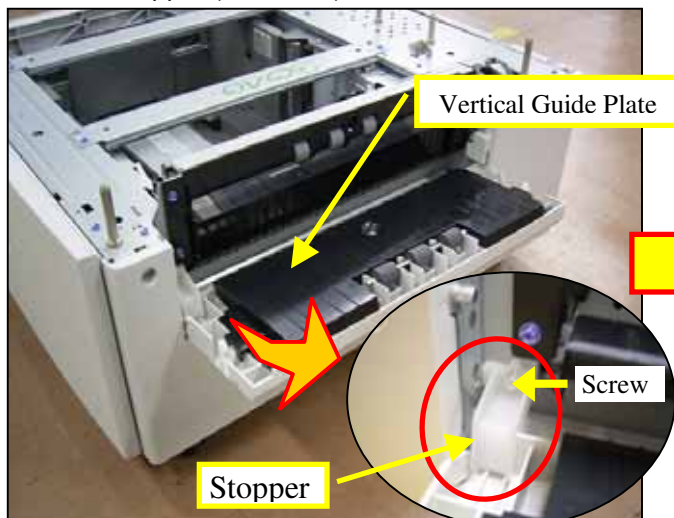
1. Open the vertical guide plate, and then remove the stopper (screw x 1).

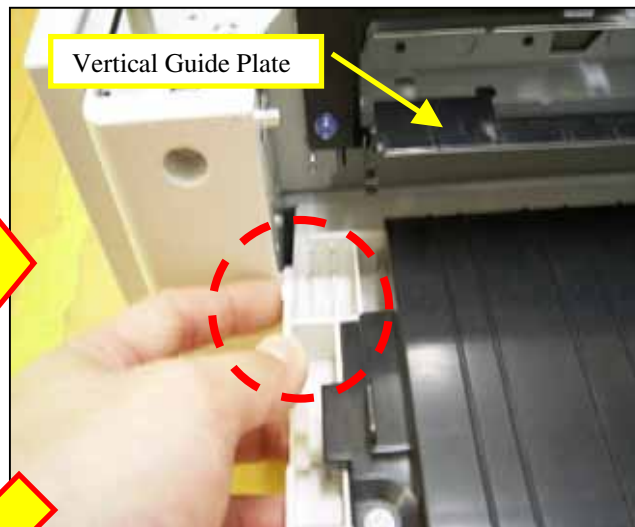
2. Remove the vertical guide plate.

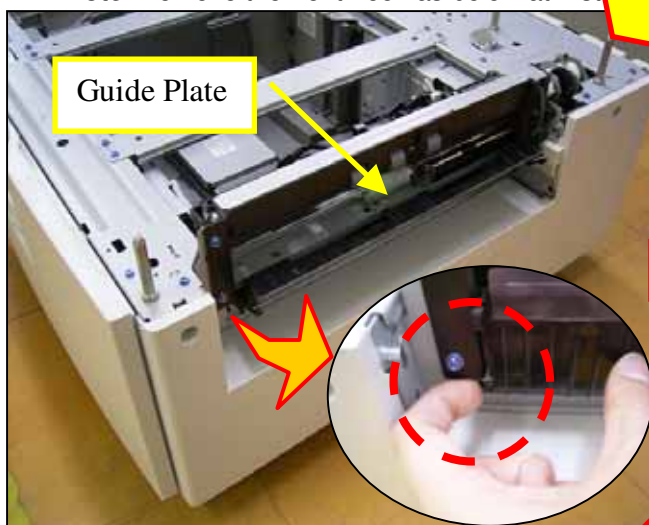
3. Remove the guide plate.

Note: Remove the front hook as below at first

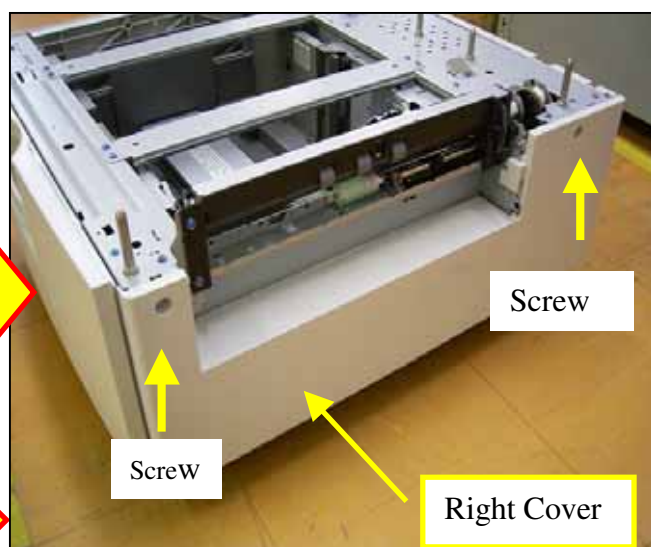
4. Remove the right cover (screw x 2).

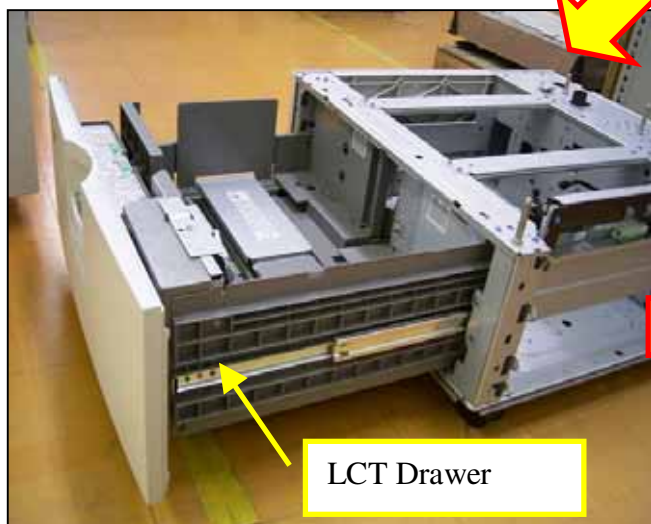
5. Pull out the LCT drawer

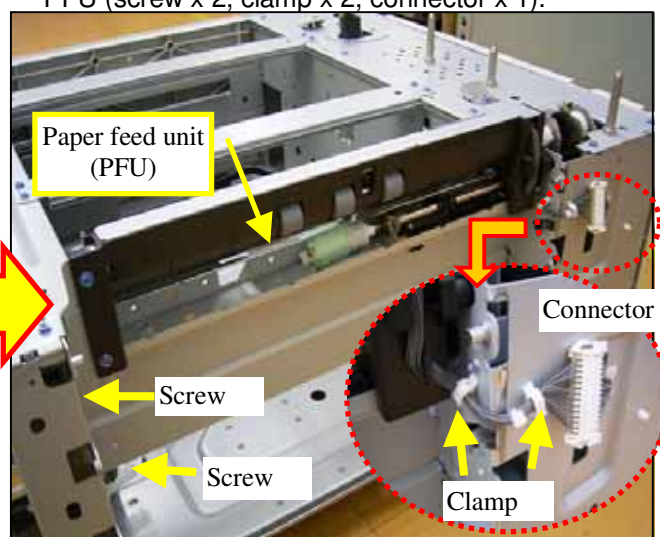
6. Remove the screw, clamp and connector for the PFU (screw x 2, clamp x 2, connector x 1).

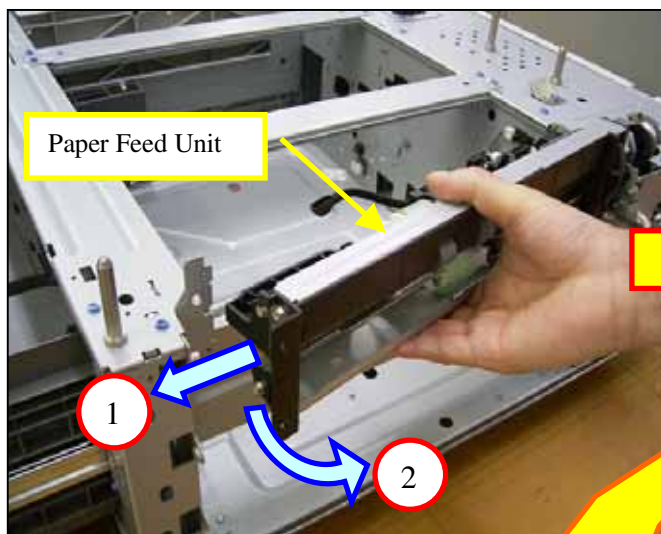
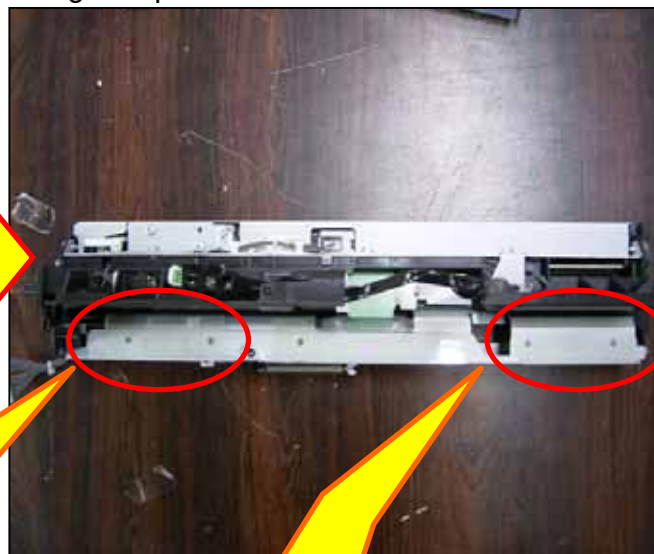
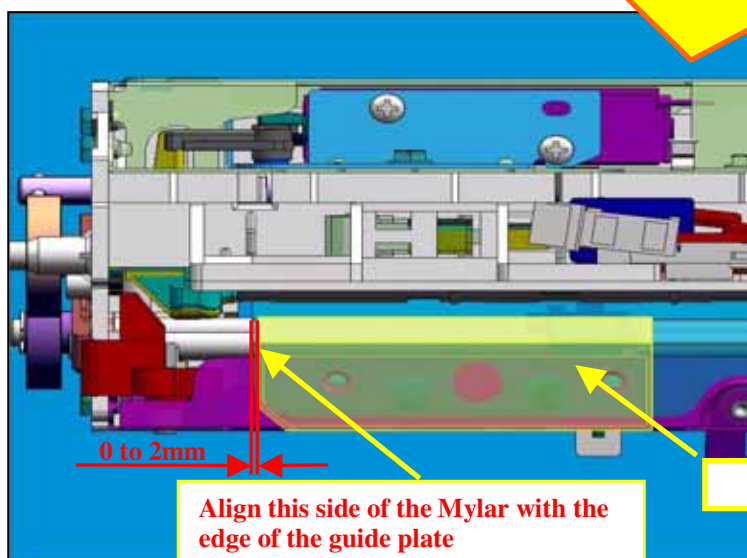
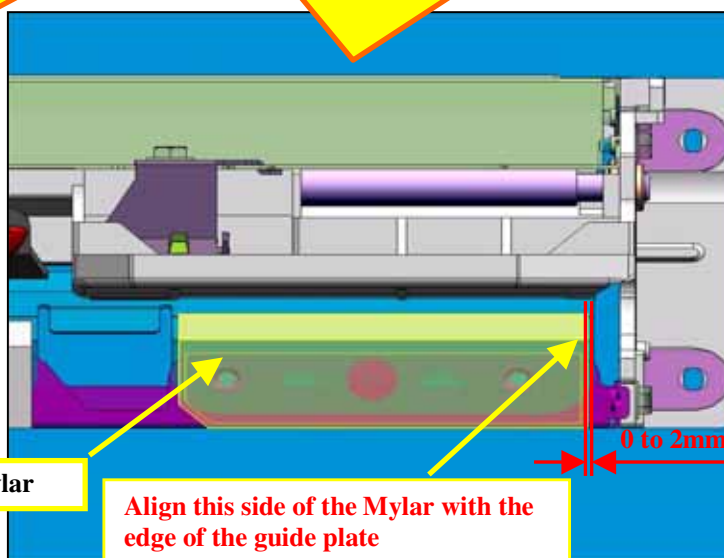
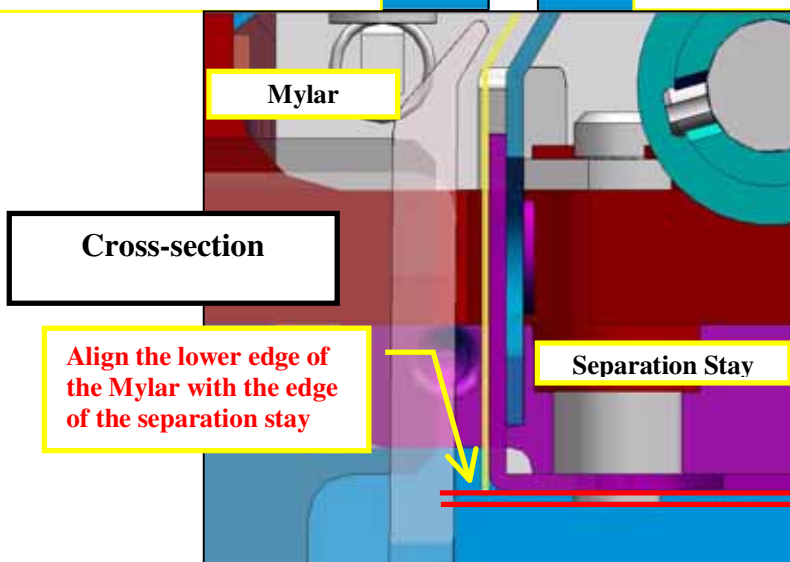
7. Remove the paper feed unit (PFU) as show in the illustration below.

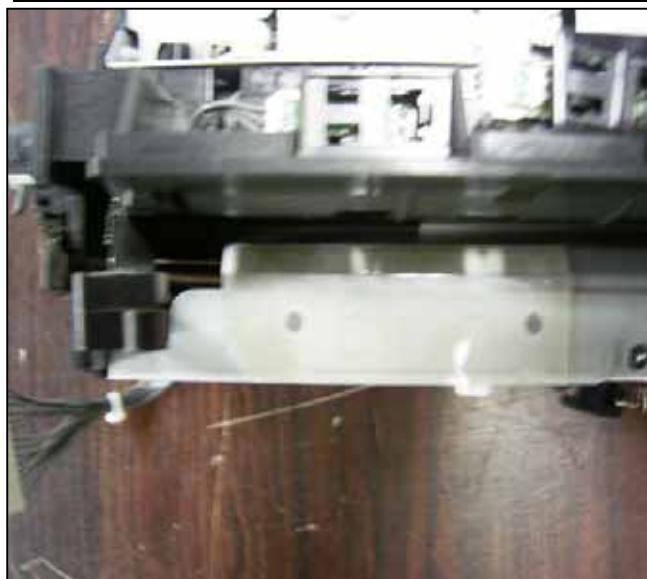
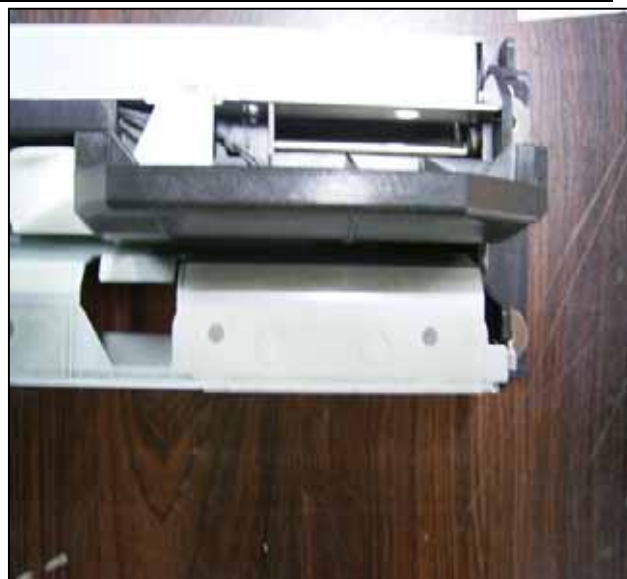
8. Attach two Mylars to the separation guide plate.

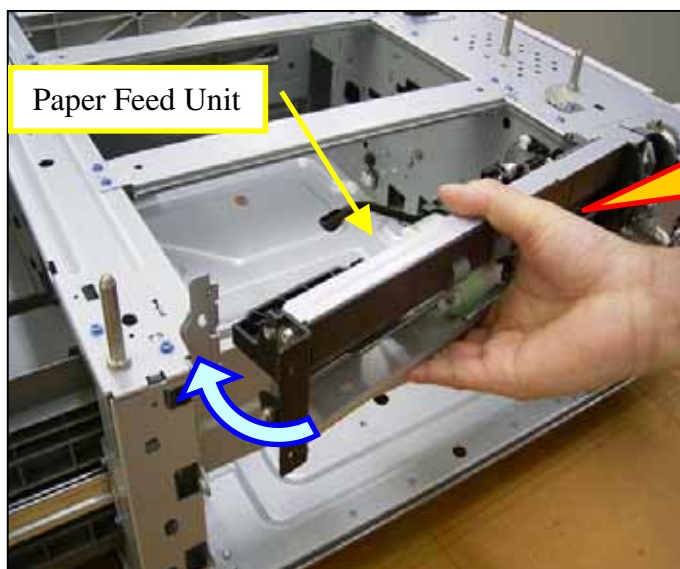
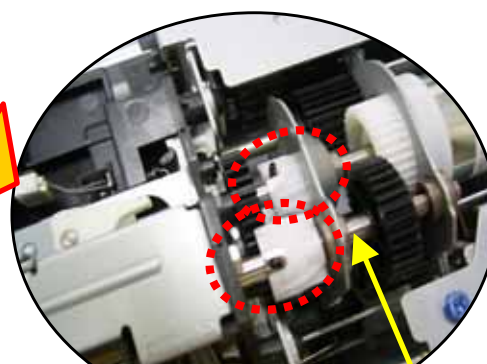
9. Reattach the paper feed unit.

Make sure the two couplings and two pins of the shafts are engaged correctly.
