Model: Bellini		Date: 25-Apr-03	No.: RA294061
Subject: Service Parts of Punch Heads		Prepared by: S. Orita	
From: 2nd Tech Support Sec. Service Support Dept.			
Classification:	<input checked="" type="checkbox"/> Troubleshooting <input type="checkbox"/> Mechanical <input type="checkbox"/> Paper path <input type="checkbox"/> Other ()	<input type="checkbox"/> Part information <input type="checkbox"/> Electrical <input type="checkbox"/> Transmit/receive	<input type="checkbox"/> Action required <input type="checkbox"/> Service manual revision <input type="checkbox"/> Retrofit information

Model: B-C1 Punch Unit	Date:17-Aug-09	No.: RA812001
------------------------	----------------	---------------

Subject: Punch Unit		Prepared by: T.Toriumi	
From: 2nd Tech. Support Sec. Service Support Dept.			
Classification:	<input type="checkbox"/> Troubleshooting <input type="checkbox"/> Mechanical <input type="checkbox"/> Paper path <input type="checkbox"/> Other ()	<input checked="" type="checkbox"/> Part information <input type="checkbox"/> Electrical <input type="checkbox"/> Transmit/receive	<input type="checkbox"/> Action required <input type="checkbox"/> Service manual revision <input type="c

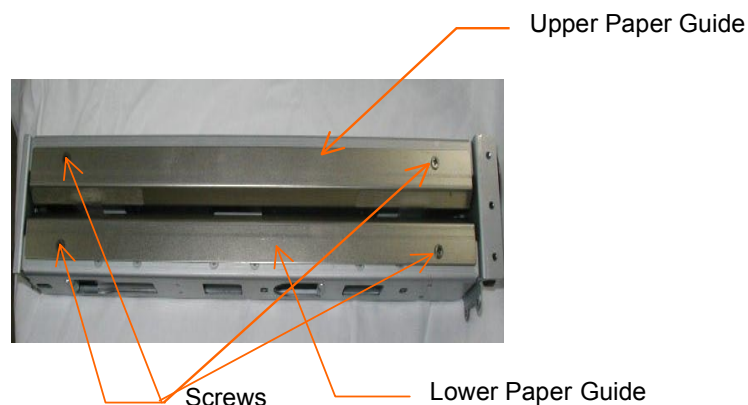
1. Remove the upper and lower guides (4 screws).

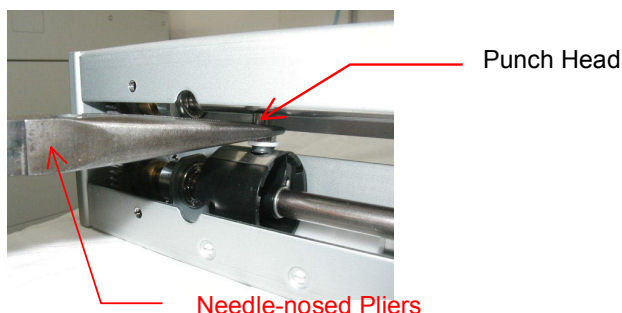
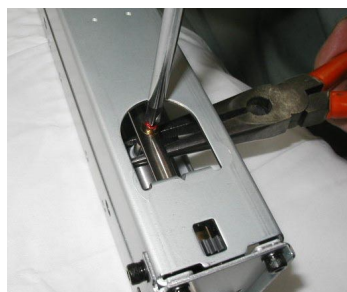
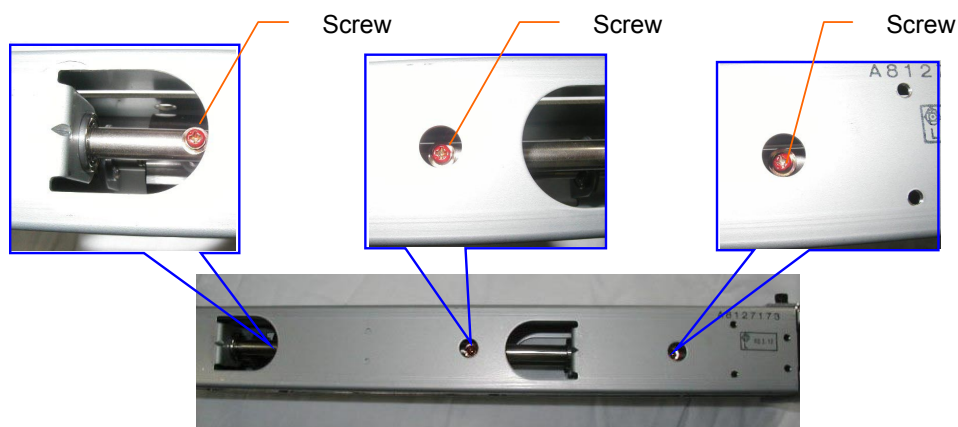
2. Rotate the drive gear until the punch head and punch head receiver are aligned.
3. Remove the punch head, holding the head with a pair of needle-nosed pliers (1 screw per head).

NOTE: a. Do not touch the punch head with bare hands.
b. Do not remove any other screws.

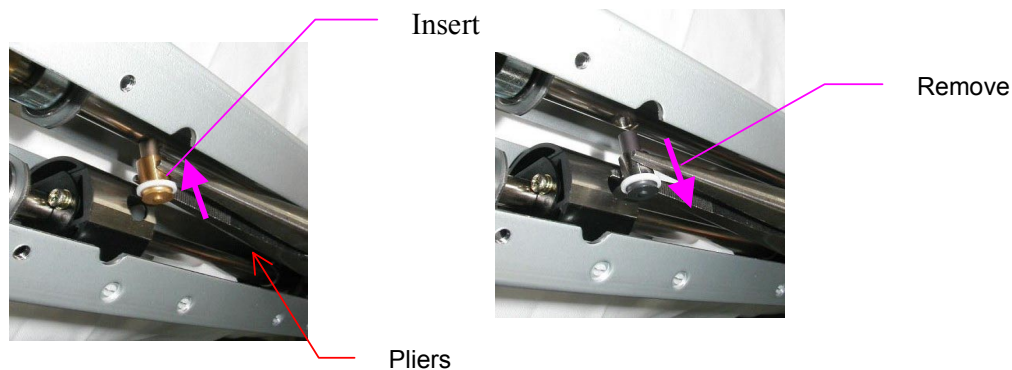
4. Insert the new punch head.

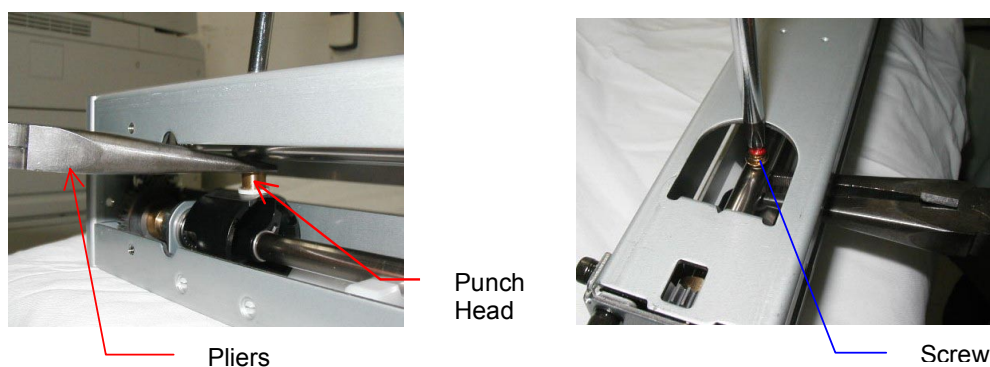
5. Secure the new punch head in place, holding it with a pair of needle-nosed pliers (1 screw).

NOTE: a. Do not touch the punch head with bare hands.
b. Make sure to attach the head perpendicular (90 degrees) to the shaft.
c. Do not remove any other screws.

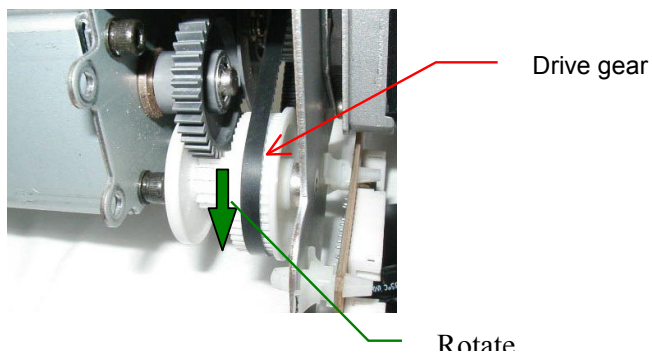
6. Reinstall the paper guides (4 screws).
7. Rotate the drive gear manually and confirm that the punch head/receiver mechanism functions smoothly (that the two are properly aligned with one another).

Note: Do not forcibly rotate the gear. If it is difficult to rotate, replace the entire punch unit.
