Model: Model V-C1 Finisher (SR841)	Date: 29-Mar-06	No.: RB706001
------------------------------------	-----------------	---------------

Subject: Stopper Vibrating Plate		Prepared by: H. Matsui	
From: 2nd Tech. Support Sec. Service Support Dept.			
Classification:	<input type="checkbox"/> Troubleshooting <input type="checkbox"/> Mechanical <input type="checkbox"/> Paper path <input type="checkbox"/> Other (      )	<input checked="" type="checkbox"/> Part information <input type="checkbox"/> Electrical <input type="checkbox"/> Transmit/receive	<input type="checkbox"/> Action required <input type="checkbox"/> Service manual revision <input type="checkbox"/> Retrofit information

## Important Note Regarding a New Finisher Accessory

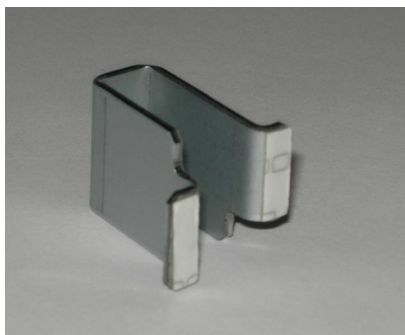
The following part was added to the accessory list for the Finisher Adapter Kit B698.

**Service parts P/N:** B6984125

**Purpose:** To improve stapling when using curled paper.

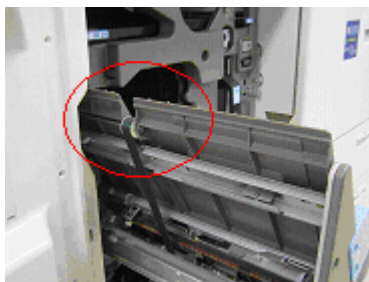
Stapler tray

Excessive force was placed on the shaft bearing (stapler tray rib shown below), damaging the area.

If the symptom occurs, attach the new shaft bracket (B8304783) and modified shaft (B7064785).

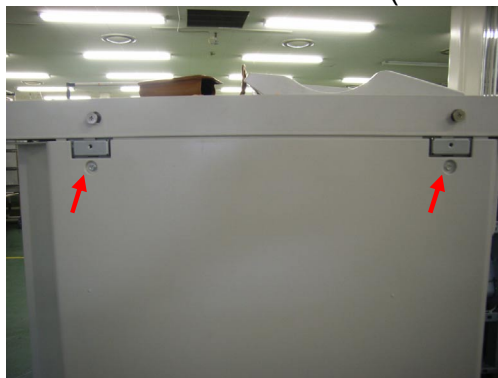
1. Remove the rear cover (screw x 2).

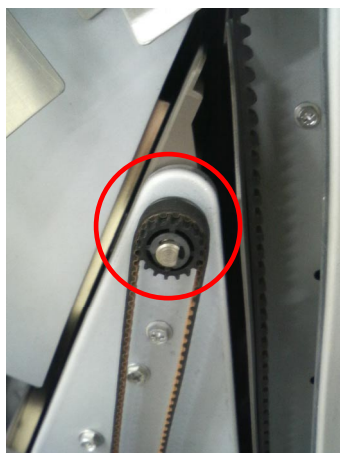
2. Remove the E-ring.
3. Remove the belt.
4. Pull out the stapler unit.
5. Remove the pulley.

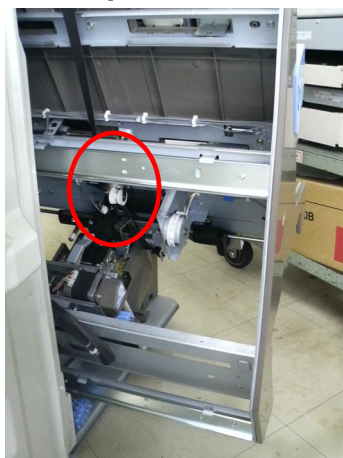
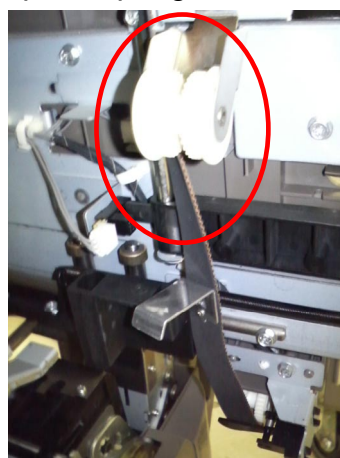
6. Remove the belt from the pulley to loosen the belt.

**Important:** Be careful that you do not bend the plate spring.

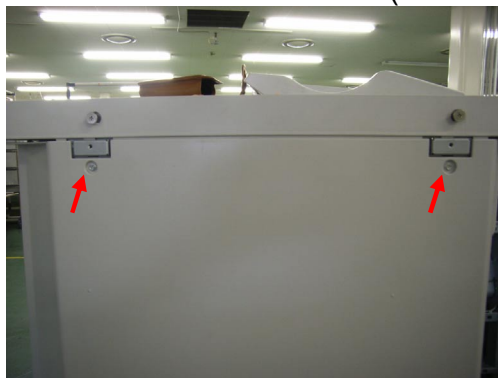
1. Remove the rear cover (screw x 2).

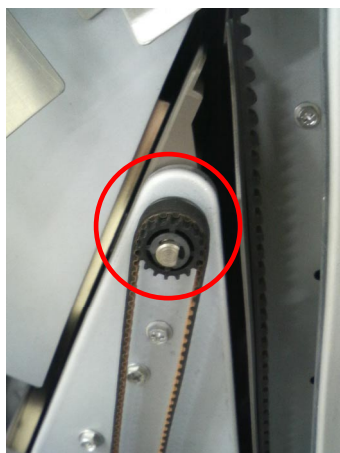
2. Remove the E-ring.
3. Remove the belt.
4. Pull out the stapler unit.
5. Remove the pulley.

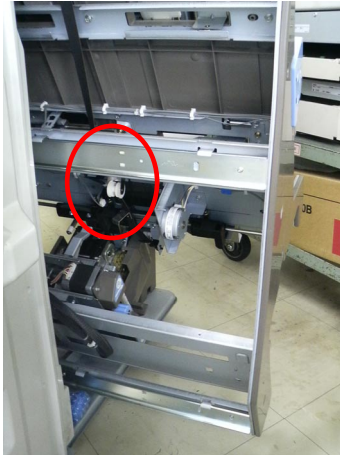
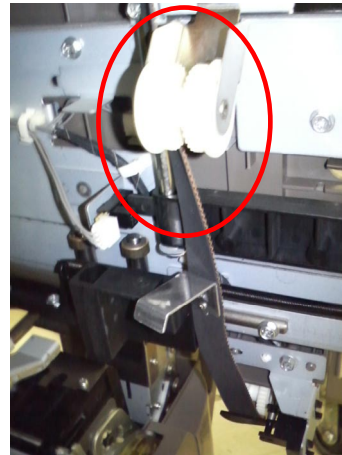
6. Remove the belt from the pulley to loosen the belt.

**Important:** Be careful that you do not bend the plate spring.

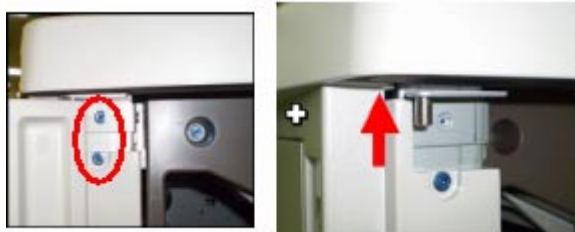
1. Remove the front cover (screws x 2) and left side inner cover (screw x 1).

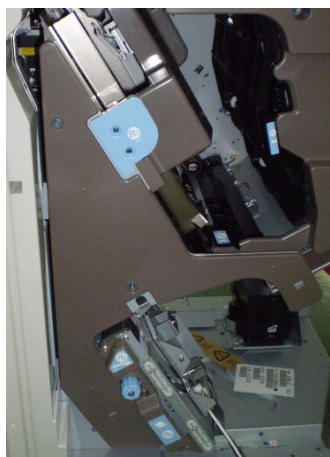
2. Remove the inner cover (screws x 2).

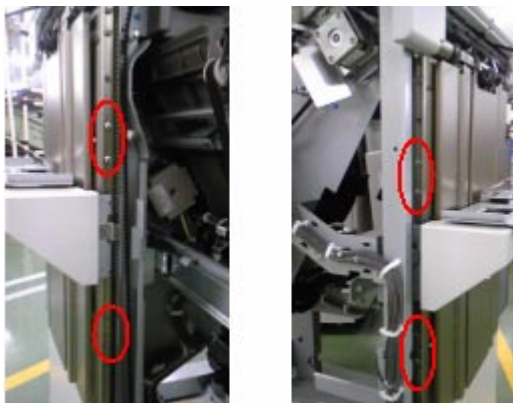
**4. Move the tray down to its lowest position.****5. Remove the 4 screws for the end fence, and then tip the end fence so that you can access the connector inside.****6. Remove the connector.**

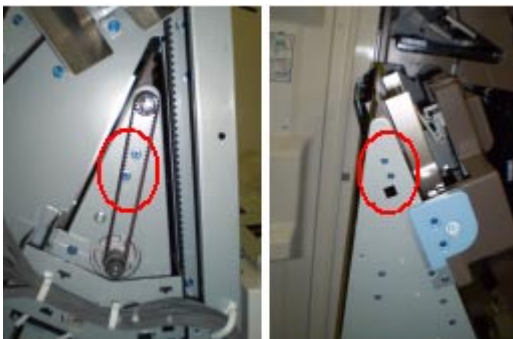
**7. Remove the screws for the upper stay (screws x 2 each side).**

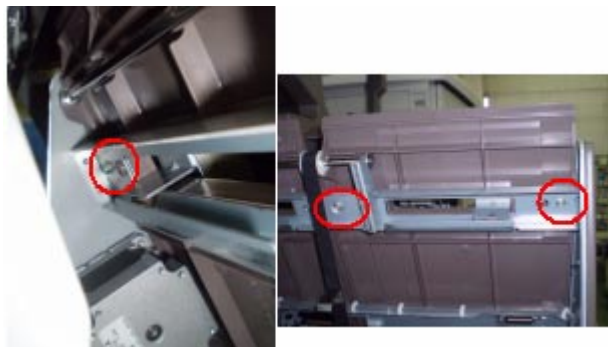
**8. Remove the upper stay (screws x 3) and replace it with P/N B4784738.**
