# Technical Bulletin

Model: MET-C1k	)	e: 27-Nov-14	No.: RD147125		
Subject: Parts ch	nange information for BU3070	tray	Prepared by: E.I	Hinata	
From: 1st Tech S	Service Sect., MFP/P Tech Serv	vice Dept.			
Classification:	<ul> <li>Troubleshooting</li> <li>Mechanical</li> <li>Paper path</li> <li>Product Safety</li> </ul>	Part info	al	 □ Serv	n required ice manual revision ofit information 2

## BU3070 Bridge Unit

## Side Tray Type M3

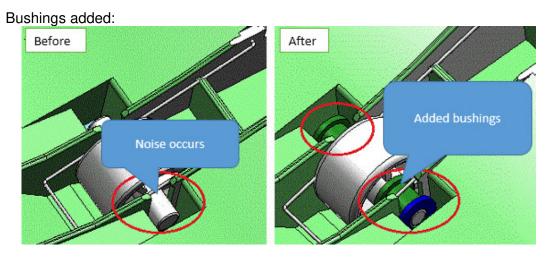
- 1) Bushings were added to the driven roller.
- 2) The position of the gear was changed and grease was added.
- 3) Some parts were deleted from service parts (but still included in assemblies). **See tables below.**

**Reason:** To minimize noise that may occur when the gear contacts the roller.

**IMPORTANT:** Due to the above changes, make sure to replace the cover, side guide plate, and roller shaft **together as a set.**

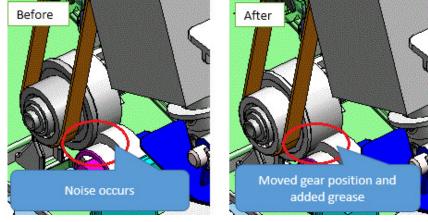
Gear position changed, grease added:

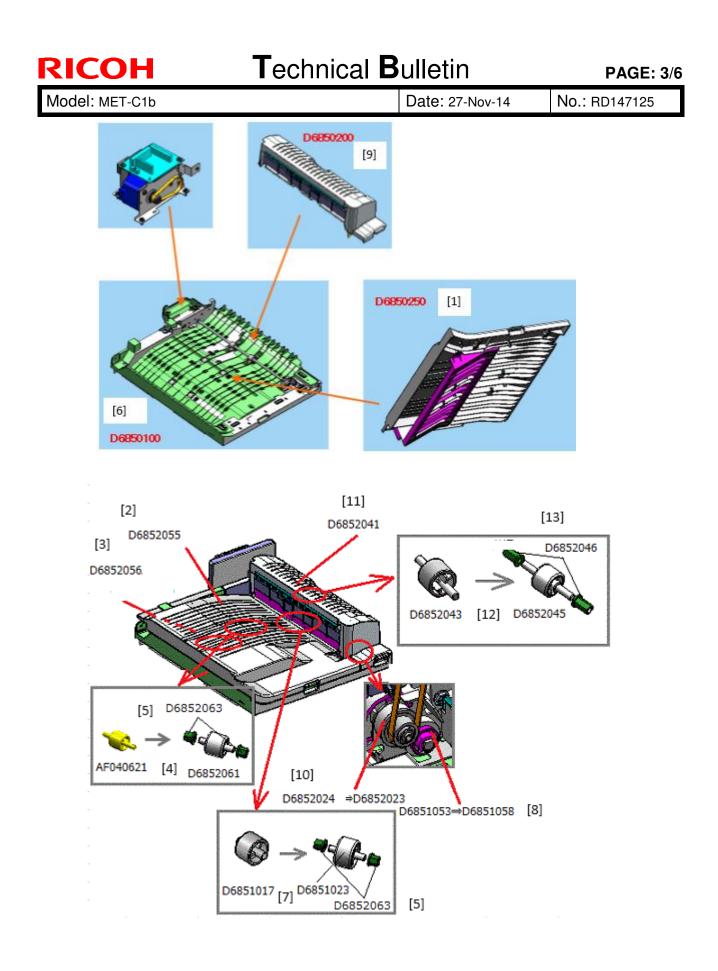
Important: Install parts #4 (D6852061) and #5 together as a set.

Important: Install parts #7 (D6851023) and #5 together as a set.

Important: Install parts #12 (D6852045) and #13 together as a set.

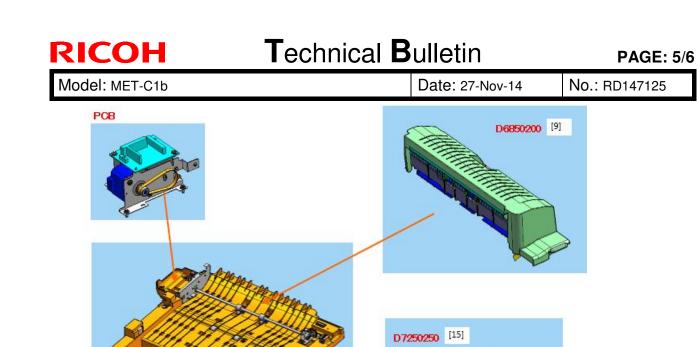
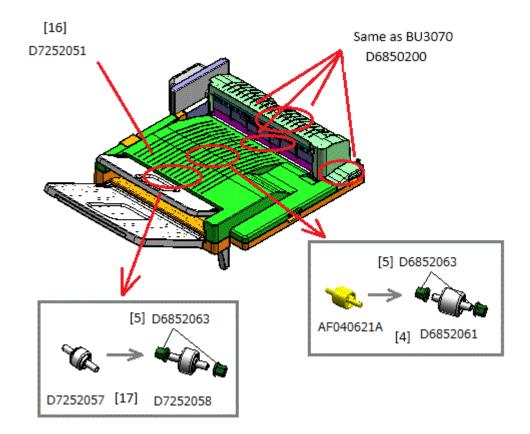
D7250100 [14]

Important: Install parts #7 (D6851023) and #5 together as a set.

Important: Install parts #4 (D6852061) and #5, #5 and #17 (D7252058) together as a set.

Important: Install parts #12 (D6852045) and #13 together as a set.
