Model: Aegis-C1 (D016)	Date: 23-Jan-12	No.: RD016018

Subject: Part Changes; Handle assembly and Shoe	Prepared by: A. Takada
From: PP Tech Service Dept., 1st PP Tech Service Sect.

Model: AG-P1/C1	Date: 13-Feb-12	No.: RD016020

Subject: Parts Changes – Scanner Cover		Prepared by: S. Sasaki
From: 1st PP Tech Service Sec., PP Tech Service Dept.,

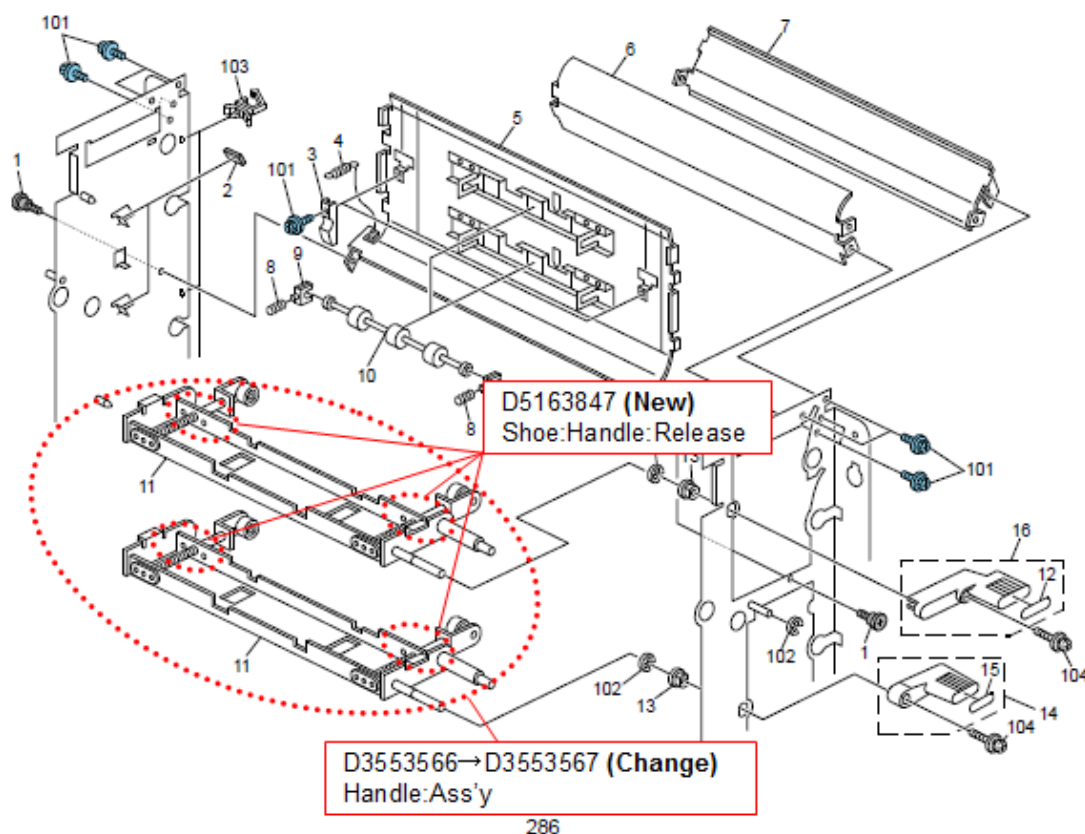
134.Transfer Section 1 (D016)

Change: Shape of the Handle assembly and Shoe

**Reason:** To enable usage of common parts with different products

Shape of the Shoe was partially modified.

Handle was also modified in accordance with the shape change of the Shoe.
　　(Shape of the plate was also modified.)

D5163847 (New)
Shoe:Handle:Release

D3553566→D3553567 (Change)
Handle:Ass'y

- If the unit is now installed with D3553566, replace with D3553567. D5163847 is not needed.
- D5163847 can be attached ONLY to D3553567.
- The modification described in this bulletin also applies to Aries C-1.5 (D095), LCT RT5020 (D355), LCIT RT5050 (D532), and LCIT RT5060 (D516).

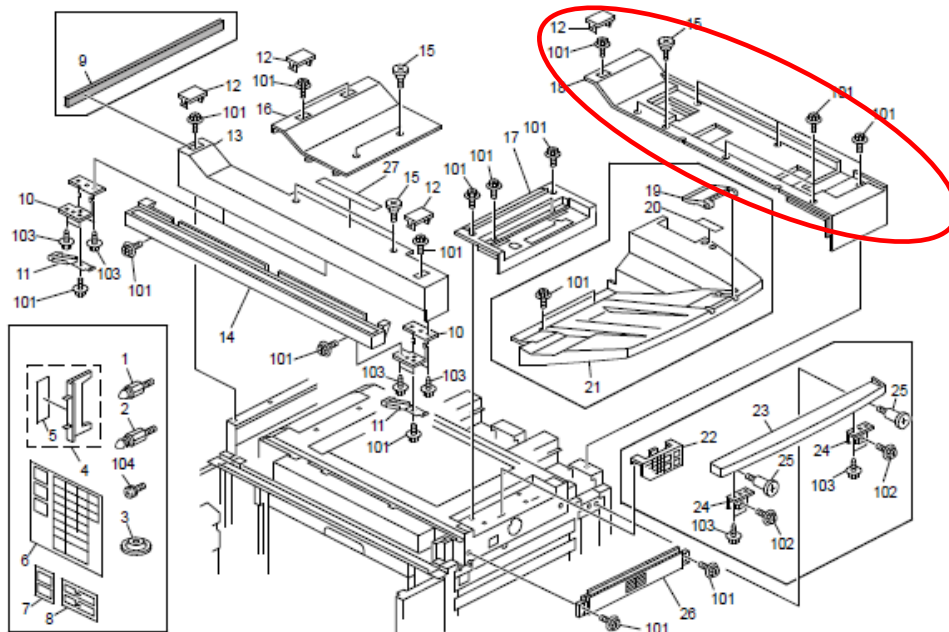
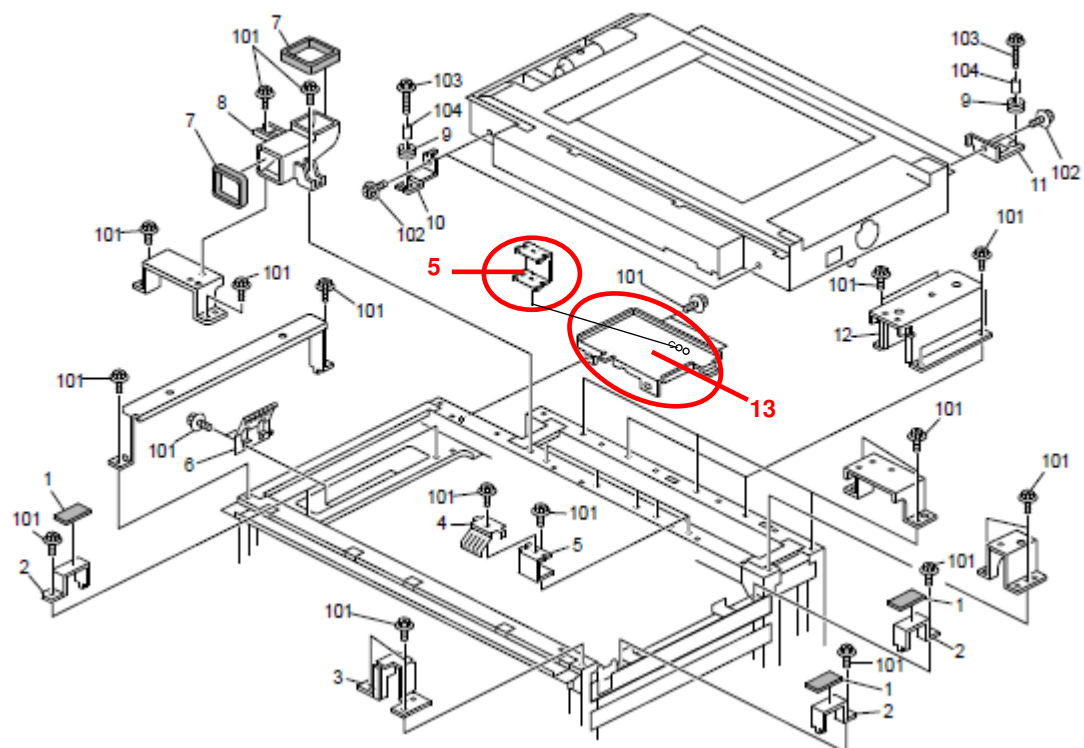
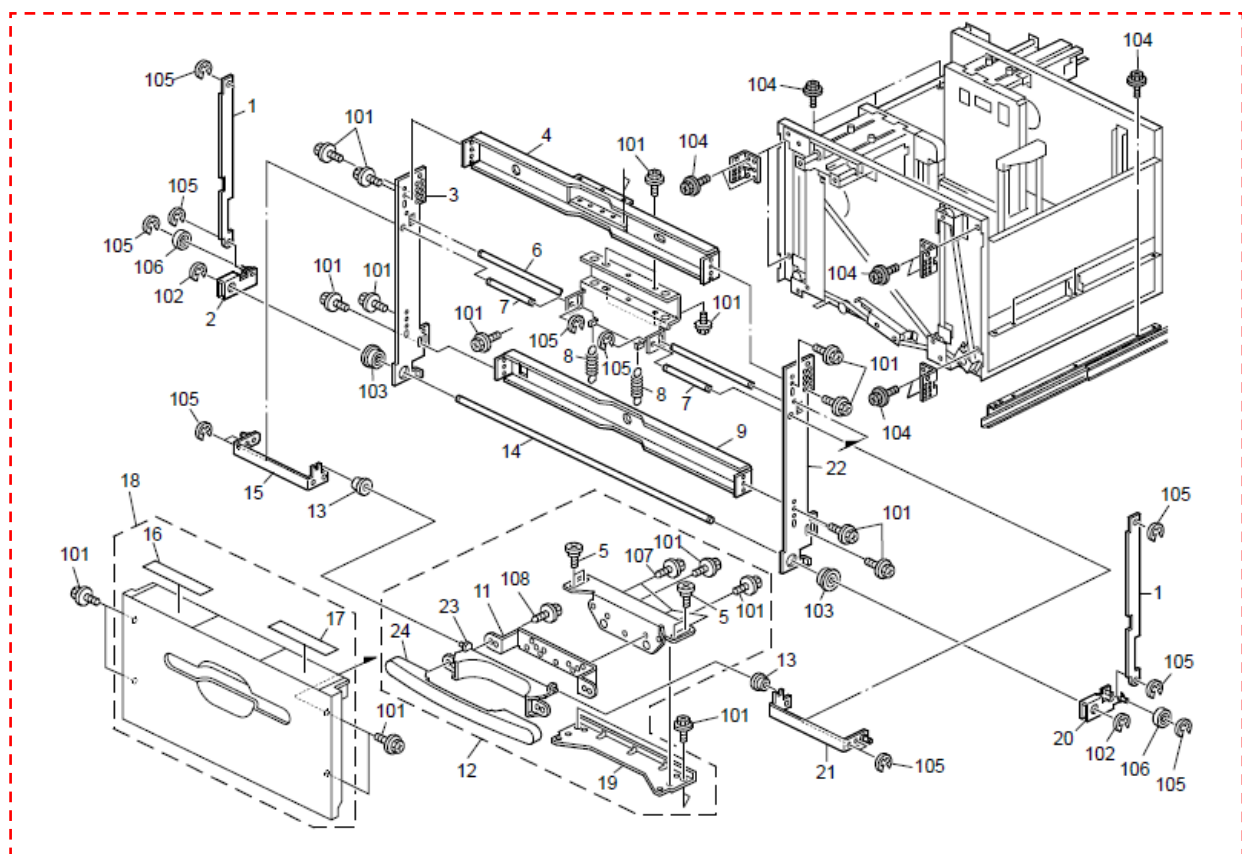
**106.Exterior 1 (D016)**

Change: Material of the scanner cover / addition of brackets

Reason: To improve the durability of the scanner cover

*NOTE 1: Interchangeability is X/O as a set.
