Model: Model C-C1		Date: 13-Apr-04	No.: RB173001
Subject: Service Manual Correction		Prepared by: A. Ishiyama	
From: 1st Technical Support sec. Service Support Dept.			
Classification:	<input type="checkbox"/> Troubleshooting <input type="checkbox"/> Mechanical <input type="checkbox"/> Paper path <input type="checkbox"/> Other (      )	<input type="checkbox"/> Part information <input type="checkbox"/> Electrical <input type="checkbox"/> Transmit/receive	<input type="checkbox"/> Action required <input checked="" type="checkbox"/> Service manual revision <input type="checkbox"/> Retrofit information

Please apply the following revisions to your Service Manuals. This bulletin contains the revised pages only, which has been posted to the RISSN server along with a separate full-manual version.

Model: Model C-C1		Date: 2-Jul-04	No.: RB173002
Subject: Machine Firmware History		Prepared by: A. Ishiyama	
From: 1st Technical Support Sec. Service Support Dept.			
Classification:	<input type="checkbox"/> Troubleshooting <input type="checkbox"/> Mechanical <input type="checkbox"/> Paper path <input type="checkbox"/> Other (      )	<input type="checkbox"/> Part information <input type="checkbox

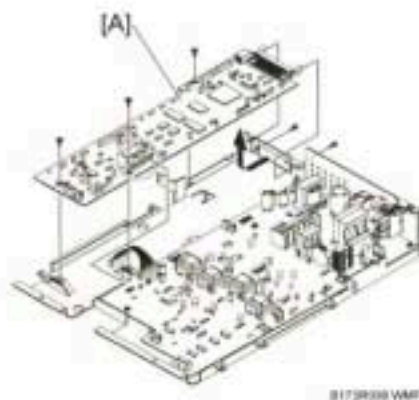
### 3.10 MAIN PBA (MAIN BOARD)

**NOTE:** 1) Print out the system data list in Tech mode to keep programmed data before you do the replacement procedure.  
2) Do the "Clear All Memory" in Tech mode (➡ 5.2.3) after you finish the replacement procedure.

1. Before you remove the main PBA, you must remove these:
  - Rear cover (➡ 3.2)
  - Side covers (➡ 3.3)
  - Scanner Ass'y (➡ 3.5)
  - Engine shield ass'y (➡ 3.9)
2. Disconnect one connector. Then remove the five screws from the main PBA. Then remove the main PBA [A].
