Model: CM-C1			Dat	e: 12-Jan-06	No.: RB273001a		
RTB Correction The items in bold italics have been corrected or added.							
Subject: Countermeasure for poor image quality Prepared by: T. Shintani					Shintani		
From: 1st Tech. Support Sec. Service Support Dept.							
Classification:		☐ Part info	rmat	tion	n required		
	☐ Mechanical	☐ Electrica	al	☐ Servi	ce manual revision		
	☐ Paper path	☐ Transm	it/rec	eive	fit information		
	☐ Product Safety	Other ()

Model: Model CM-C1			Dat	ate: 1-Feb-06		No.: RB273002
Subject: Limitat	(Prepared	by: T.SI	hintani		
From: 1st Tech. Support Sec. Service Support Dept.						
Classification:	☐ Troubleshooting	☐ Part info	ormat	tion [Action	required
		☐ Electric	al		Servic	e manual revision
	☐ Paper path	☐ Transm	it/rec	eive [Retrof	it information
	⊠ Other ()

Model: Model CM-C1		Date: 6-Nov-06)6	No.: RB273006	
Subject: Light copy image		Prepared by: T.Shintani		hintani		
From: 1st Tech. Support Sec. Service Support Dept.						
Classification:	assification: Troubleshooting Part inform Mechanical Electrical			tion		required ce manual revision
	☐ Paper path ☐ Other ()	☐ Transm	it/rec	eive	Retrot	fit information

Subject: Machine stall problem		Prep

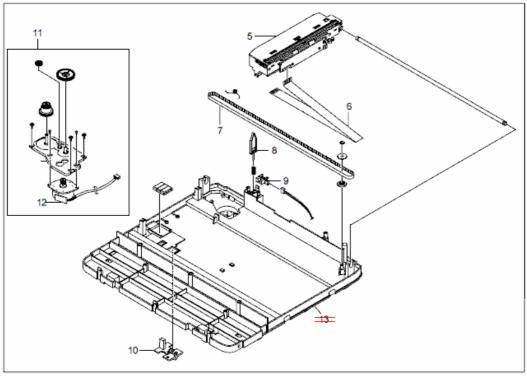
Change: The lower scanner cover was deleted and the scanner unit was newly registered. **Reason:** The parts vendor stopped supplying the cover as an individually replaceable part.

Old part	New part	Description	Q'ty	Int	Page	Index	Note
number	number						
	B2739810	Scanner Unit	1	-	15	*	
B2739582		Cover - Scanner Lower	0	-	15	13

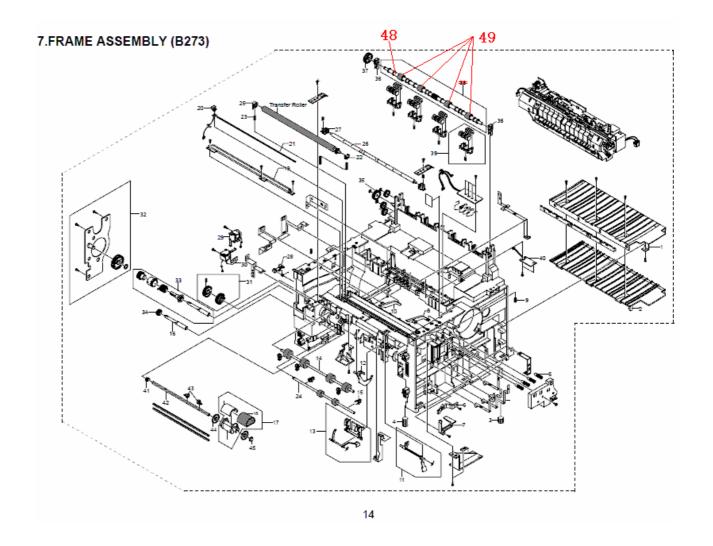
Reason: The Parts Catalog was corrected.

Old Part Number	New Part Number	Description	Q'ty	Int	Page	Index	Note
H9149725	H9149725	EXIT ROLLER POLE	1	0/0	14	38→48	
113143723	G1449752	EXIT ROLLER	4		14	38→49
