Model: Model S-C2		Date: 25-May-04	No.: RB129001
Subject: When installing the optional paper tray unit (B421)		Prepared by: A. Ishiyama	
From: 1st Tech. Support Sec. Service Support Dept.			
Classification:	<input checked="" type="checkbox"/> Troubleshooting	<input type="checkbox"/> Part information	<input checked="" type="checkbox"/> Action required
	<input type="checkbox"/> Mechanical	<input type="checkbox"/> Electrical	<input type="checkbox"/> Service manual revision
	<input type="checkbox"/> Paper path	<input type="checkbox"/> Transmit/receive	<input type="checkbox"/> Retrofit information
	<input type="checkbox"/> Other ()

Model: Stella-C2		Date: 23-Jul-04	No.: RB129002
Subject: PS3 Option not functioning		Prepared by: M. Ishihara	
From: 1st Tech. Support Sec. Service Support Dept.			
Classification:	<input checked="" type="checkbox"/> Troubleshooting	<input type="checkbox"/> Part information	<input checked="" type="checkbox"/> Action required
	<input type="checkbox"/> Mechanical	<input type="checkbox"/> Electrical	<input type="checkbox"/> Service manual revision
	<input type="checkbox"/> Paper path	<input type="checkbox"/> Transmit/receive	<input type="checkbox"/> Retrofit in

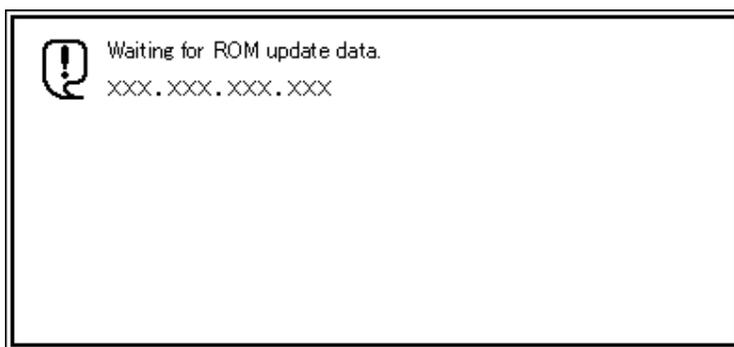
- If an error occurs during the update, the system automatically restarts, the message shown below appears, and the machine waits to receive the firmware file again. If the update is interrupted by a power failure, the same thing happens once the power is restored.

The following message appears for Type 1 firmware:
