Model: Stella-C1		Date: 9-Jan-02	No.: RB044001
Subject: PS2 Option		Prepared by: K. Ugaeri	
From: Technical Services Dept., GTS Division			
Classification:	<input checked="" type="checkbox"/> Troubleshooting <input type="checkbox"/> Mechanical <input type="checkbox"/> Paper path <input type="checkbox"/> Other (      )	<input type="checkbox"/> Part information <input type="checkbox"/> Electrical <input type="checkbox"/> Transmit/receive	<input checked="" type="checkbox"/> Action required <input type="checkbox"/> Service manual revision <input checked="" type="checkbox"/> Retrofit information

Subject: Optional Printer Controller		Prepared by: A. Ishiyama	
From: Technical Services sec. Service Planning Dept.			
Classification:	<input checked="" type="checkbox"/> Troubleshooting	<input type="checkbox"/> Part information	<input checked="" type="checkbox"/> Action required
	<input type="checkbox"/> Mechanical	<input type="checkbox"/> Electrical	<input type="checkbox"/> Service manual revision
	<input type="checkbox"/> Paper path	<input type="checkbox"/> Transmit/receive	<input type="checkbox"/> Retrofit information
	<input type="checkbox"/> Other (       )

Model: Stella-C1		Date: 05-Ap

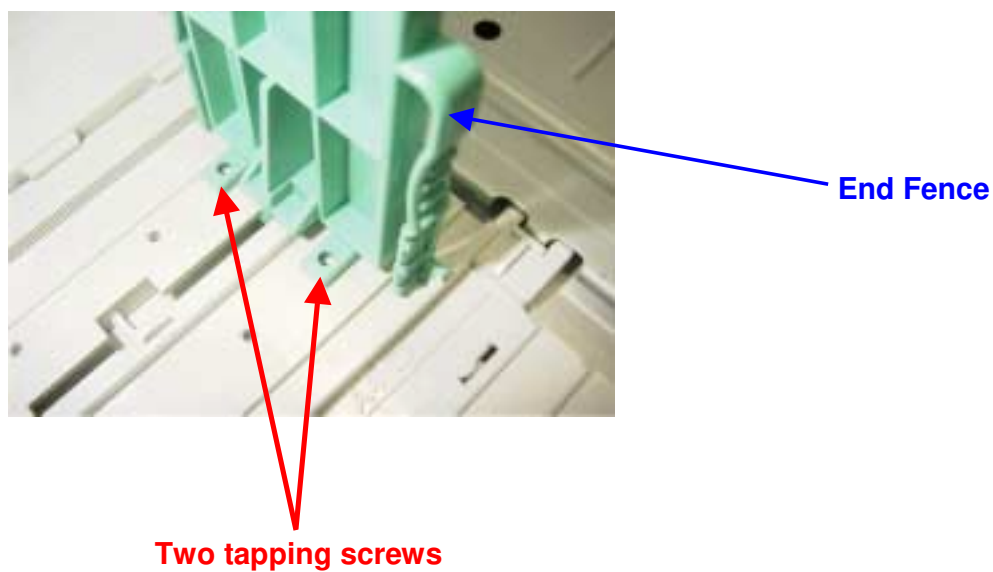
## Fixing the End Fence in Place

- Depending on the usage conditions of the customer, it may advantageous to fix the end fence in place as well. This requires two tapping screws, which are not included with the tray unit.
- Please inform the customer that once the side fence is secured in place, 1) the paper size cannot be changed (until the next service visit), and 2) moving the fixed fence by force may damage the fence and/or cassette base.

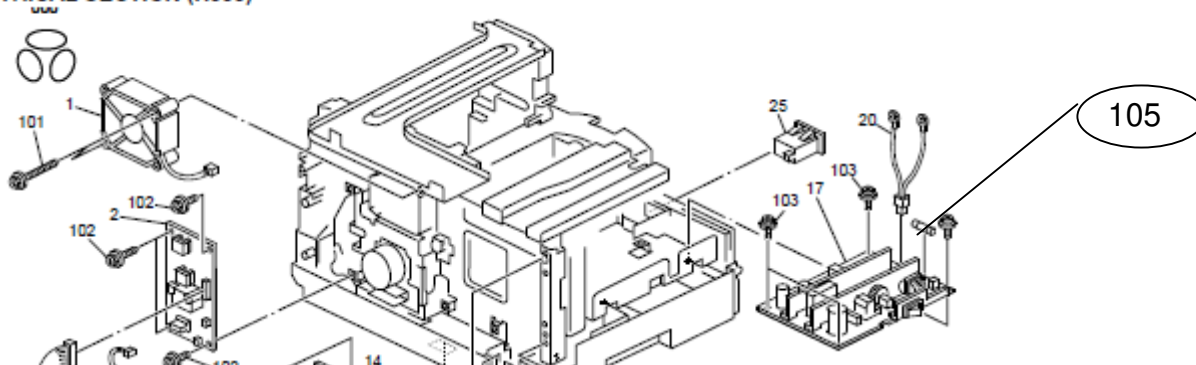
## 14.ELECTRICAL SECTION (H555)

**Change/Cause:** Index number 105 was missing.
