| Model: Model S-F2 | | Date: 30-Jan-03 | No.: RH556001 |
| Subject: Service Manual Correction (Model S-F2) | | Prepared by: M. Mano | |
| From: Technical Service Sec. Service Planning Dept. | | | |

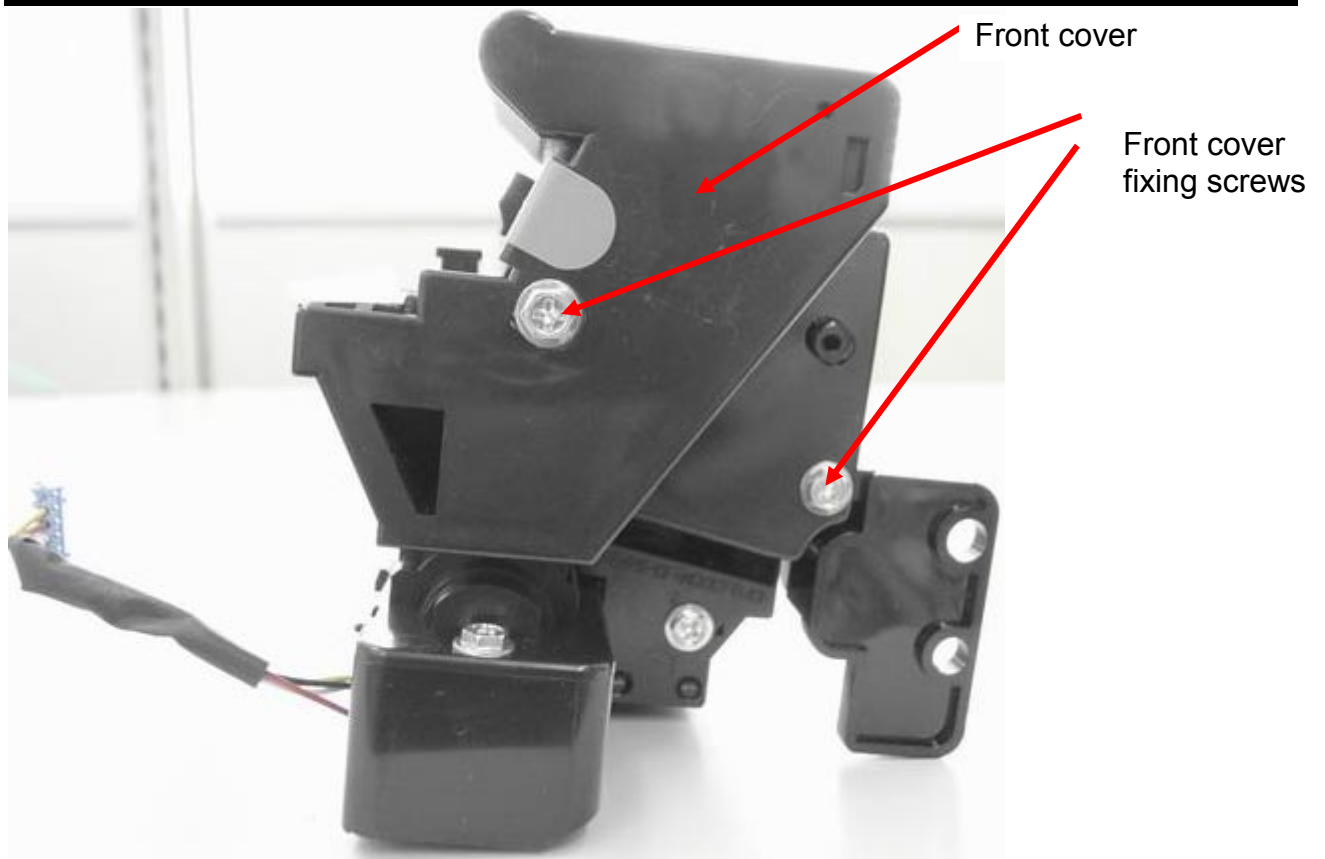
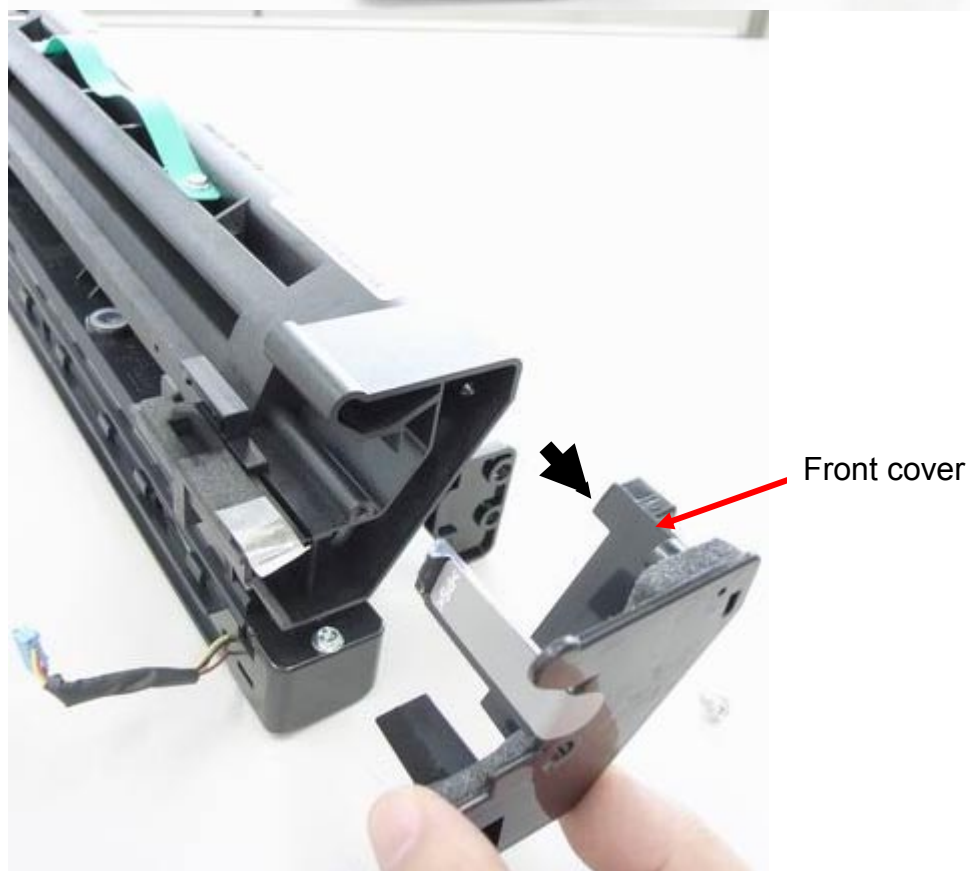
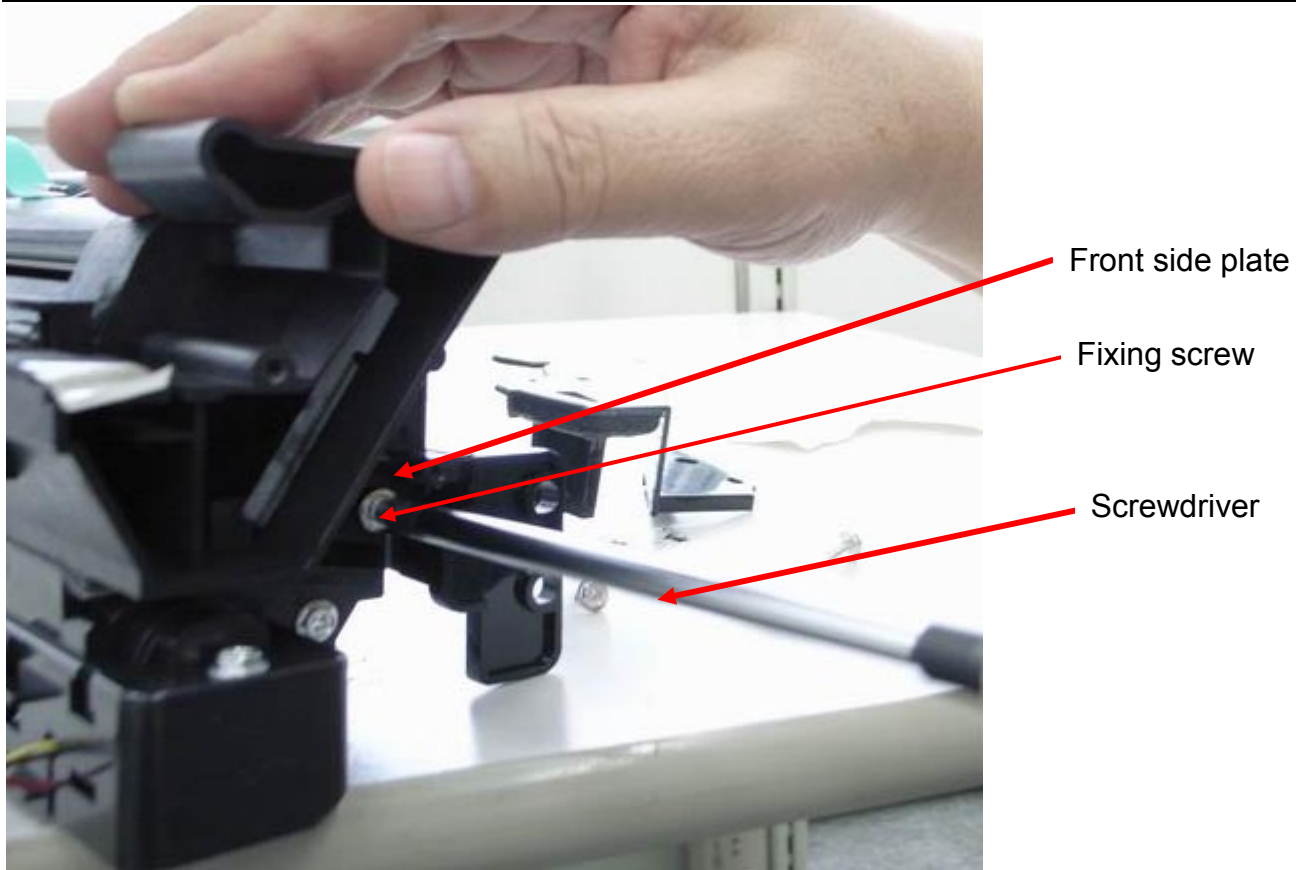
During the installation of a new machine, developer leaks out of the PCU.

This is caused by one or more of the following:

4. Loosen the fixing screw for the front side plate.
 5. Press the front side plate in the direction of the white arrow (**see the photo on the next page**).
- Note:** This is to eliminate the gap between the front side plate and the PCU base.
