Model: Russian-C2		Date: 24-Oct-01	No.: RB022001
Subject: The fax function does not work		Prepared by: S. Tomoe	
From: Technical Services Dept., GTS Division			
Classification:	<input checked="" type="checkbox"/> Troubleshooting	<input type="checkbox"/> Part information	<input type="checkbox"/> Action required
	<input type="checkbox"/> Mechanical	<input type="checkbox"/> Electrical	<input type="checkbox"/> Service manual revision
	<input type="checkbox"/> Paper path	<input type="checkbox"/> Transmit/receive	<input type="checkbox"/> Retrofit information
	<input type="checkbox"/> Other ()

Model: Russian-C2		Date: 26-Oct-01	No.: RB022002
Subject: Major differences between Russian-C1 and Russian-C2		Prepared by: S. Tomoe	
From: Technical Services Dept., GTS Division			
Classification:	<input type="checkbox"/> Troubleshooting <input type="checkbox"/> Part information <input type="checkbox"/> Action required <input type="checkbox"/> Mechanical <input type="checkbox"/> Electrical <input type="checkbox"/> Service manual revision <input type="checkbox"/> Paper path <input type="checkbox"/> Transmit/receive <input type="checkbox"/> Retrofit information <input checked="" type="checkbox"/> Ot

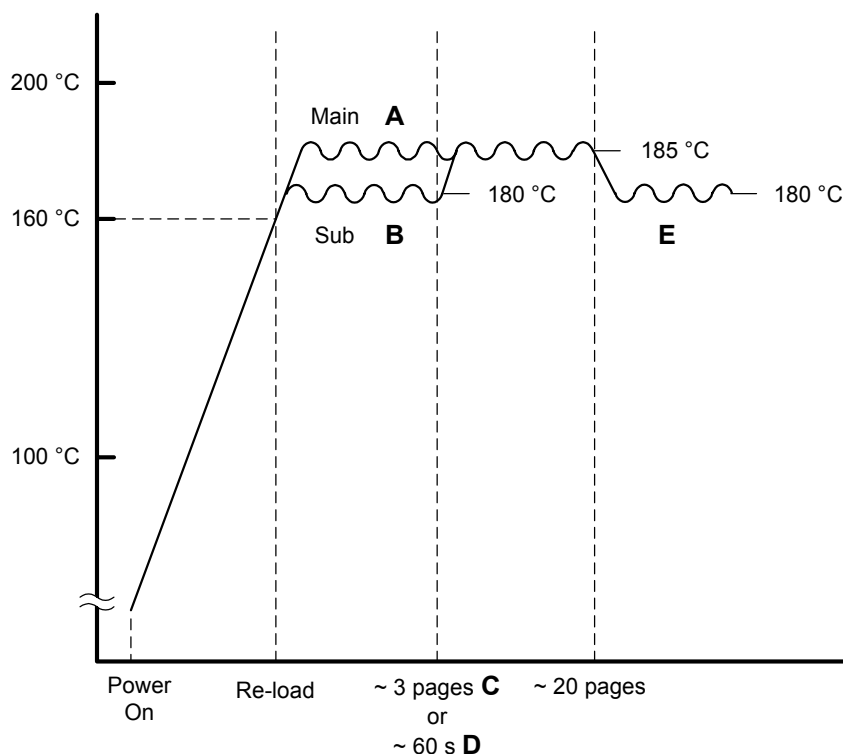
3. Fusing Temperature Control

The fusing temperatures for each stage following warm-up have been increased to the values shown below. Also, the fusing temperature for Energy Saver Mode has been increased from 150 to 160 degrees C.

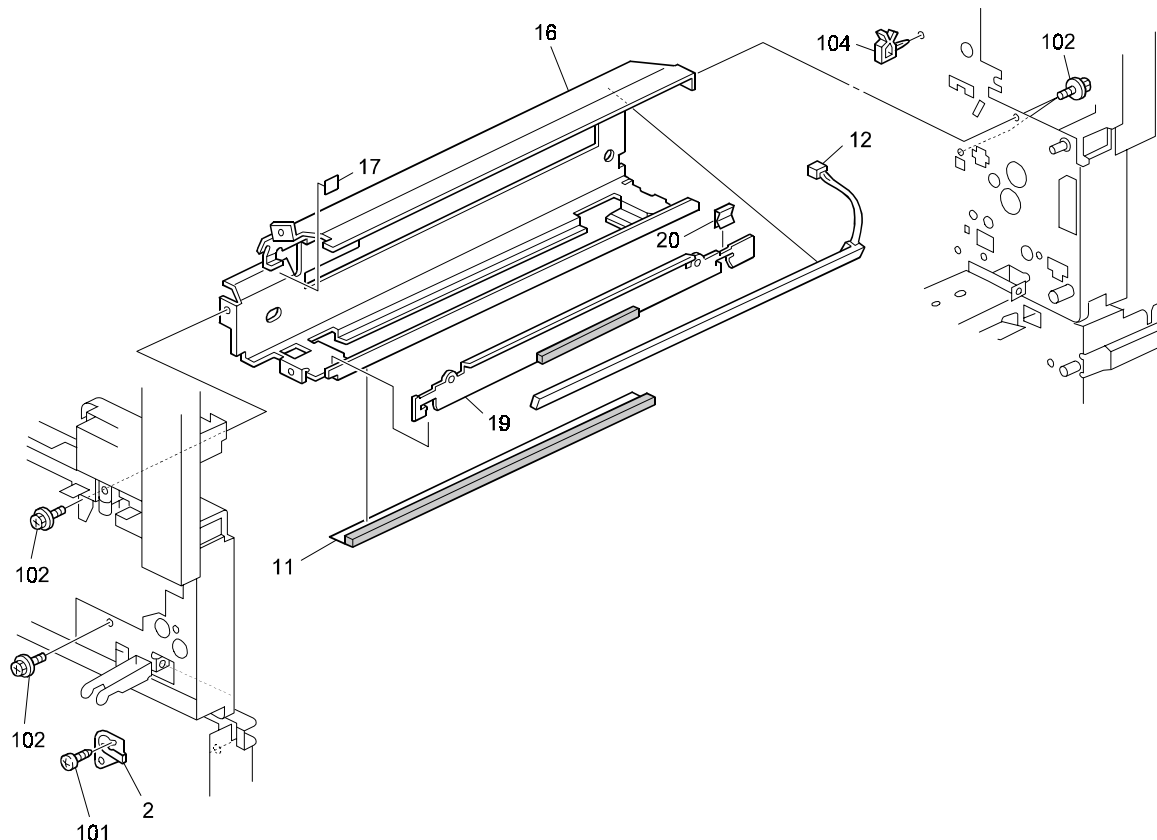
In accordance with this change, the shape of the PCU Guide Plate has also been changed.

Old part number	New part number	Description	Q'ty	Int	Page	Index	Note
B0241051	B0271051	PCU Guide Plate	1-1	X/O	35	16	
	B0272711	Cleaning Pad – Regist Roller	0-1	X/O	35	19	
	B0272714	Clip	0-1	X/O	35	20
