Model: Adonis-C2		Date: 23-May-01	No.: RB003001
Subject: Software Release Information		Prepared by: K. Takagi	
From: Technical Services Dept., GTS Division			
Classification:	<input type="checkbox"/> Troubleshooting <input type="checkbox"/> Part information <input type="checkbox"/> Action required <input type="checkbox"/> Mechanical <input type="checkbox"/> Electrical <input type="checkbox"/> Service manual revision <input type="checkbox"/> Paper path <input type="checkbox"/> Transmit/receive <input type="checkbox"/> Retrofit information <input checked="" type="checkbox"/> Other ()

Model: Adonis-C2		Date: 24-Jul-01	No.: RB003009
Subject: Service Card Release History (MFP)		Prepared by: K. Takagi	
From: Technical Services Dept., GTS Division			
Classification:	<input type="checkbox"/> Troubleshooting <input type="checkbox"/> Part information <input type="checkbox"/> Action required <input type="checkbox"/> Mechanical <input type="checkbox"/> Electrical <input type="checkbox"/> Service manual revision <input type="checkbox"/> Paper path <input type="checkbox"/> Transmit/receive <input type="checkbox"/> Retrofit information <input checked="" type="checkbox"/> Other ()

Model: Adonis-

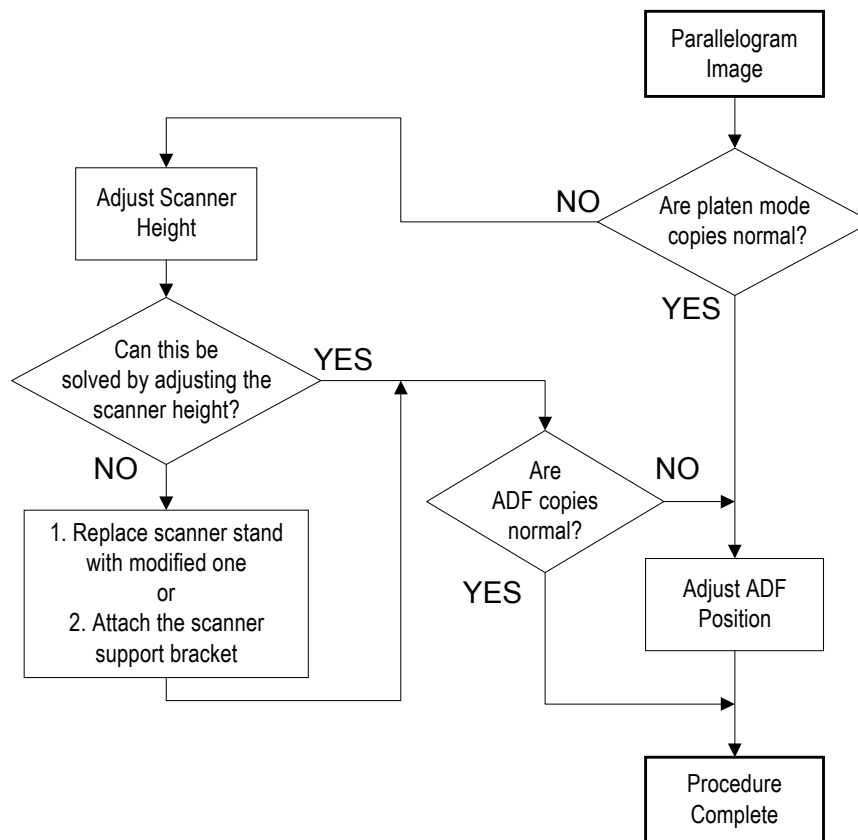
ADF Position Adjustment

When the copy image comes out as shown above, please follow the flow chart on the next page and perform the necessary adjustment.

- 1.1 Remove the screw [A] that secures the Right ADF hinge to the scanner.
- 1.2 Remove the black seal [B] from the Right ADF hinge.
- 1.3 Insert the screw [A] into the slotted hole, but do not tighten it yet.
- 1.4 Adjust the ADF position [C] until the skew disappears.
- 1.5 Tighten the screws to fix the ADF in place.

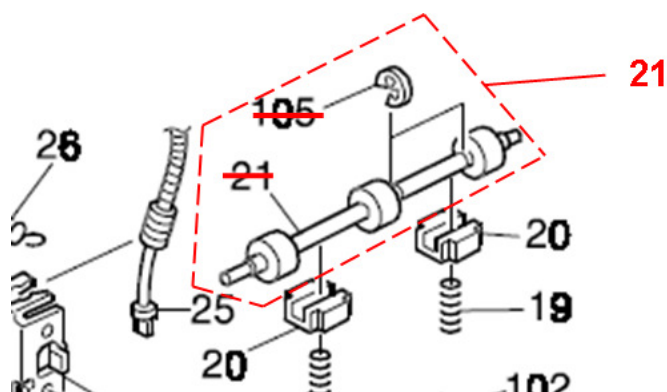
Change: The retaining ring was deleted as an individual service part and included as part of the driven roller service part.

Reason: It is no longer possible to provide the retaining ring as an individual service part.
