Model: General RTB	Date: 4-Feb-03	No.: RGene013b
--------------------	----------------	----------------

Subject: Service remarks at installation		Prepared by: T. Itoh	
From: Technical Service Sec. Service Planning Dept.			
Classification:	<input type="checkbox"/> Troubleshooting	<input type="checkbox"/> Part information	<input type="checkbox"/> Action required
	<input type="checkbox"/> Mechanical	<input type="checkbox"/> Electrical	<input type="checkbox"/> Service manual revision
	<input type="checkbox"/> Paper path	<input type="checkbox"/> Transmit/receive	<input type="checkbox"/> Retrofit information
	<input checked="" type="checkbox"/> Other (Specification change)

Model: Adonis-C3	Date: 1-Apr-03	No.: RB082005a
------------------	----------------	----------------

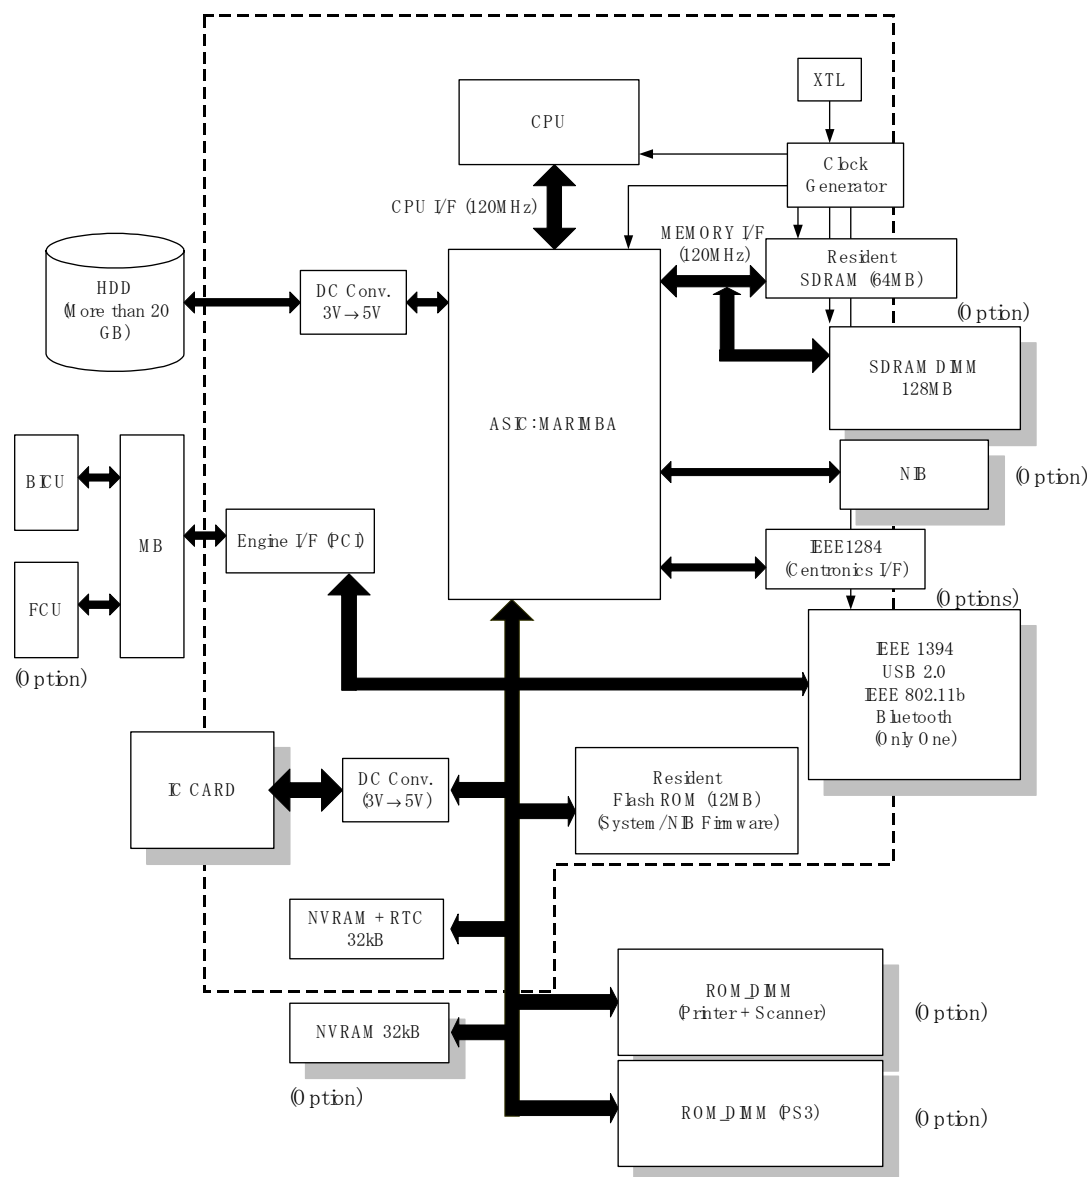
6.1.2 Controller (Page 6-4)

REVISE the following so that “256MB” is removed from the SDRAM DIMM box.

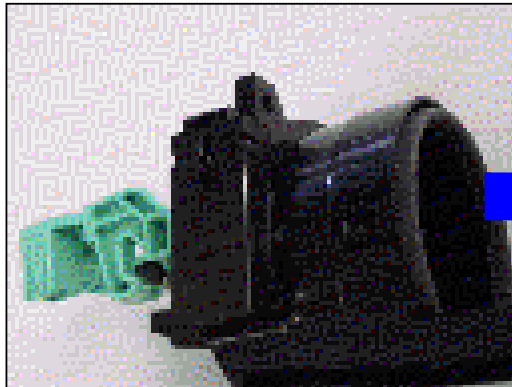
Preventing old/new toner mixing in the development unit.

1. Lower the green lever of the toner supply unit.
2. Clean the unit by vacuuming out the toner inside.

Vacuum out toner
inside

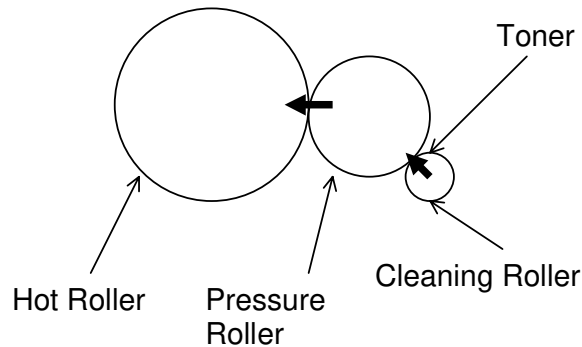
Factors for high roller temperature:

- Since the default fusing temperature is higher on the 45cpm model, the fusing unit internal temperature and therefore cleaning roller temperature is generally higher.
- The fusing temperature on both the 35/45cpm models is sometimes set higher as part of a solution for cold offset.
- The internal temperature rises when high-volume, continuous duplex jobs of 1-to-15 or more are performed on high-ACV machines.

1. Replace the cleaning roller.
2. If the fusing temperature (SP1105-001, -002) had been set higher than default, return it to its default value.
 - However, if the fusing temperature is being set above default as a solution to cold offset, simply make sure this temperature does not exceed the following:

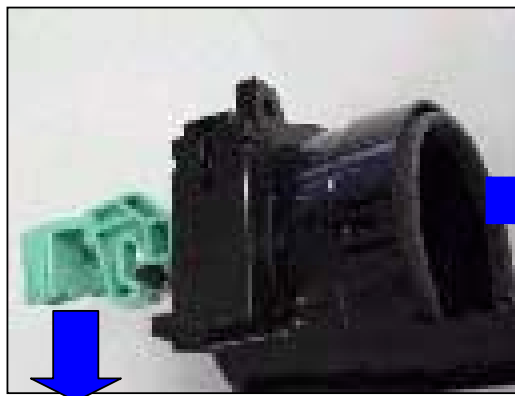
Preventing old/new toner mixing in the development unit.

1. Lower the green lever of the toner supply unit.
2. Clean the unit by vacuuming out the toner inside.

Pull down the green lever

Vacuum out toner
inside

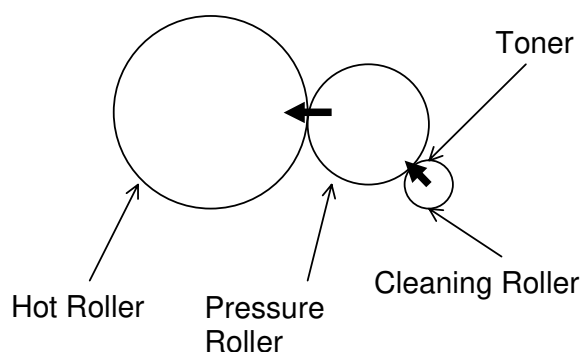
Causes of high roller temperature:

- Since the default fusing temperature is higher on the 45cpm model, the fusing unit internal temperature and therefore cleaning roller temperature is generally higher.
- The fusing temperature on both the 35/45cpm models is sometimes set higher as part of a solution for cold offset.
- The internal temperature rises when high-volume, continuous duplex jobs of 1-to-15 or more are performed on high-ACV machines.

If the symptom is reported in the field, do the following:
