Model: Adonis-C3e/f	Date: 11-Nov-03	No.: RB135001a
---------------------	-----------------	----------------

Subject: Firmware Release History (BICU)		Prepared by: Y.Urushihara	
From: 1st Tech. Support Sec. Service Support Dept.			
Classification:	<input type="checkbox"/> Troubleshooting <input type="checkbox"/> Mechanical <input type="checkbox"/> Paper path <input checked="" type="checkbox"/> Other ()	<input type="checkbox"/> Part information <input type="checkbox"/> Electrical <input type="checkbox"/> Transmit/receive	<input type="checkbox"/> Action required <input type="checkbox"/> Service manual revision <input type="checkbox"/> Retrofit information

This RTB has been issued to announce the firmware release information for the BICU.

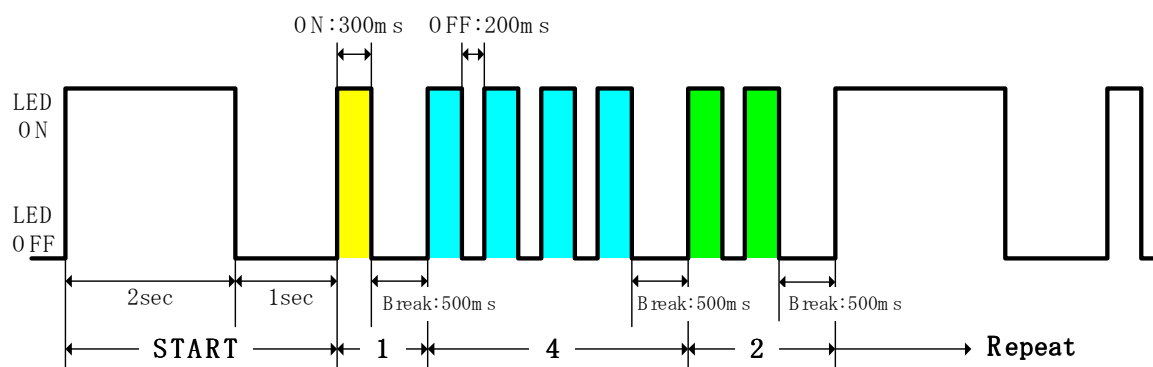
2-2. Flashing pattern when an SC has occurred:
Example: Error code **1-4-2**. (Jogger Motor Error).

- START: 2 sec ON, 1 sec OFF
- 1: 300ms ON → 500ms Break (OFF)
- 4: 300ms ON, 200ms OFF (repeat 3 times) → 300ms ON → 500ms Break
- 2: 300ms ON, 200ms OFF → 300ms ON → 500ms Break
- Return to START and repeat.

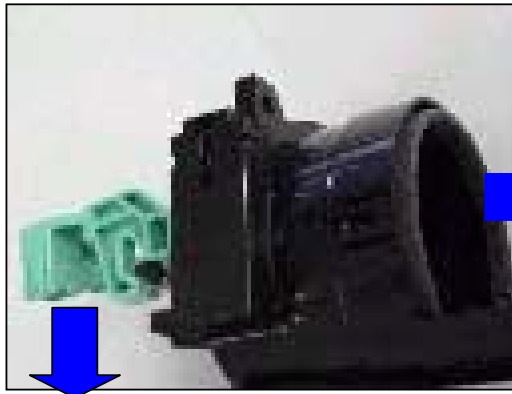
Preventing old/new toner mixing in the development unit.

1. Lower the green lever of the toner supply unit.
2. Clean the unit by vacuuming out the toner inside.

Pull down the green lever

Vacuum out toner
inside

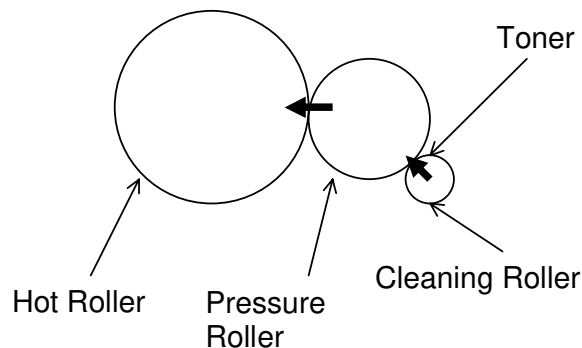
Factors for high roller temperature:

- Since the default fusing temperature is higher on the 45cpm model, the fusing unit internal temperature and therefore cleaning roller temperature is generally higher.
- The fusing temperature on both the 35/45cpm models is sometimes set higher as part of a solution for cold offset.
- The internal temperature rises when high-volume, continuous duplex jobs of 1-to-15 or more are performed on high-ACV machines.

SOLUTION

1. Replace the cleaning roller.
2. If the fusing temperature (SP1105-001, -002) had been set higher than the default, return it to its default value.
 - However, if the fusing temperature is being set above default as a solution to cold offset, simply make sure this temperature does not exceed the following:

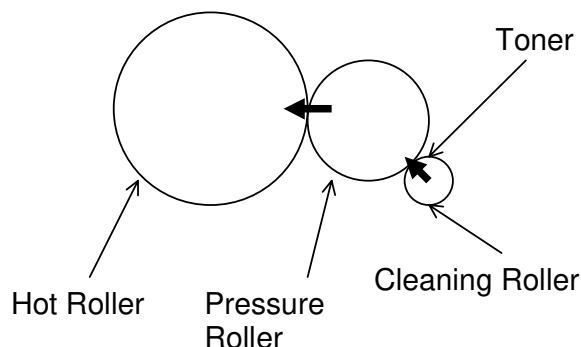
Causes of high roller temperature:

- Since the default fusing temperature is higher on the 45cpm model, the fusing unit internal temperature and therefore cleaning roller temperature is generally higher.
- The fusing temperature on both the 35/45cpm models is sometimes set higher as part of a solution for cold offset.
- The internal temperature rises when high-volume, continuous duplex jobs of 1-to-15 or more are performed on high-ACV machines.

SOLUTION

If the symptom is reported in the field, do the following:

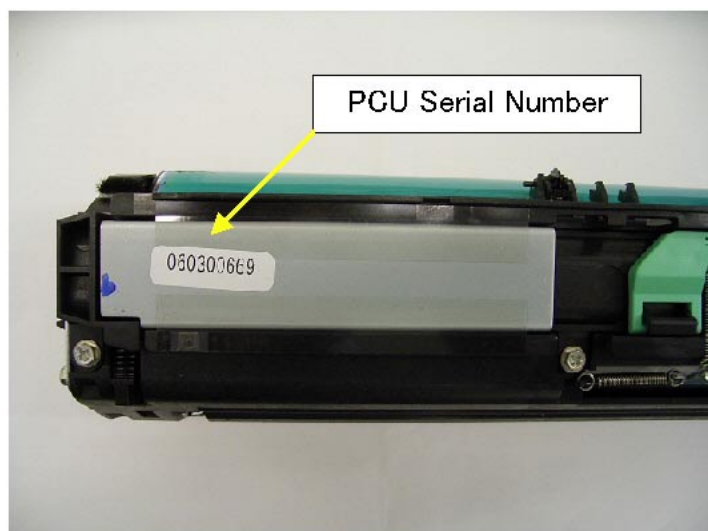
The symptom only occurs on the following service parts PCUs:

Service Parts P/N (PCU)	PCU Serial Number (PCU)	Model on which the PCU is used:
B0822203	051000001 - 060302100	Model A-C3/A-C3e/f
